**Re: June 2023 – Monthly Monitoring Report for Water License 2AM-DOH1335**

This report is comprised of the monitoring requirements set out in Part I and Schedule I of water licence 2AM-DOH1335 Amendment 2 (the license), and additional requirements from CIRNAC.

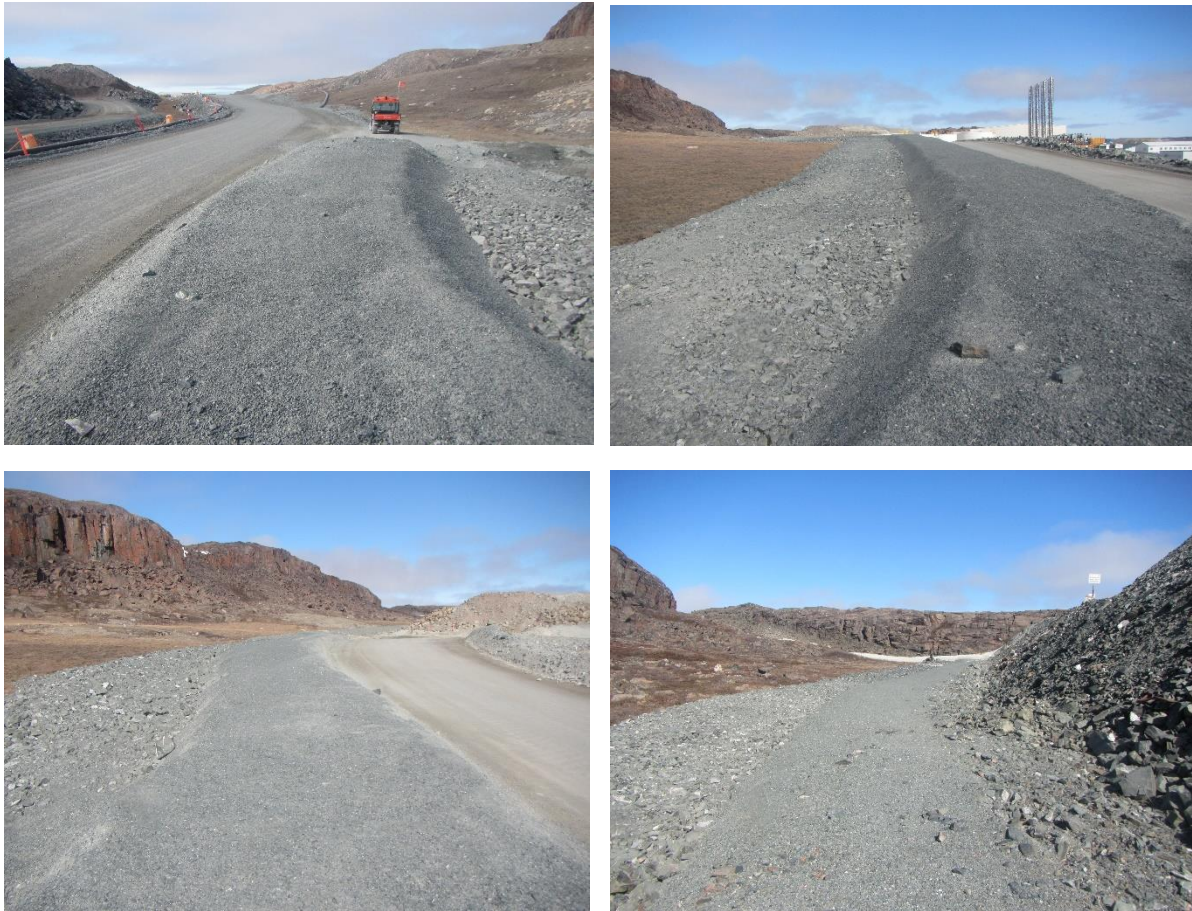
Visual monitoring was conducted at the Diversion Berm this month. No issues were identified at the Diversion Berm and associated check dam. Photos of this infrastructure are provided in Figure 3 below. Inspections of site culverts throughout the month of June were resumed.

**Figure 3. Diversion berm during June 2023**

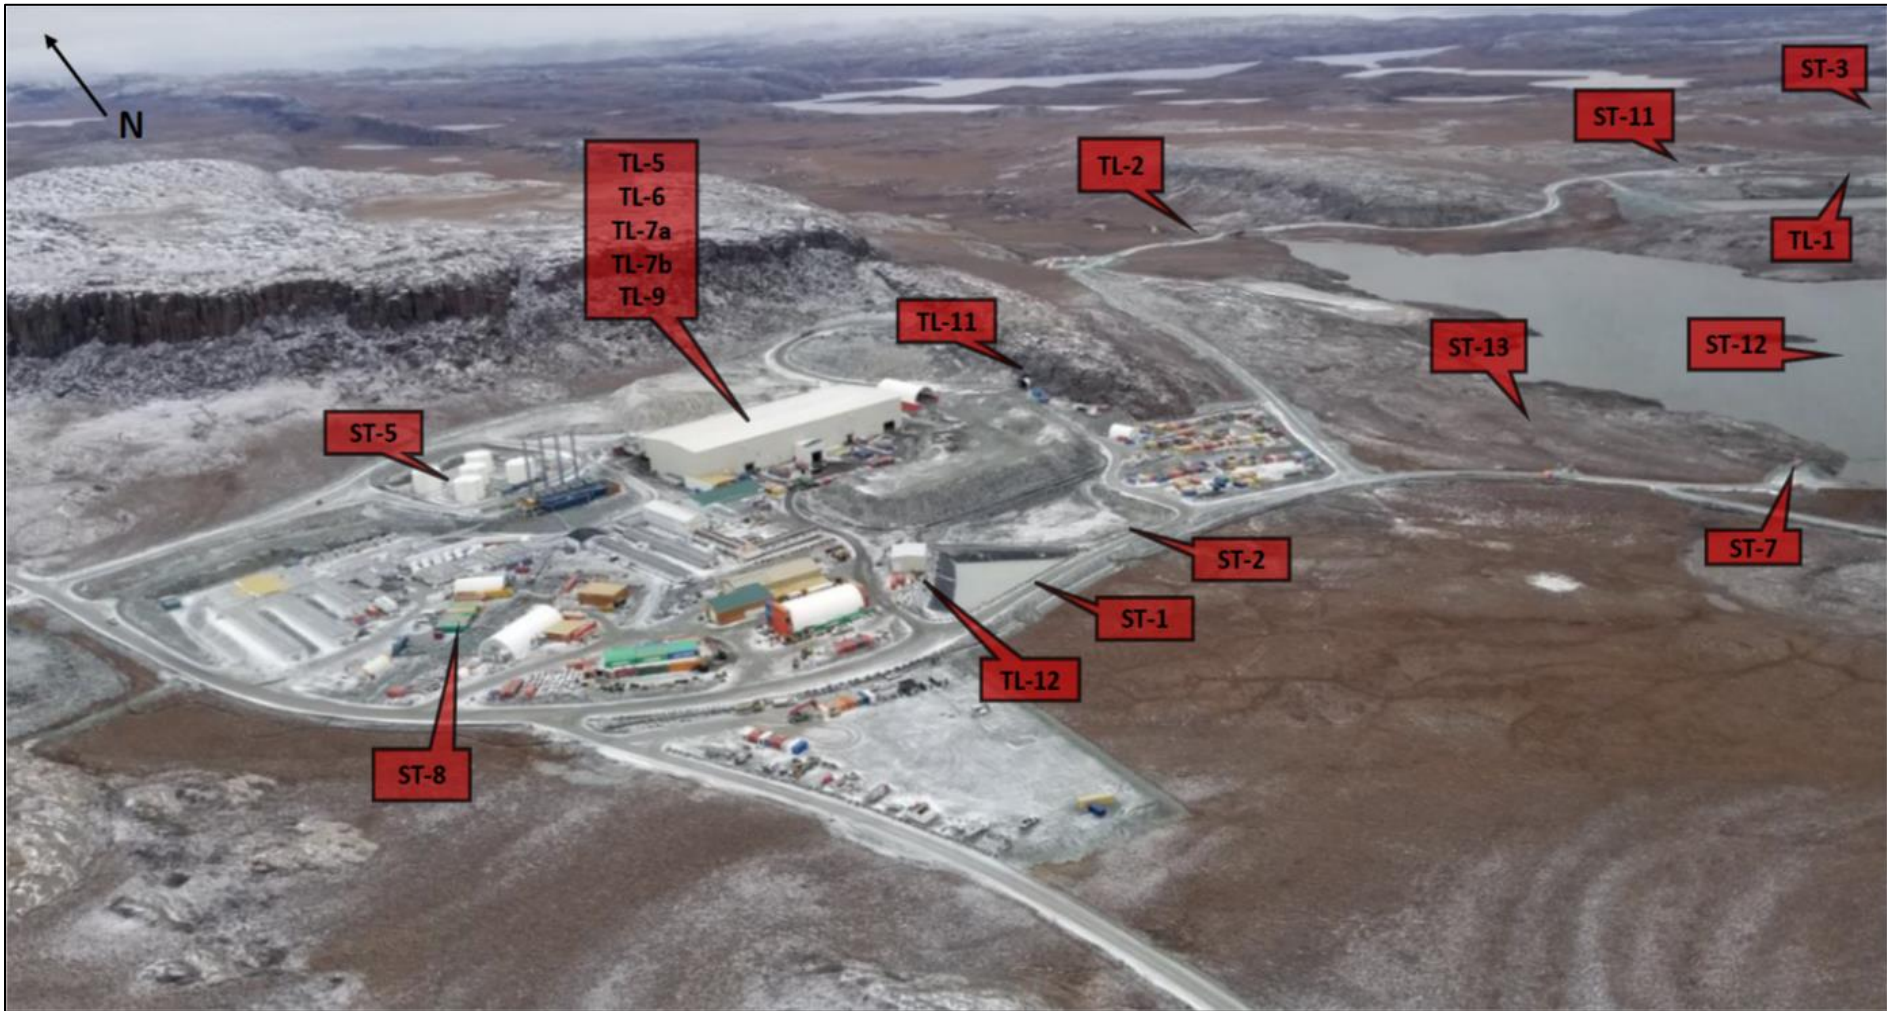
Figure 6. 2AM-DOH1335 SNP Monitoring Locations

Sampling locations monitored under this licence (seasonally or when facilities are operational) are provided in Figure 6 through Figure 8 at the end of this report.
