Re: July 2023 – Monthly Monitoring Report for Water License 2AM-DOH1335

This report is comprised of the monitoring requirements set out in Part I and Schedule I of water licence 2AM-DOH1335 Amendment 2 (the license), and additional requirements from CIRNAC.

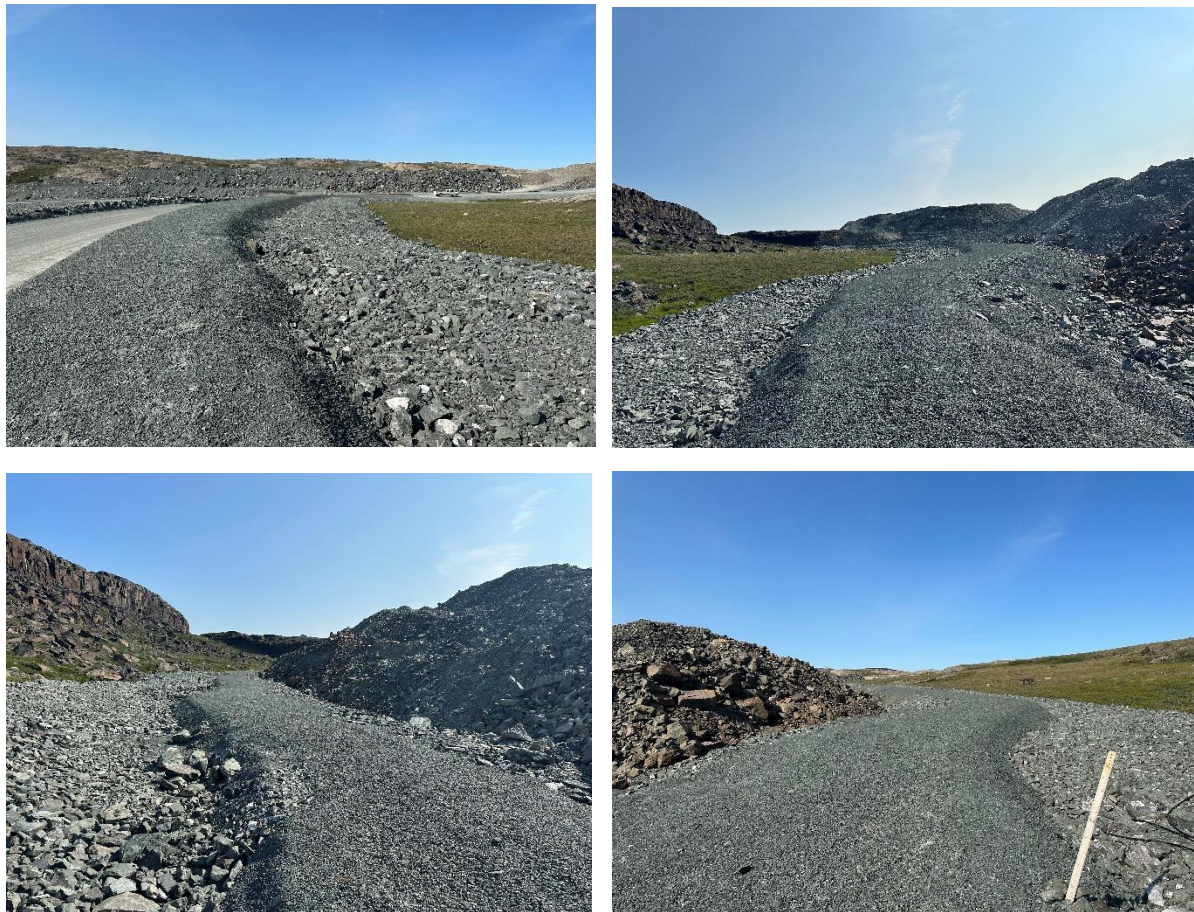
Visual monitoring was conducted at the Diversion Berm this month. No issues were identified at the Diversion Berm and associated check dam. Photos of this infrastructure are provided in Figure 3 below. Inspections of site culverts throughout the month of June were resumed.

Figure 3. Diversion berm during July 2023

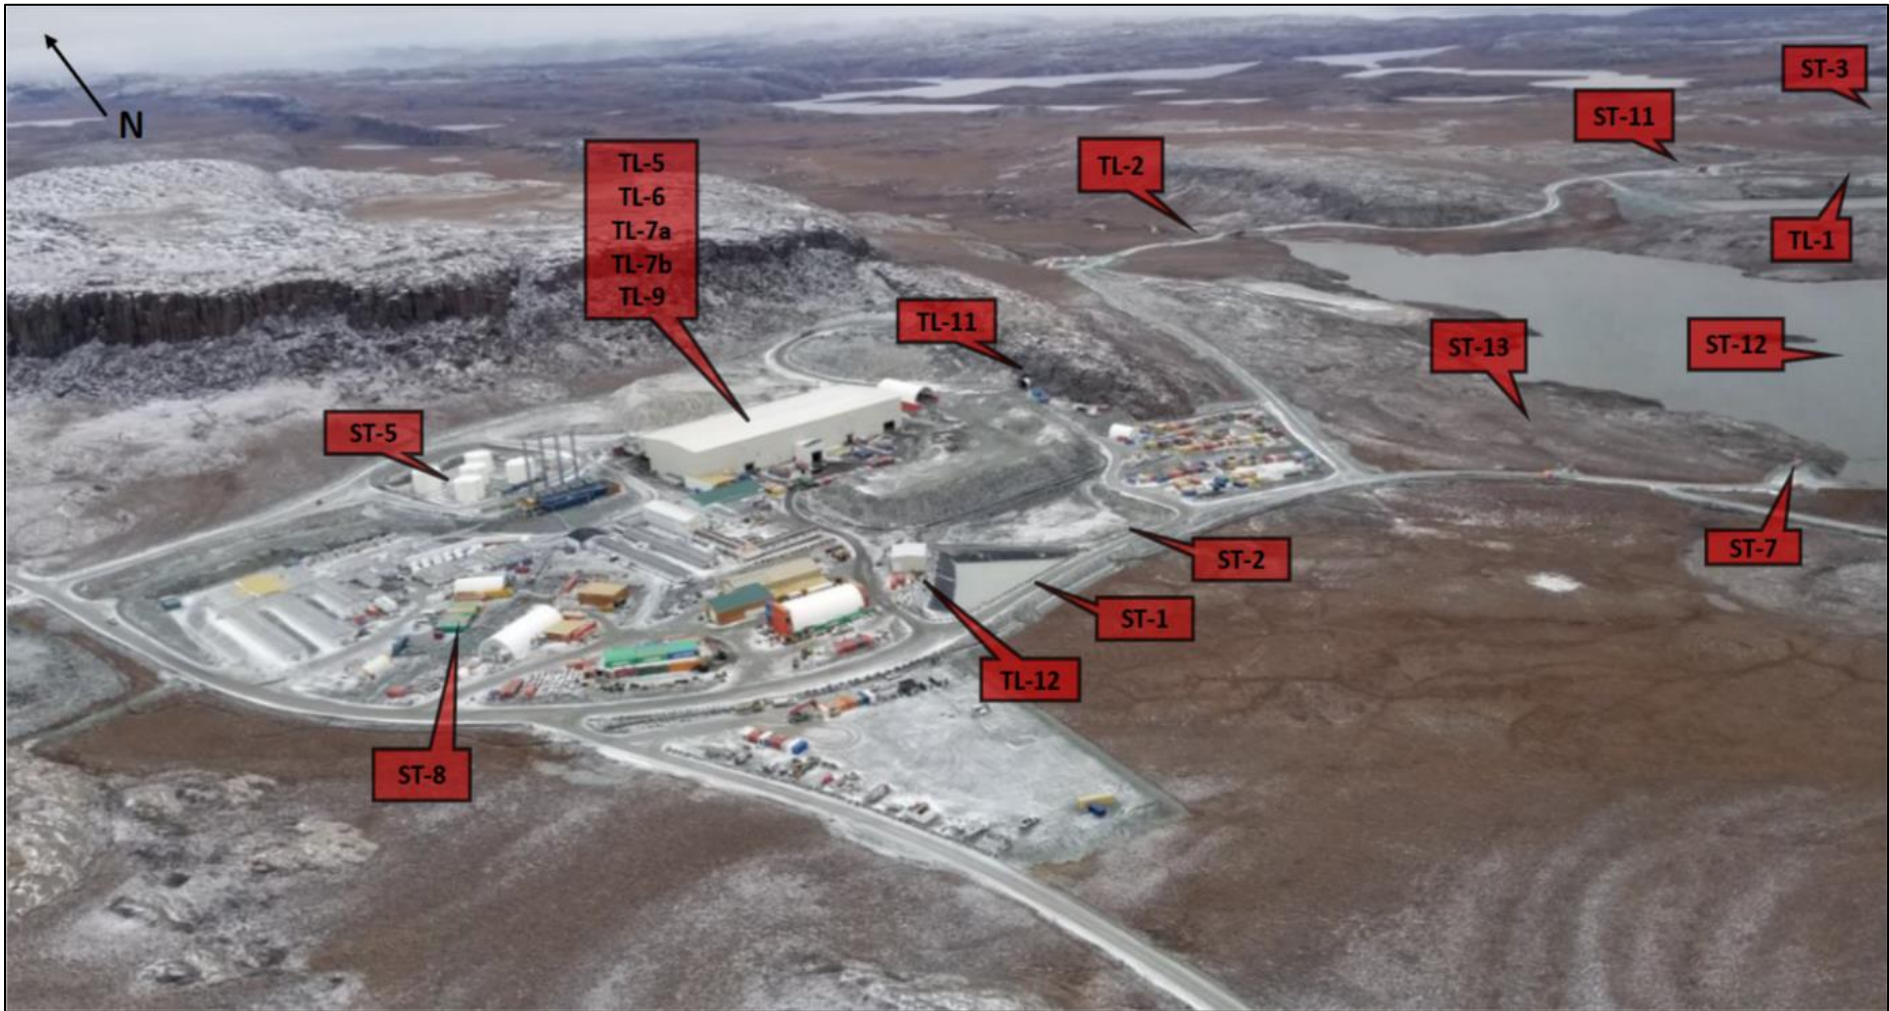
Figure 6. 2AM-DOH1335 SNP Monitoring Locations

Sampling locations monitored under this licence (seasonally or when facilities are operational) are provided in Figure 6 through Figure 8 at the end of this report.

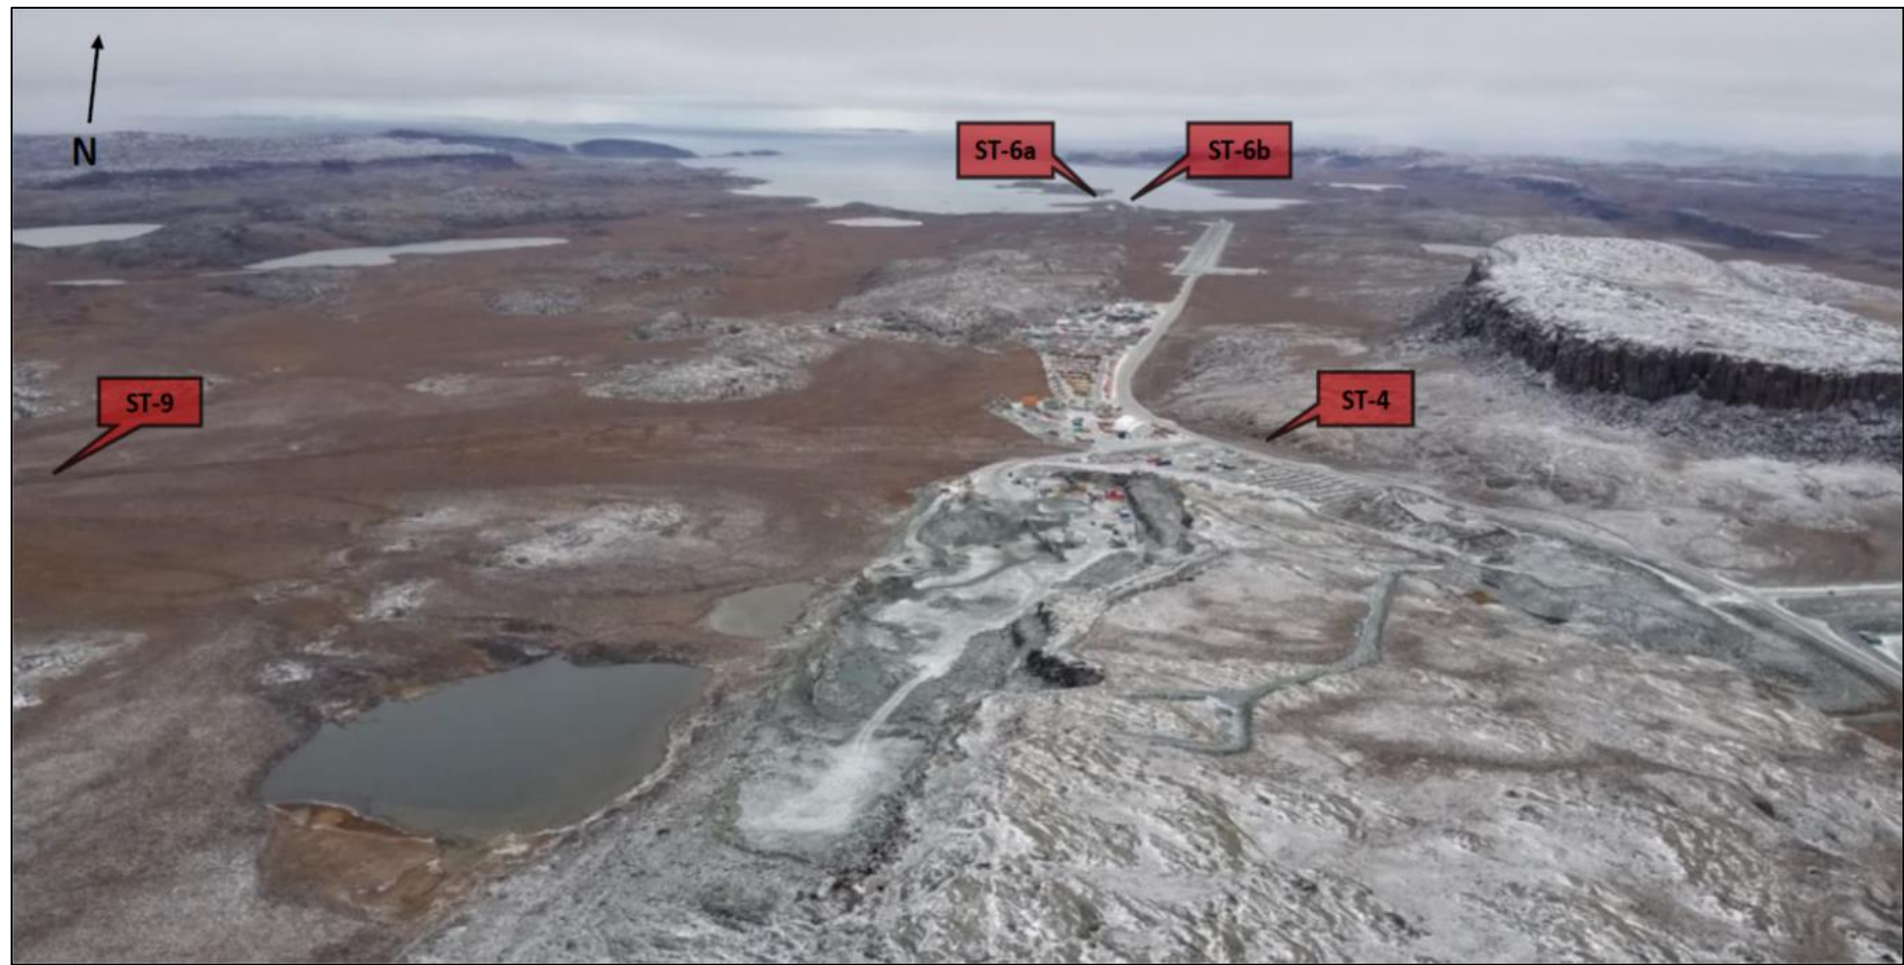
Figure 7. 2AM-DOH1335 SNP Monitoring Locations

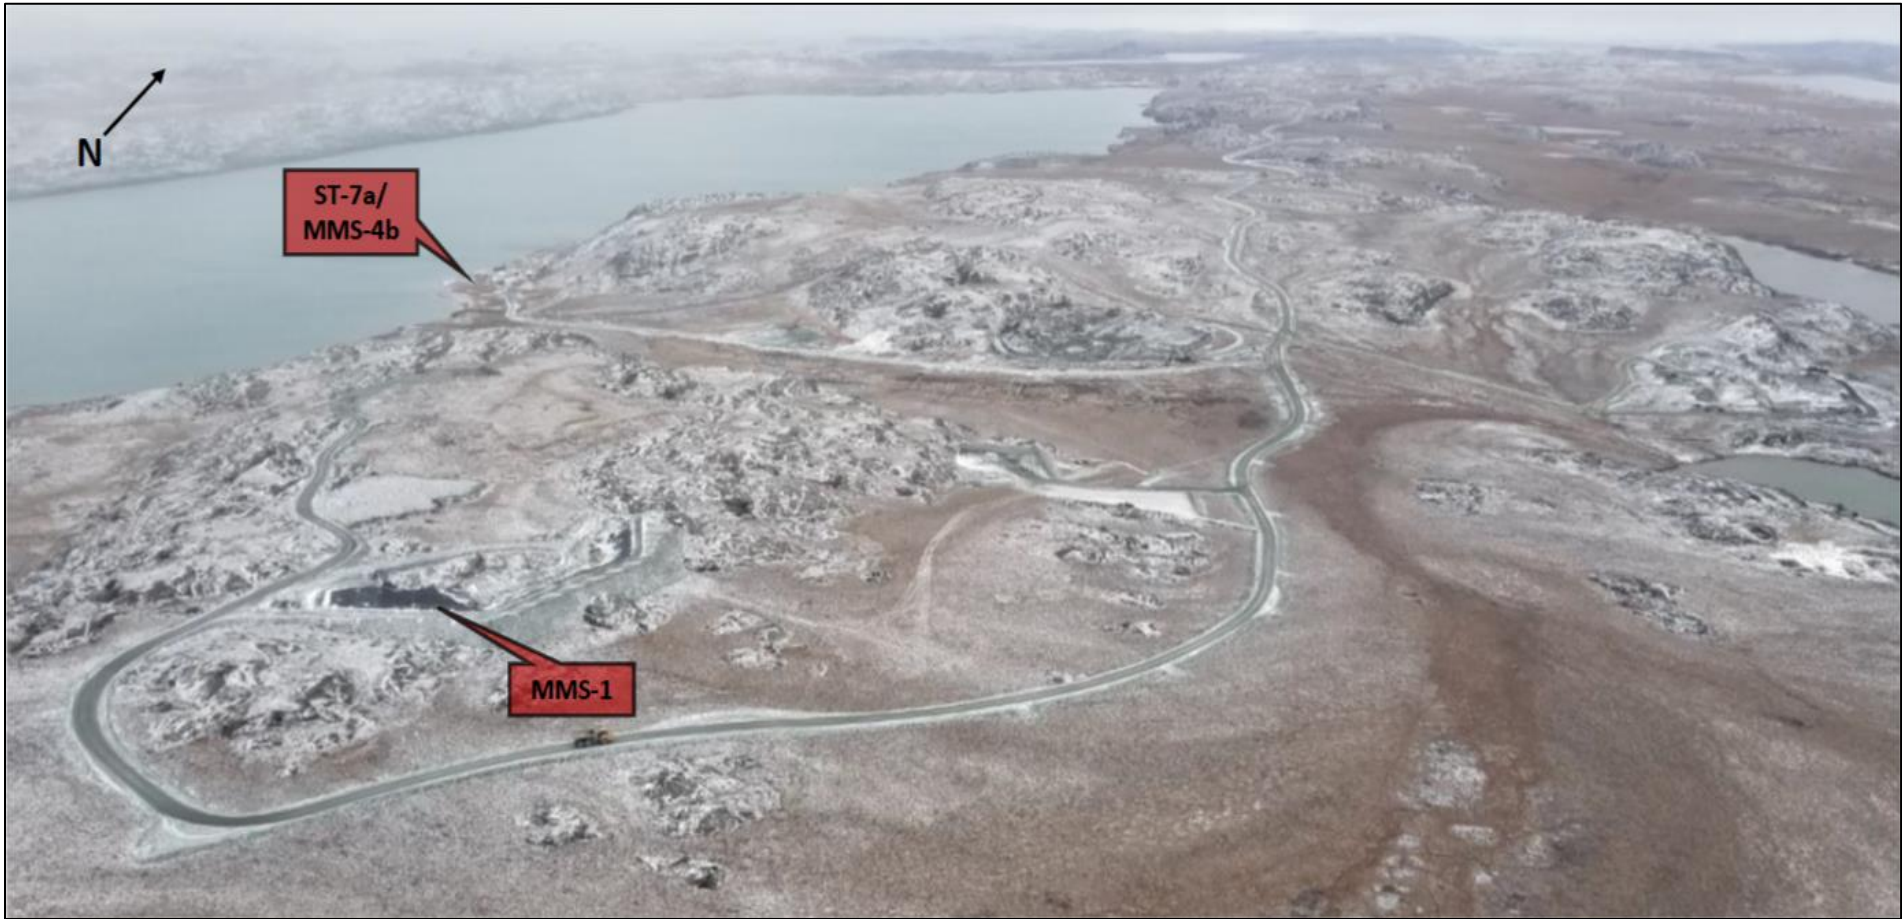
Figure 8. 2AM-DOH1335 SNP Monitoring Locations
