Re: August 2023 – Monthly Monitoring Report for Water License 2AM-DOH1335

This report is comprised of the monitoring requirements set out in Part I and Schedule I of water licence 2AM-DOH1335 Amendment 2 (the license), and additional requirements from CIRNAC.

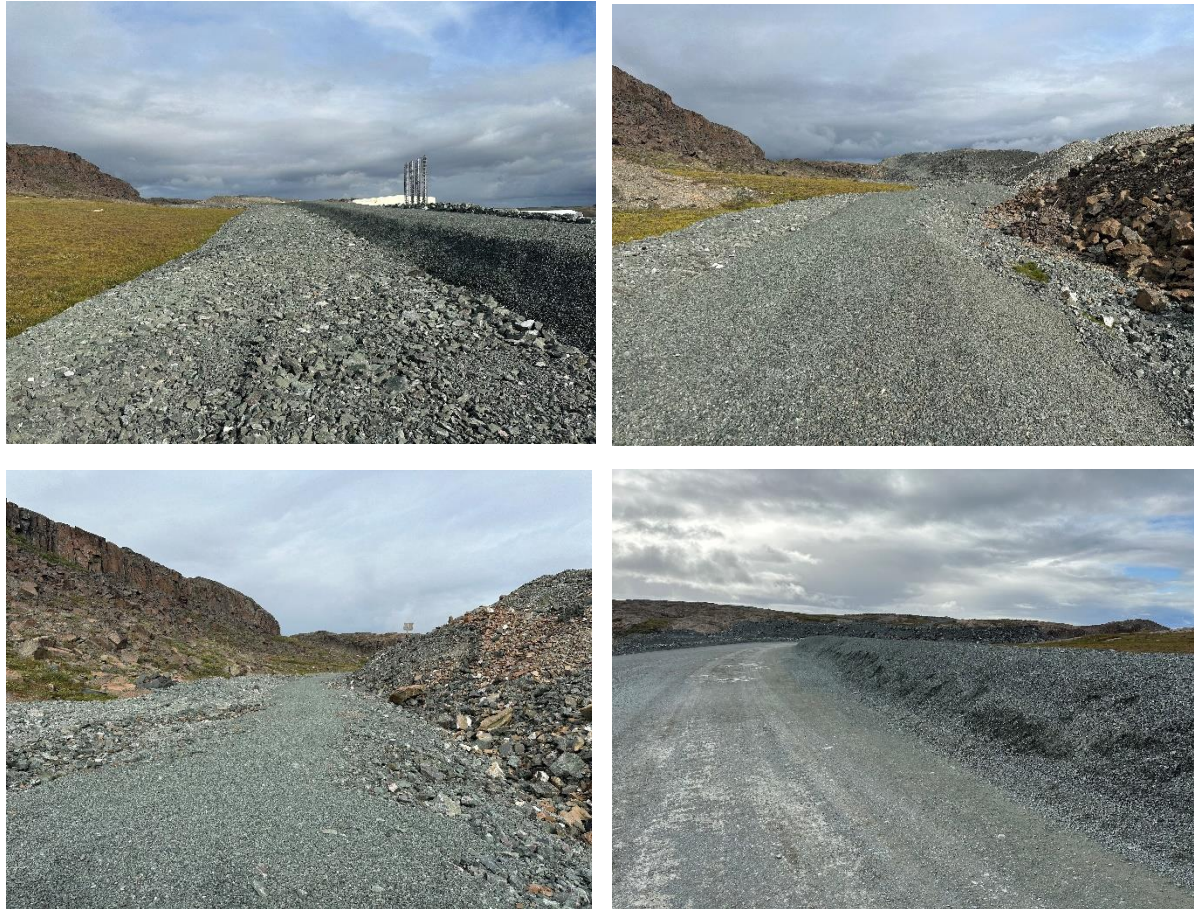
Visual monitoring was conducted at the Diversion Berm this month. No issues were identified at the Diversion Berm and associated check dam. Photos of this infrastructure are provided in Figure 3 below. Inspections of site culverts throughout the month of August were continued.

Figure 3. Diversion berm during August 2023
