**Re: October 2023 – Monthly Monitoring Report for Water License 2AM-DOH1335**

This report is comprised of the monitoring requirements set out in Part I and Schedule I of water licence 2AM-DOH1335 Amendment 2 (the license), and additional requirements from CIRNAC.

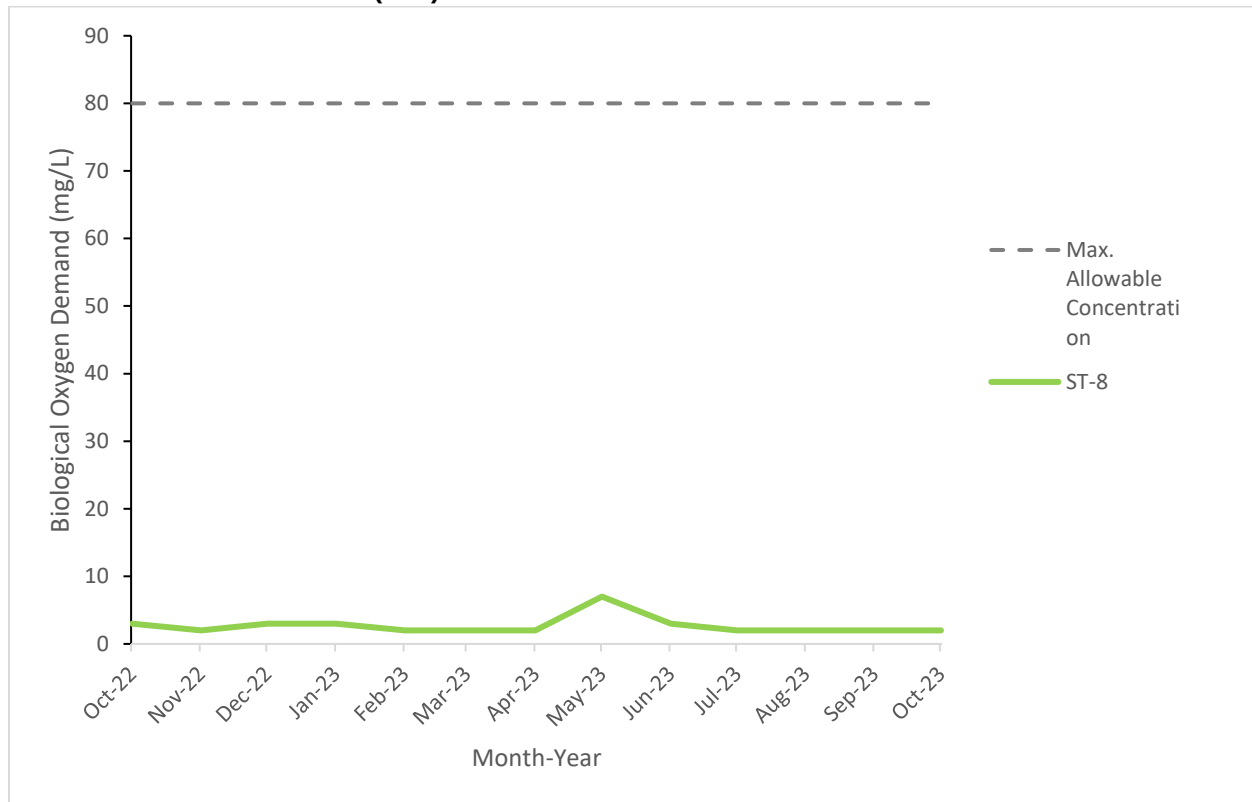
**Figure 1. Biological Oxygen Demand Results Consistently Below Discharge Criteria for Wastewater Treatment Plant (ST8)**

Figure 1 and 2 illustrates effluent quality characteristics for parameters of interest at select monitoring stations.

Note: Maximum Average Concentration as per Part F Item 4(b).

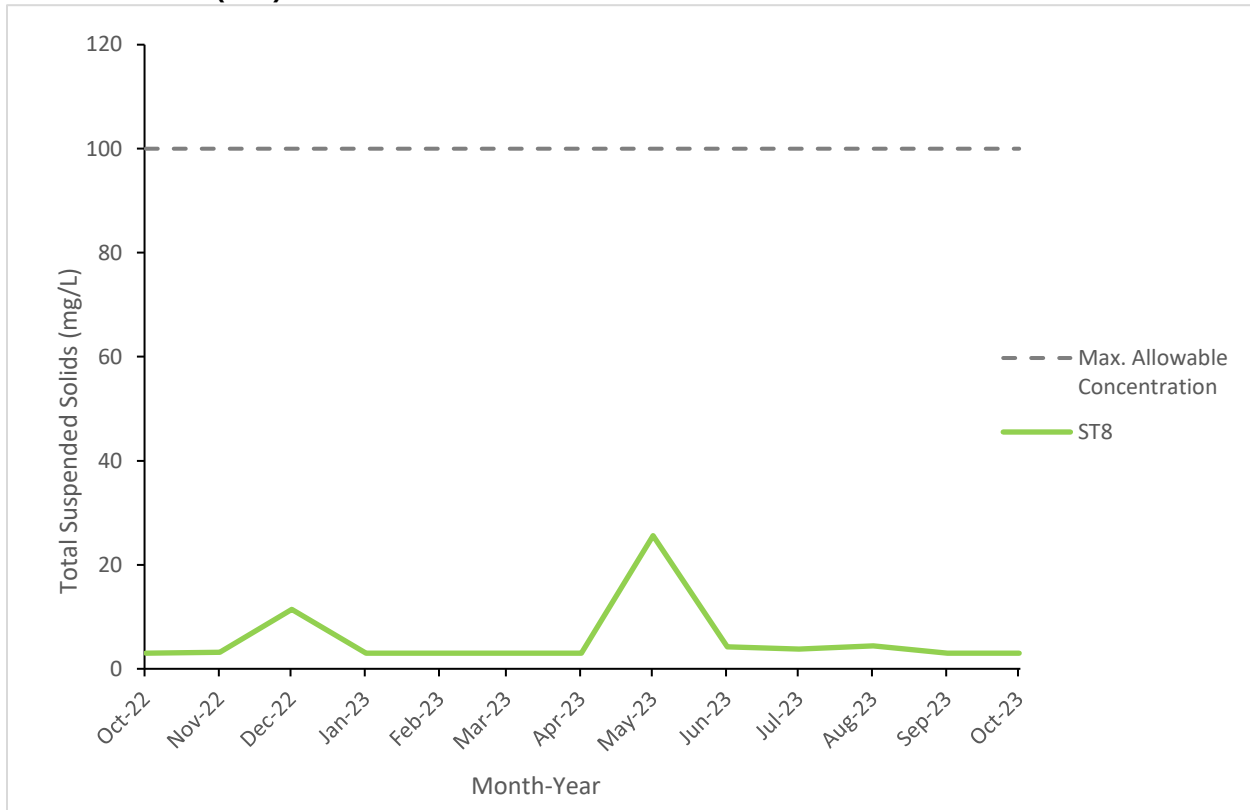
**Figure 2. Total Suspended Solids Results Consistently Below Discharge Criteria for Wastewater Treatment Plant (ST8)**

Note: Maximum Average Concentration as per Part F Item 4(b).

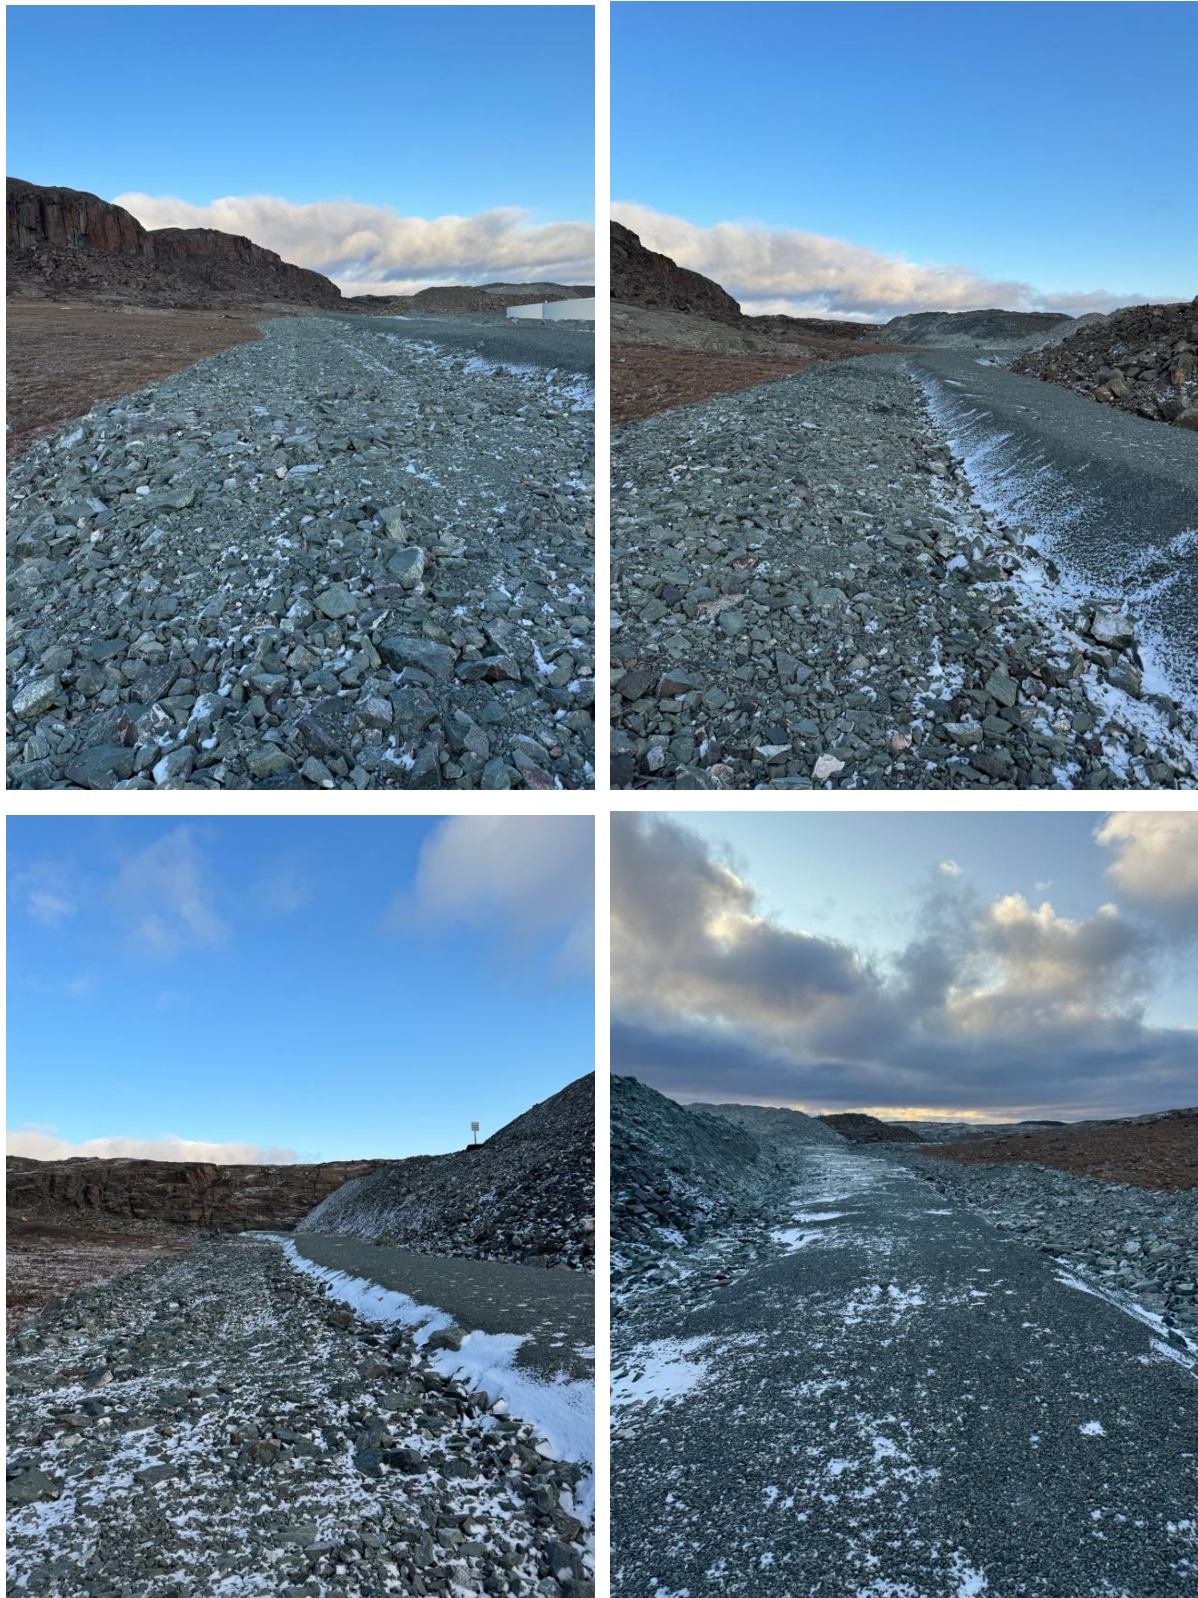
**Figure 3. Diversion berm during October 2023**

Visual monitoring was conducted at the Diversion Berm this month. No issues were identified at the Diversion Berm and associated check dam. Photos of this infrastructure are provided in Figure 3 below. Inspections of site culverts throughout the month of October were continued.
