**Re: March 2024 – Monthly Monitoring Report for Water License 2AM-DOH1335**

This report is comprised of the monitoring requirements set out in Part I and Schedule I of water licence 2AM-DOH1335 Amendment 2 (the license), and additional requirements from CIRNAC.

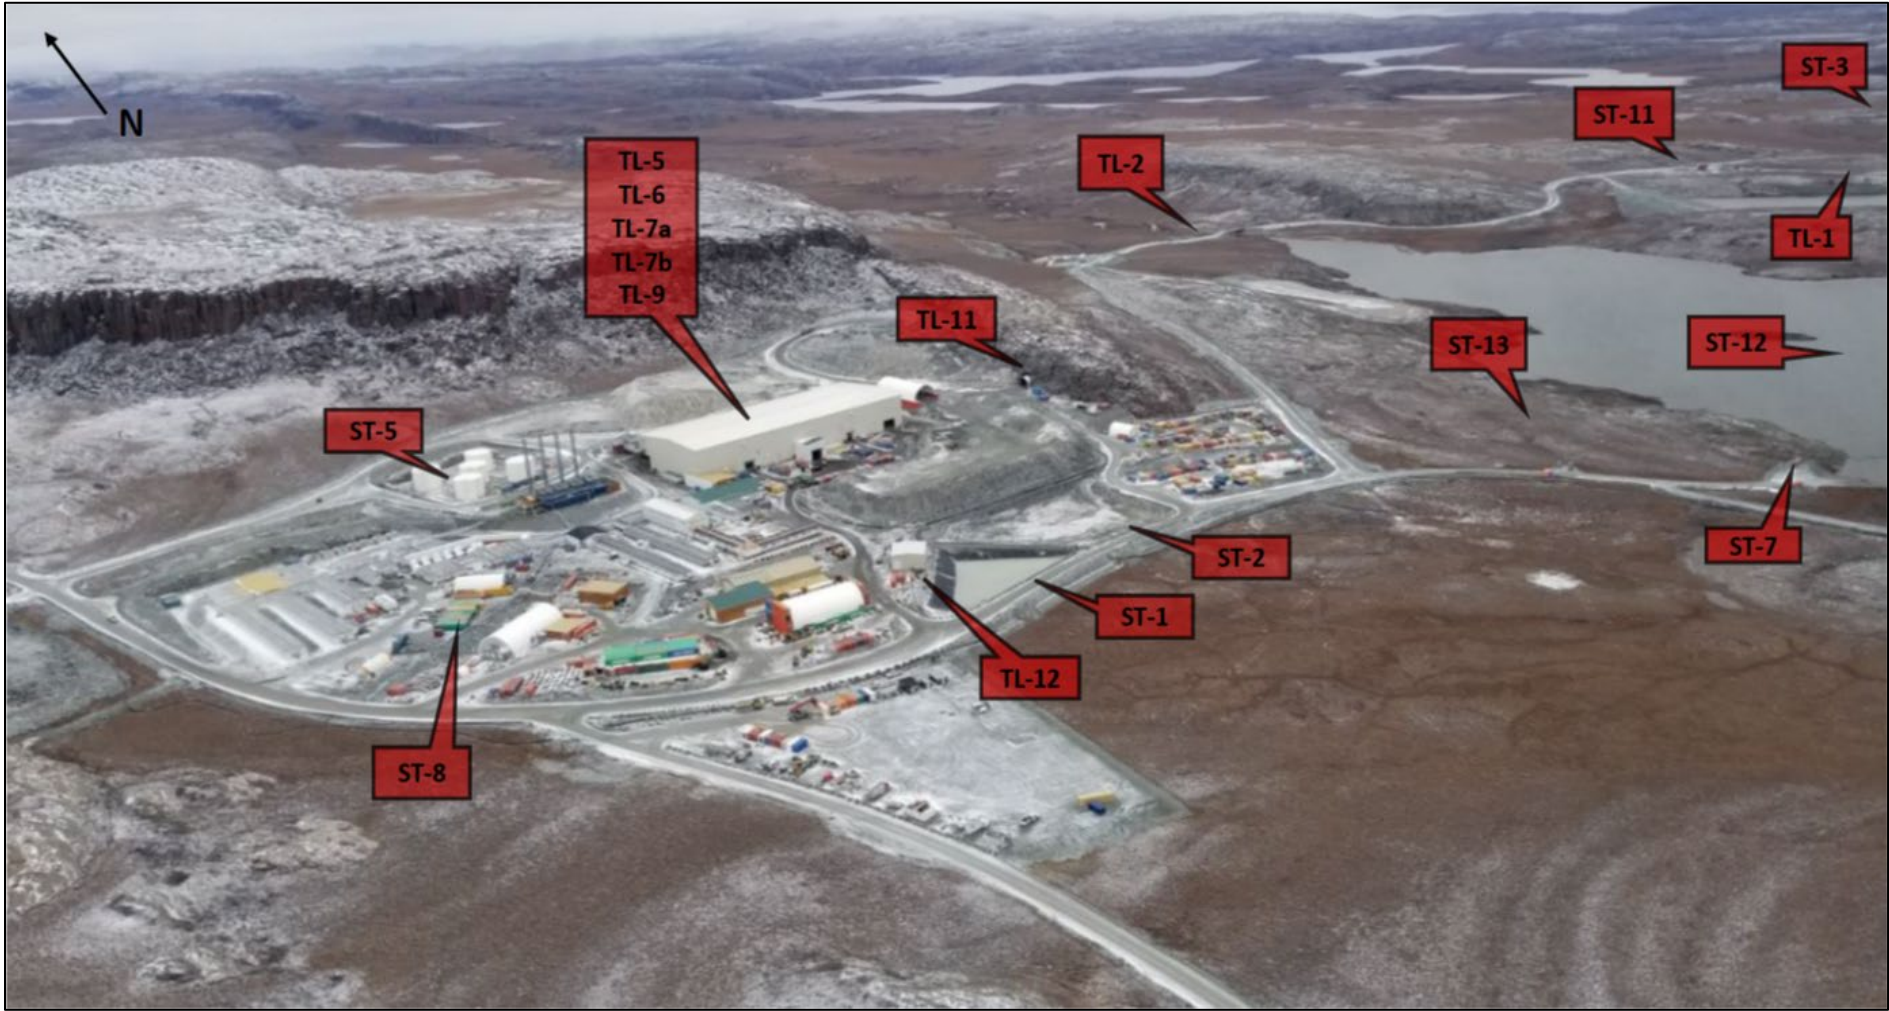
Figure 6. 2AM-DOH1335 SNP Monitoring Locations

Sampling locations monitored under this licence (seasonally or when facilities are operational) are provided in Figure 6 through Figure 8 at the end of this report.
