Re: February 2025 – Monthly Monitoring Report for Water License 2AM-DOH1335

This report is comprised of the monitoring requirements set out in Part I and Schedule I of water licence 2AM-DOH1335 Amendment 2 (the license), and additional requirements from CIRNAC.

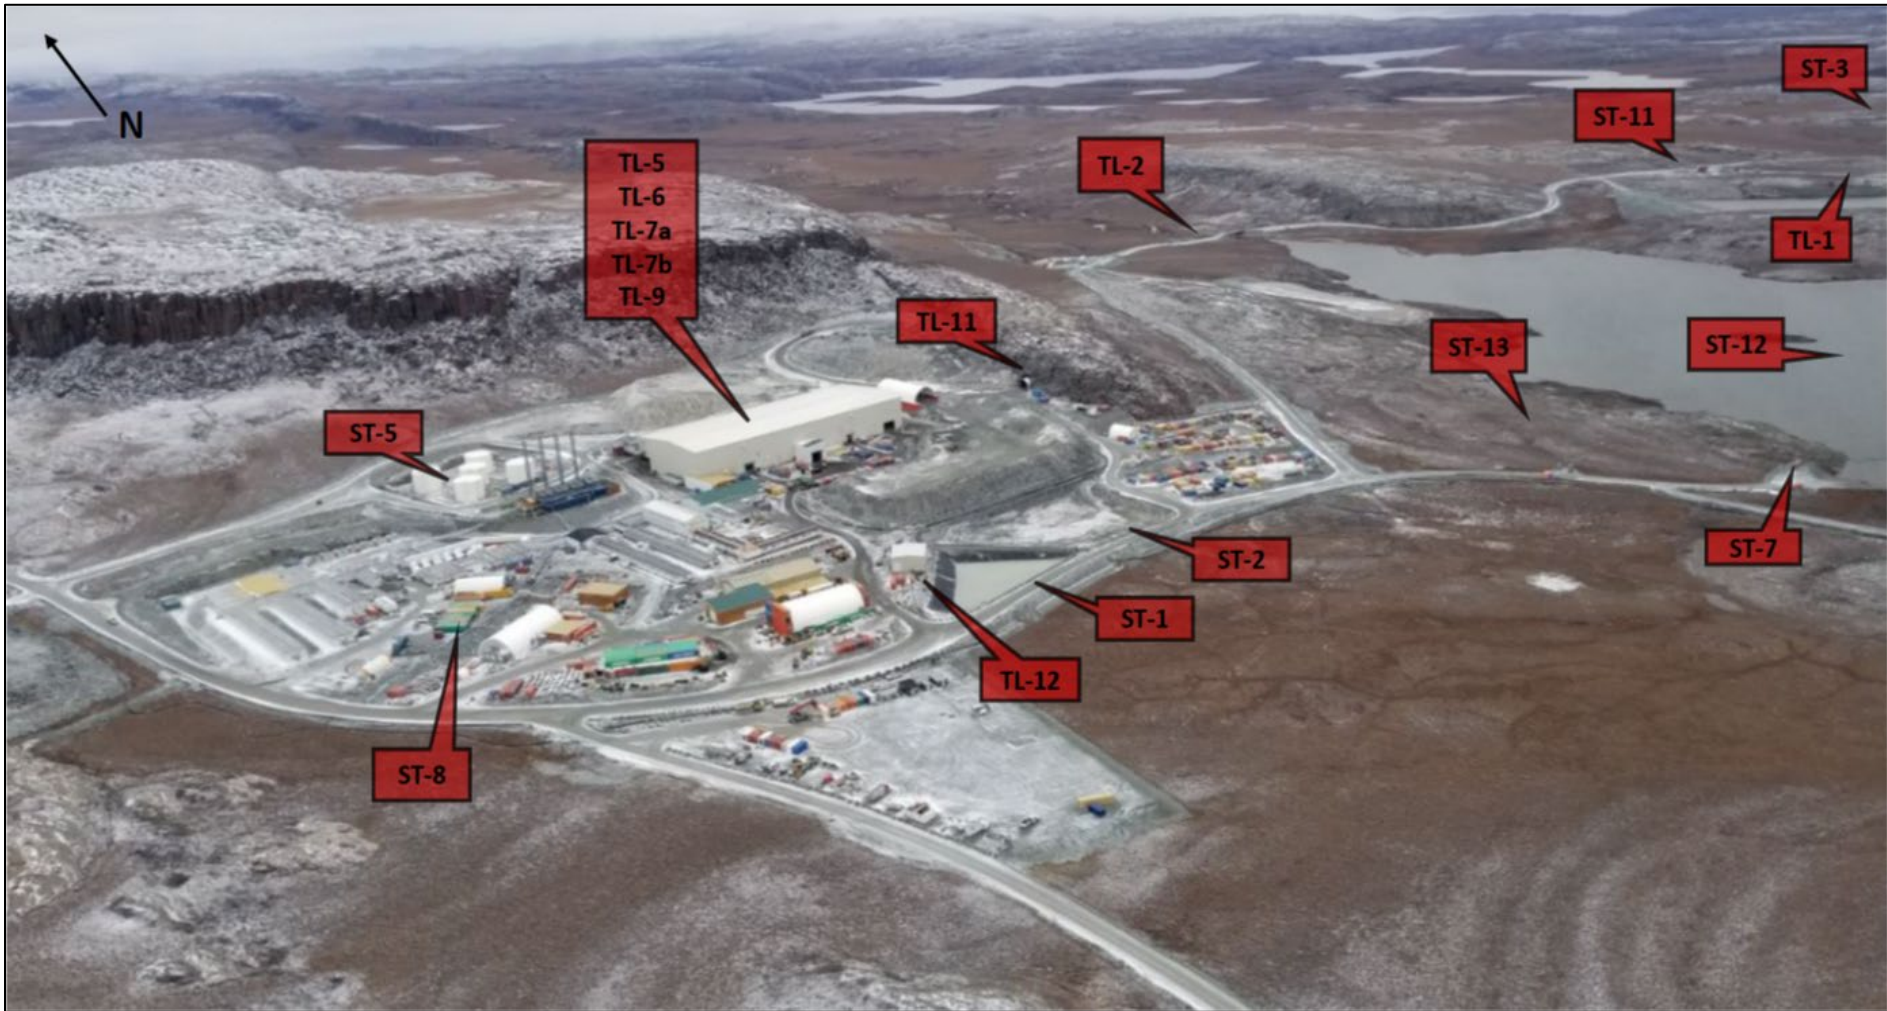
Figure 6. 2AM-DOH1335 SNP Monitoring Locations

Sampling locations monitored under this licence (seasonally or when facilities are operational) are provided in Figure 6 through Figure 8 at the end of this report.
