**Re: March 2025 – Monthly Monitoring Report for Water License 2AM-DOH1335**

This report is comprised of the monitoring requirements set out in Part I and Schedule I of water licence 2AM-DOH1335 Amendment 2 (the license), and additional requirements from CIRNAC.

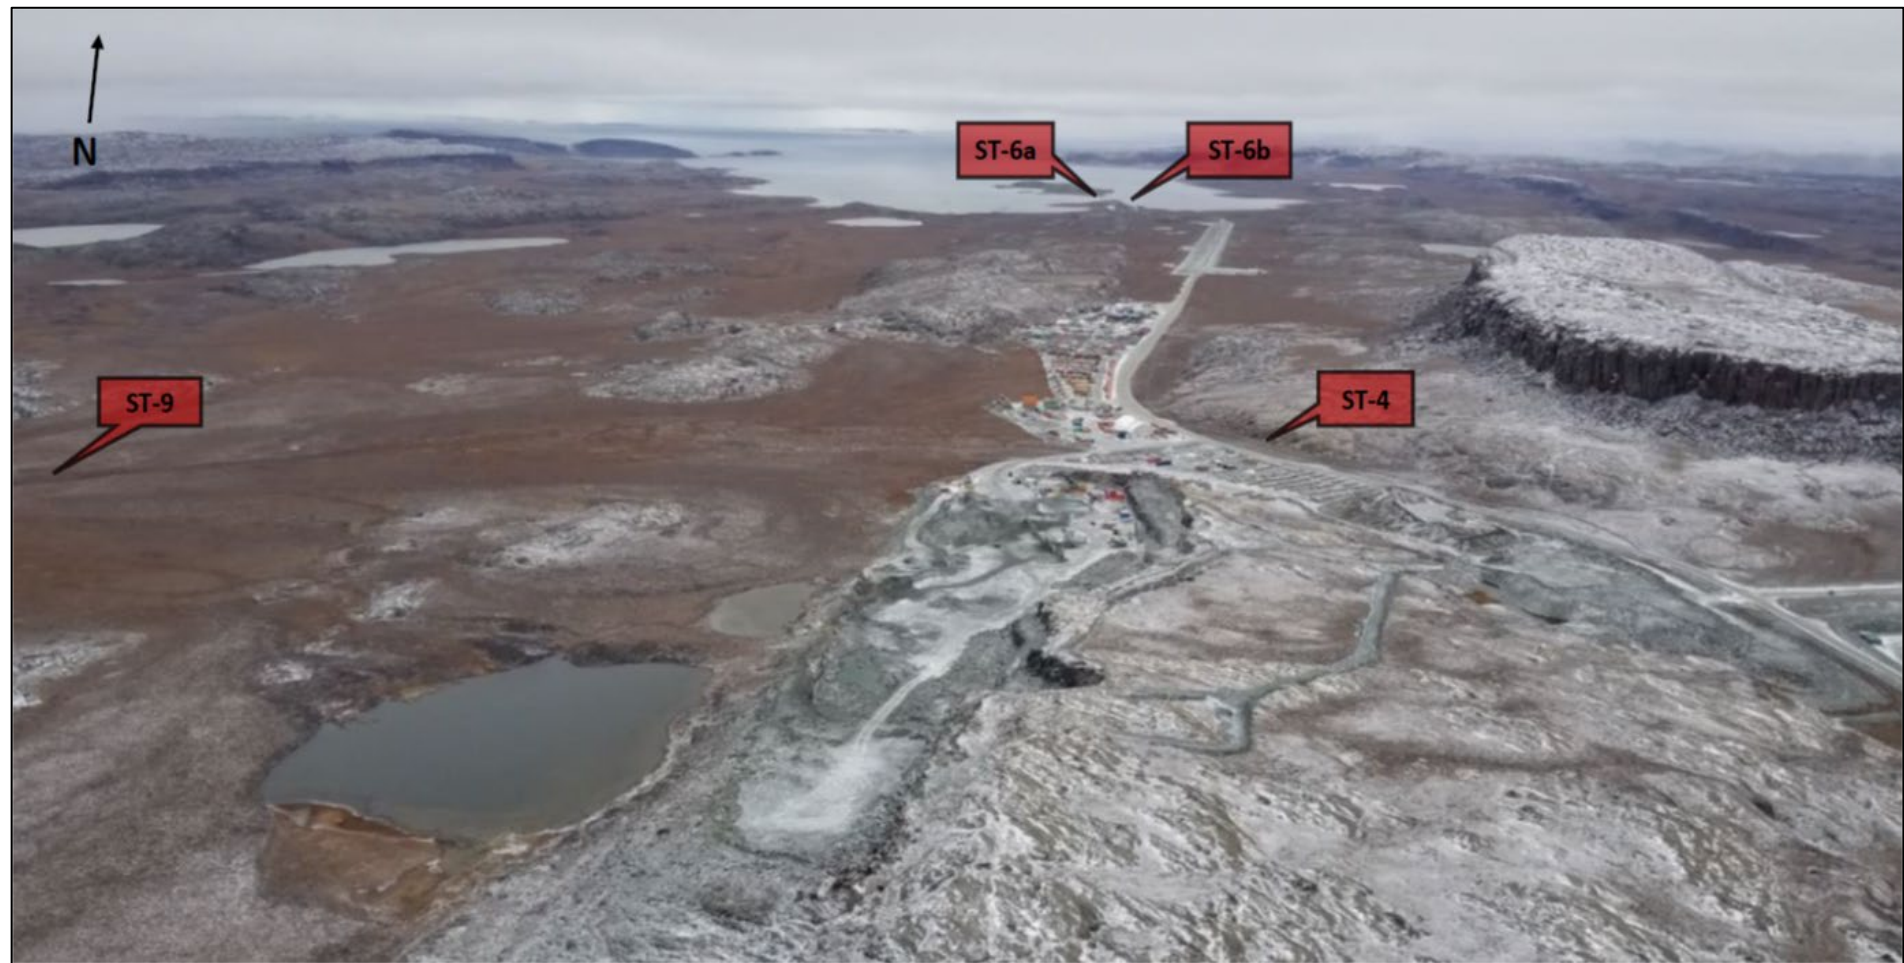
Figure 7. 2AM-DOH1335 SNP Monitoring Locations

Sampling locations monitored under this licence (seasonally or when facilities are operational) are provided in Figure 6 through Figure 8 at the end of this report.
