Re: June 2025 – Monthly Monitoring Report for Water License 2AM-DOH1335

This report is comprised of the monitoring requirements set out in Part I and Schedule I of water licence 2AM-DOH1335 Amendment 2 (the license), and additional requirements from CIRNAC.

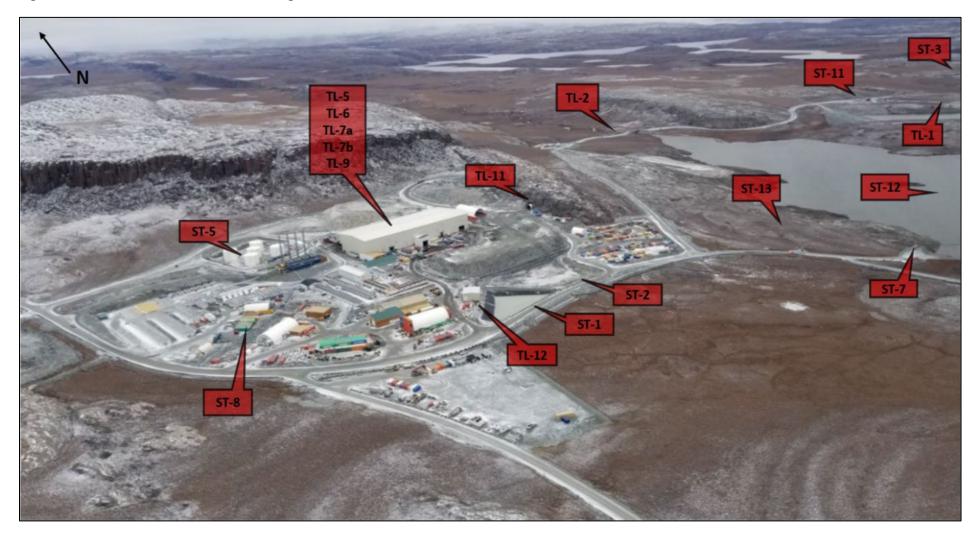
Figure 6. 2AM-DOH1335 SNP Monitoring Locations

Sampling locations monitored under this licence (seasonally or when facilities are operational) are provided in Figure 6 through Figure 8 at the end of this report.

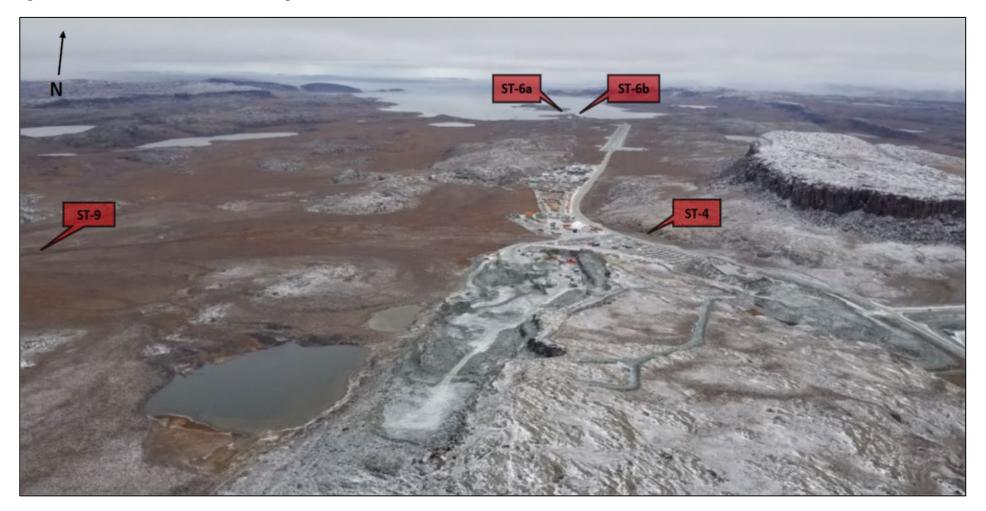
Figure 7. 2AM-DOH1335 SNP Monitoring Locations

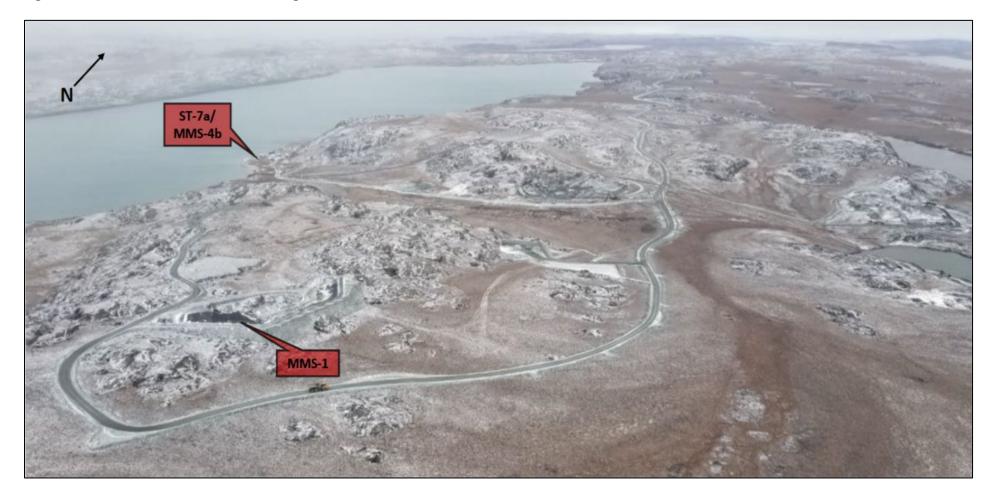
Figure 8. 2AM-DOH1335 SNP Monitoring Locations
