Job No: 1CT022.002  
Filename: AppA\_1CT022002\_NDThermistors

HOPE BAY MINING LTD.

2015 Geotechnical Inspection

**Station 0+40**  
**Ground Temperature Cable Readings**  
**by Location**

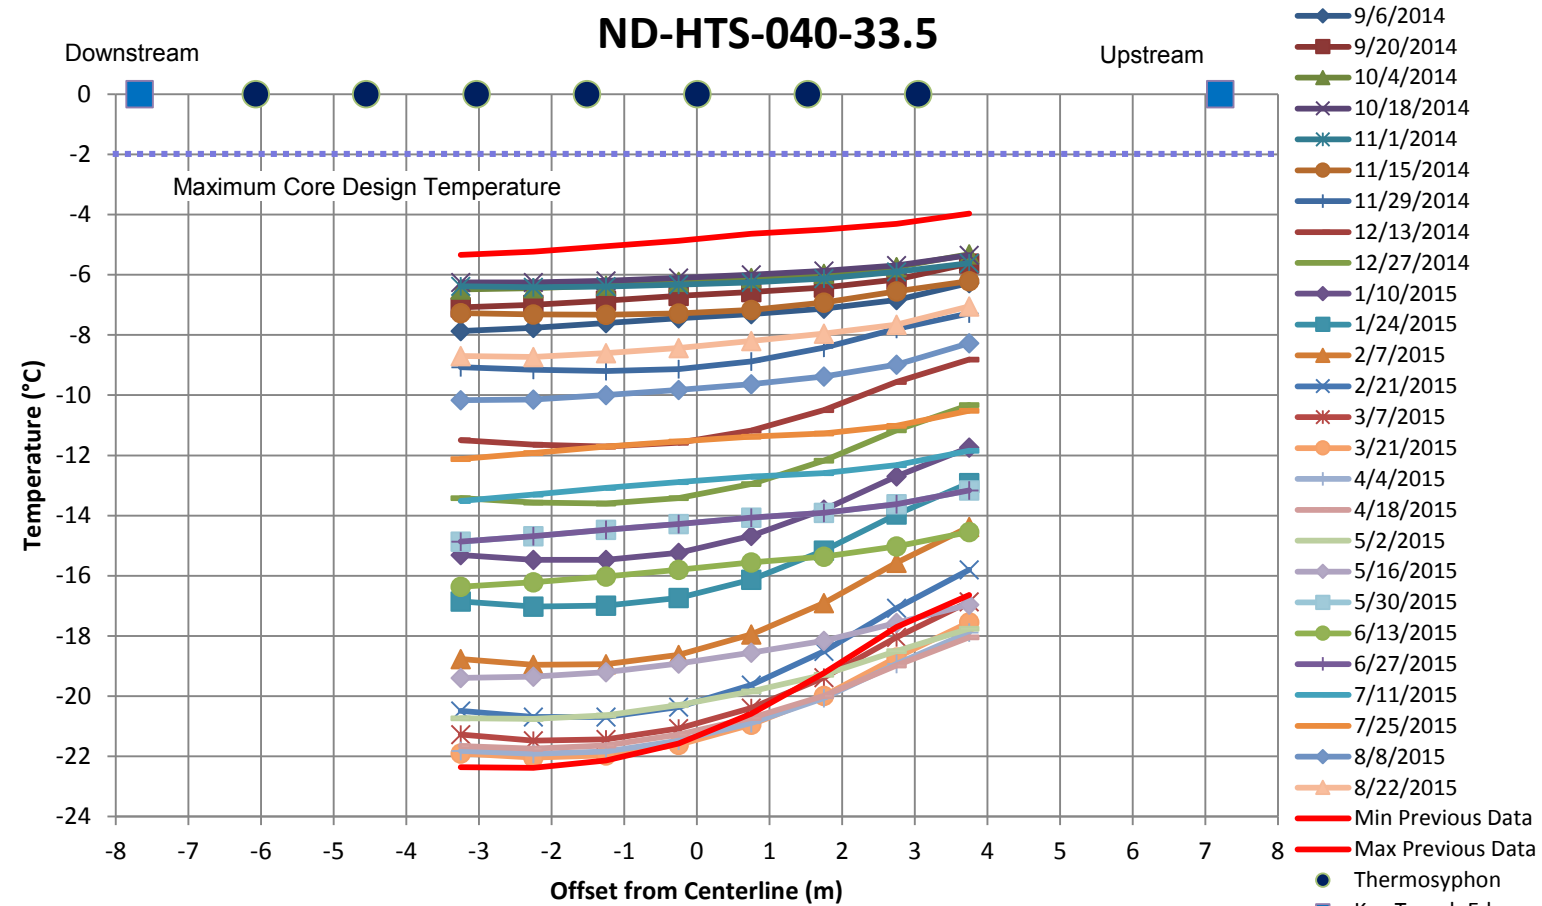
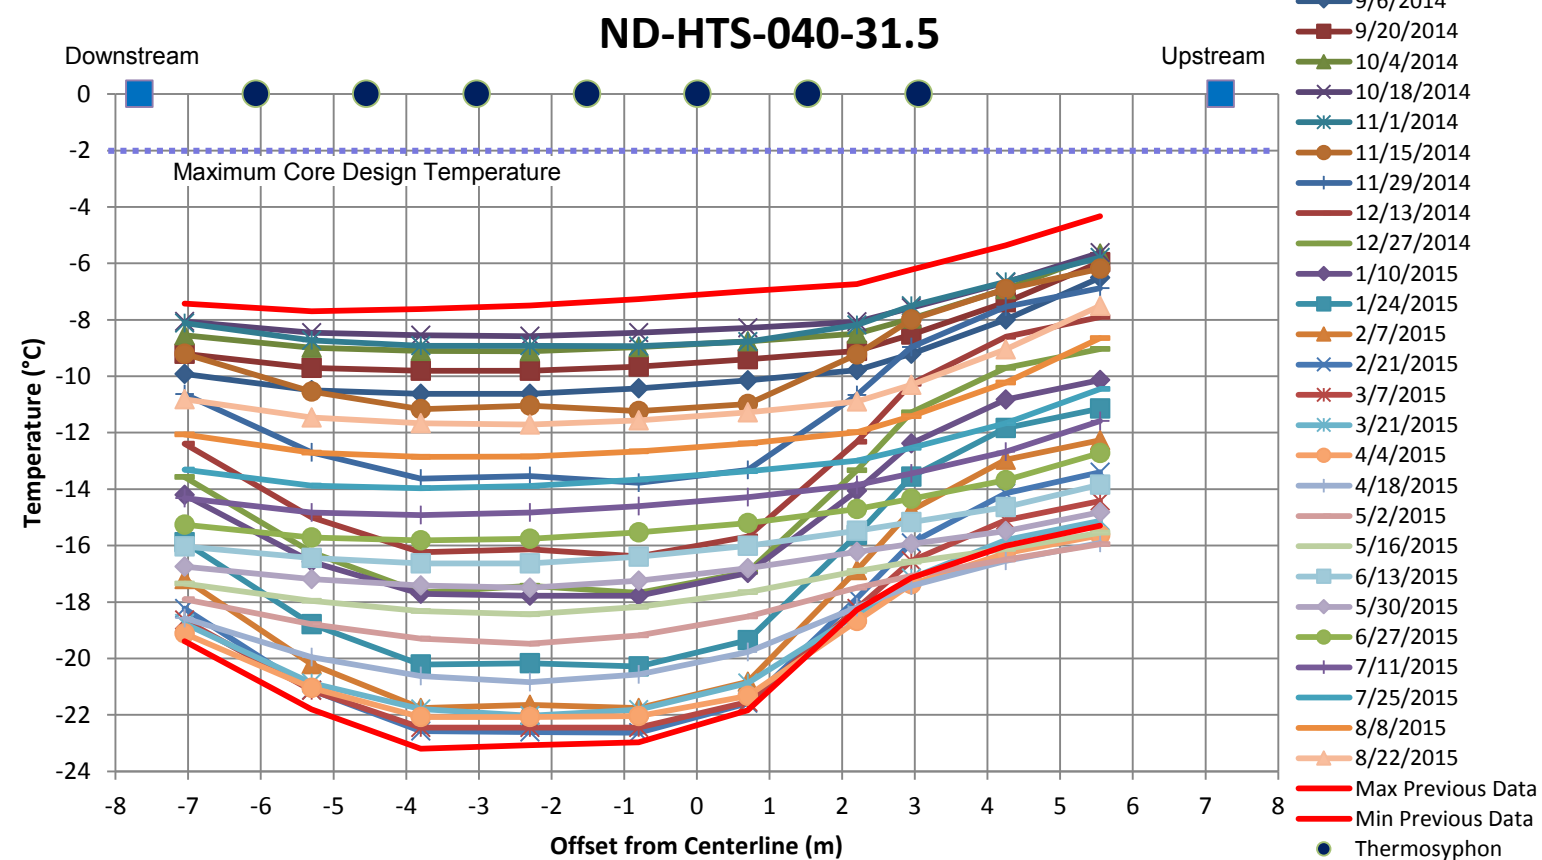
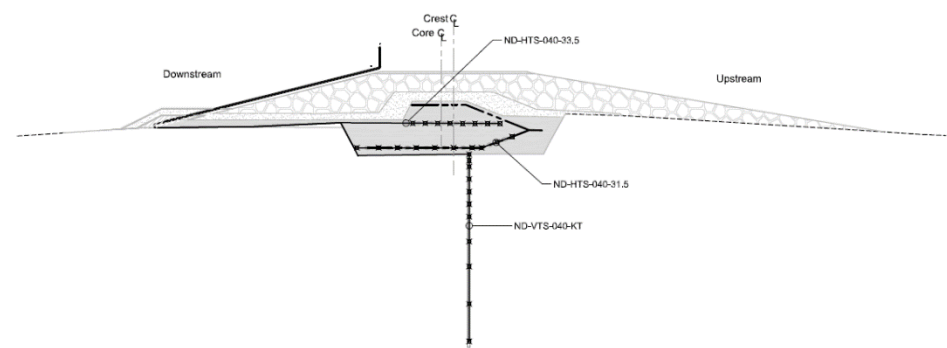
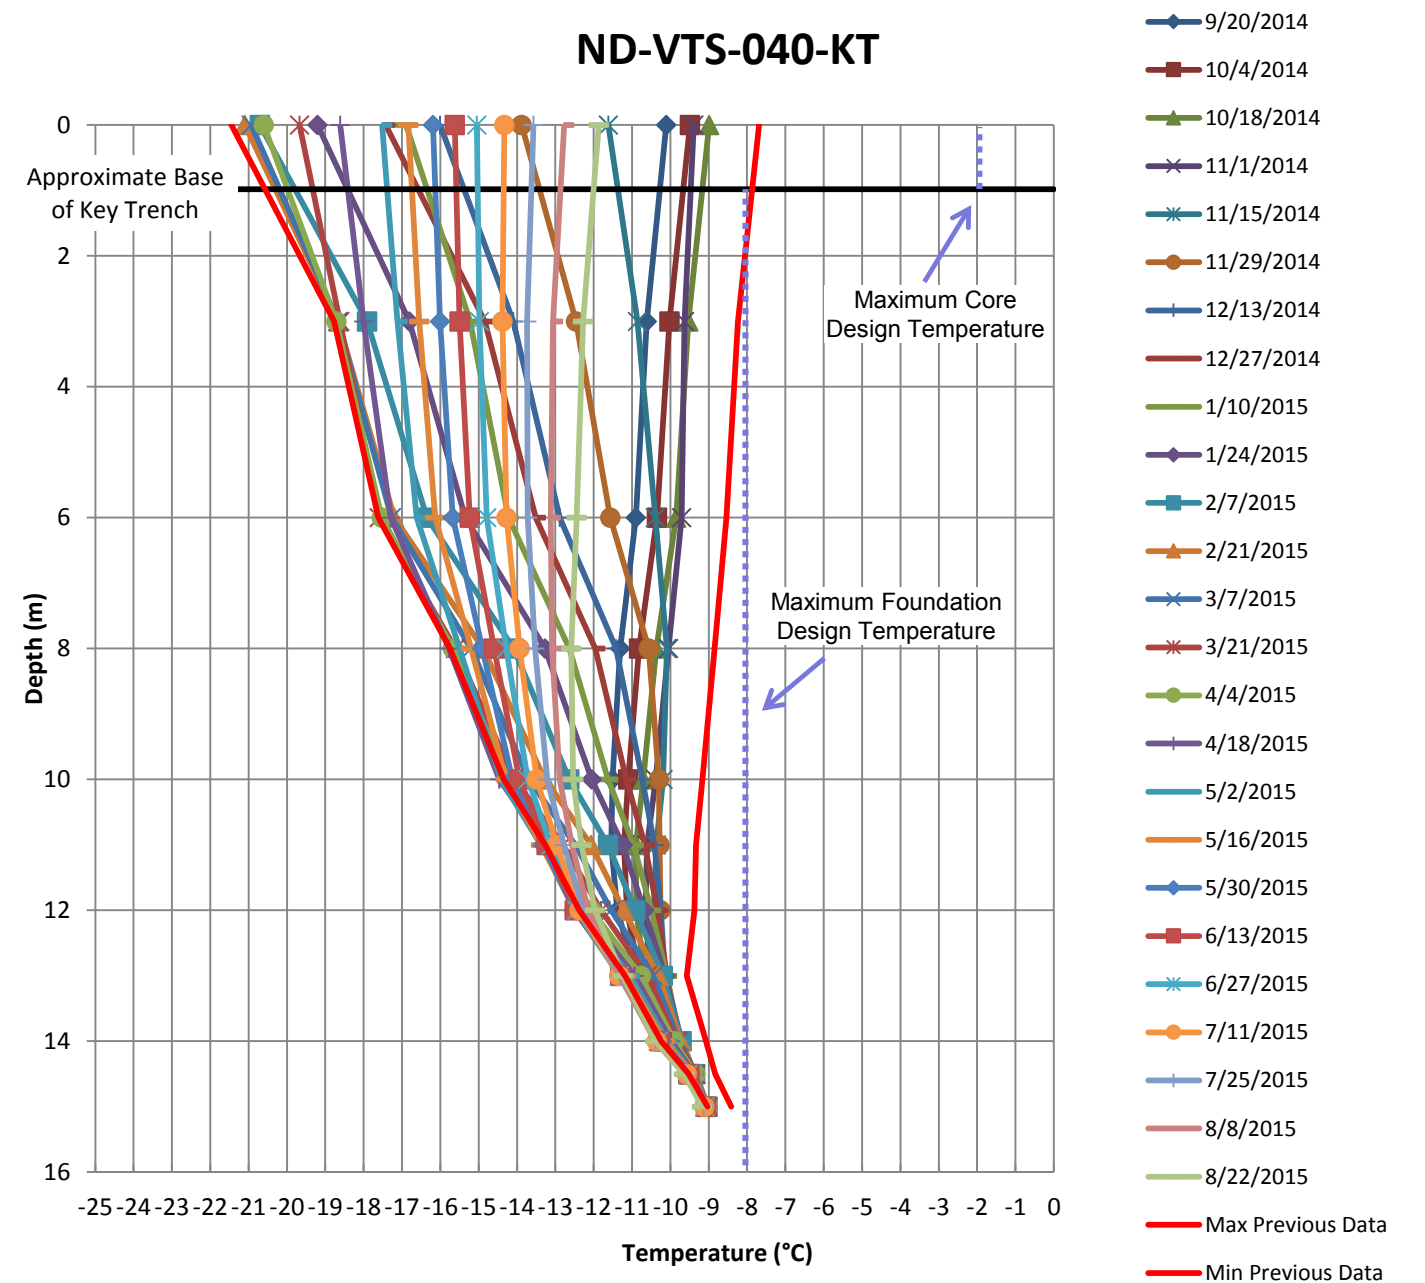
Date: Oct. 2015  
Approved: PL  
Figure: **A.2**

- Previous Data was recorded between August 2012 and September 2014

- Notes:**
- Bead numbers increase from downstream to upstream (horizontal) and top to bottom (vertical)
  - (A)** Variation in Ground Temperature Cable readings during winter months due to close proximity of Ground Temperature Cable beads to thermosyphon pipes.

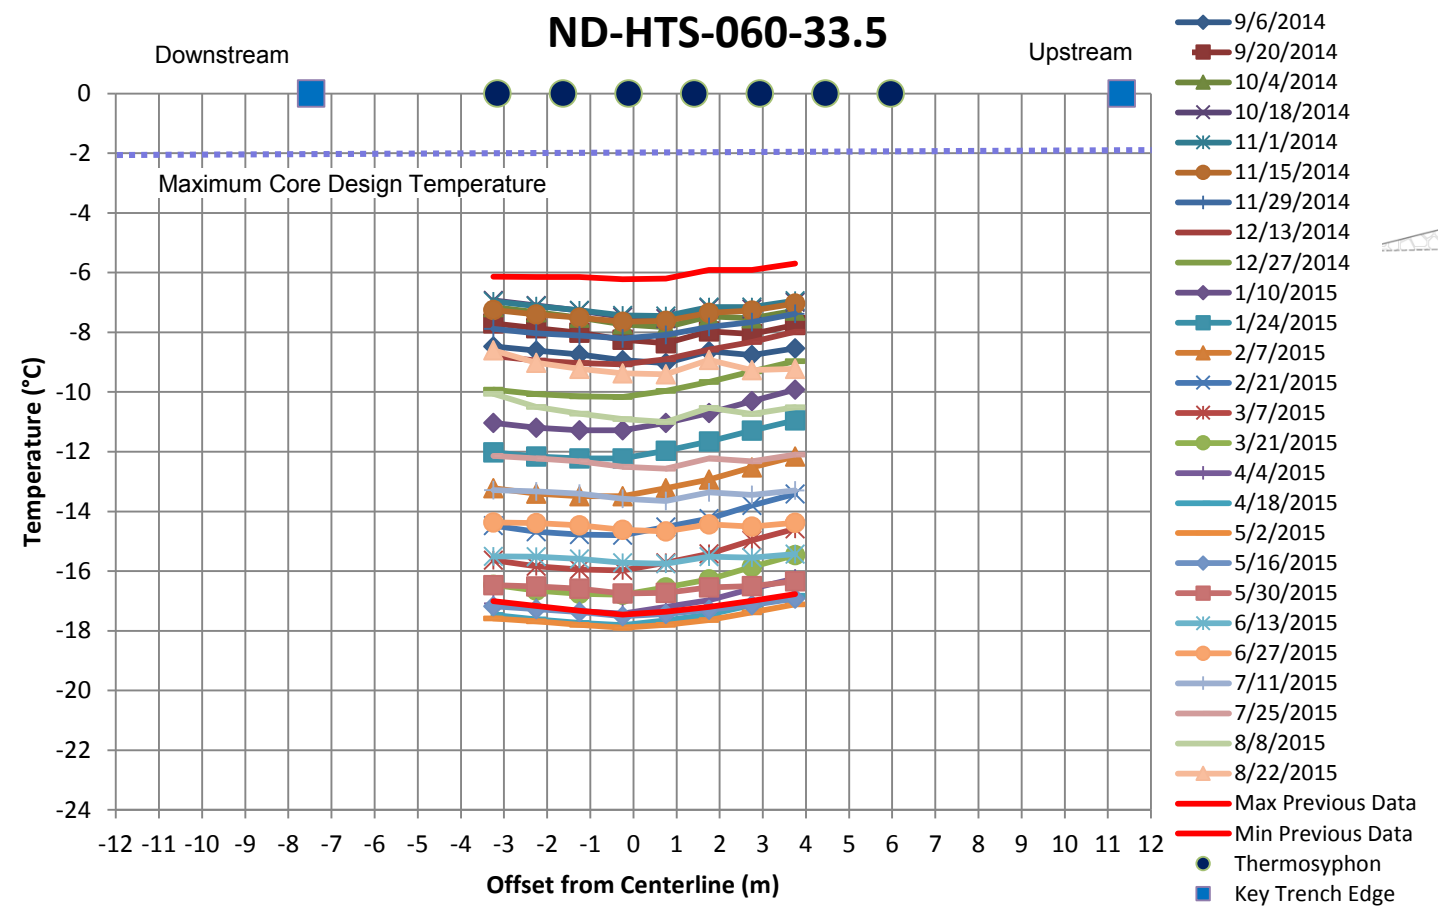
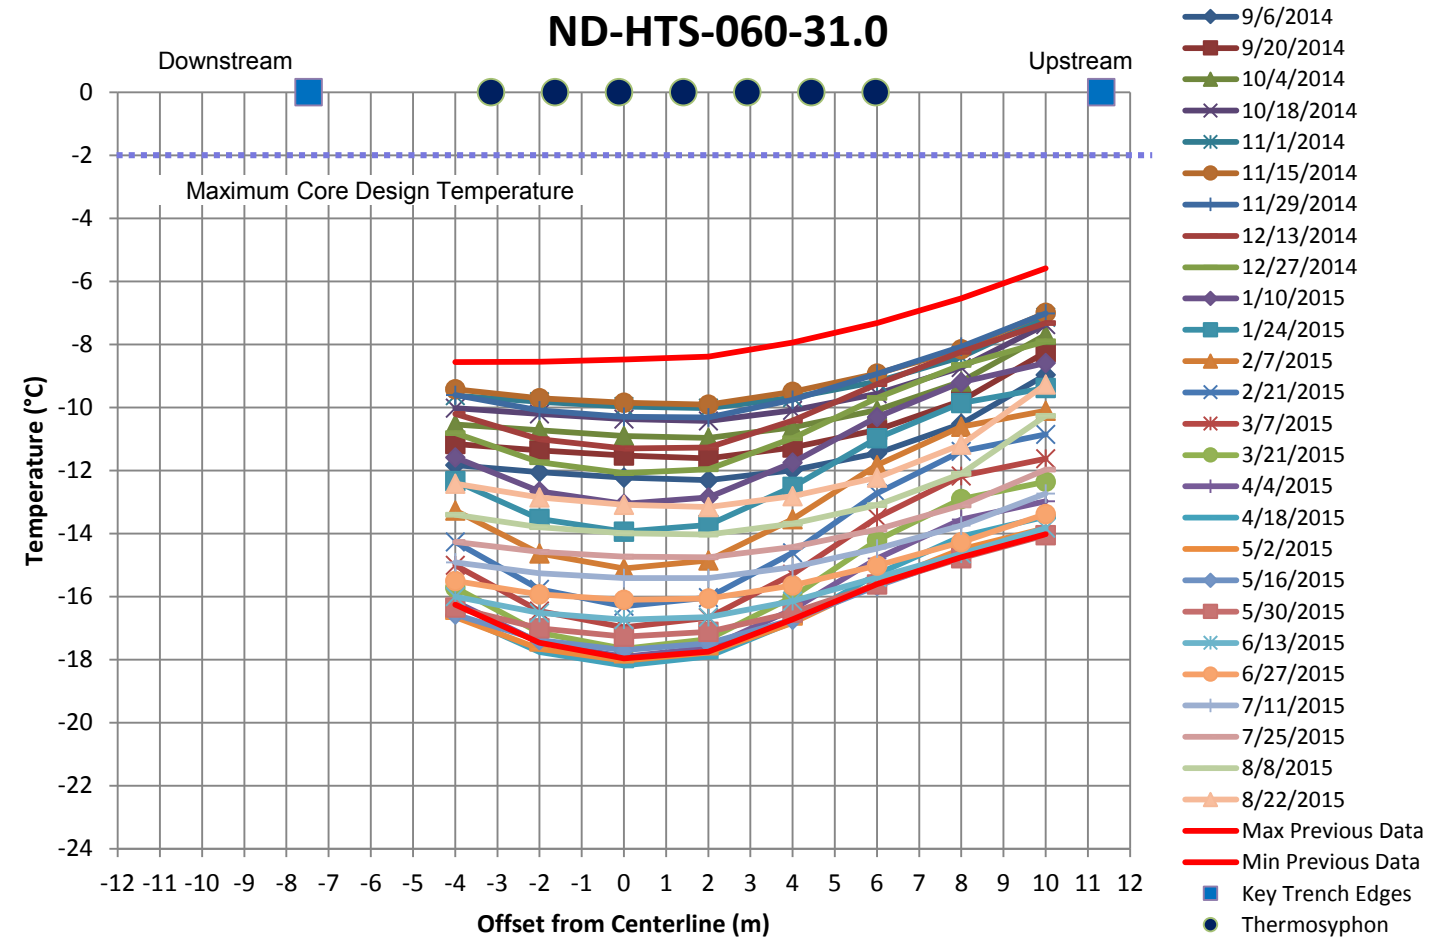
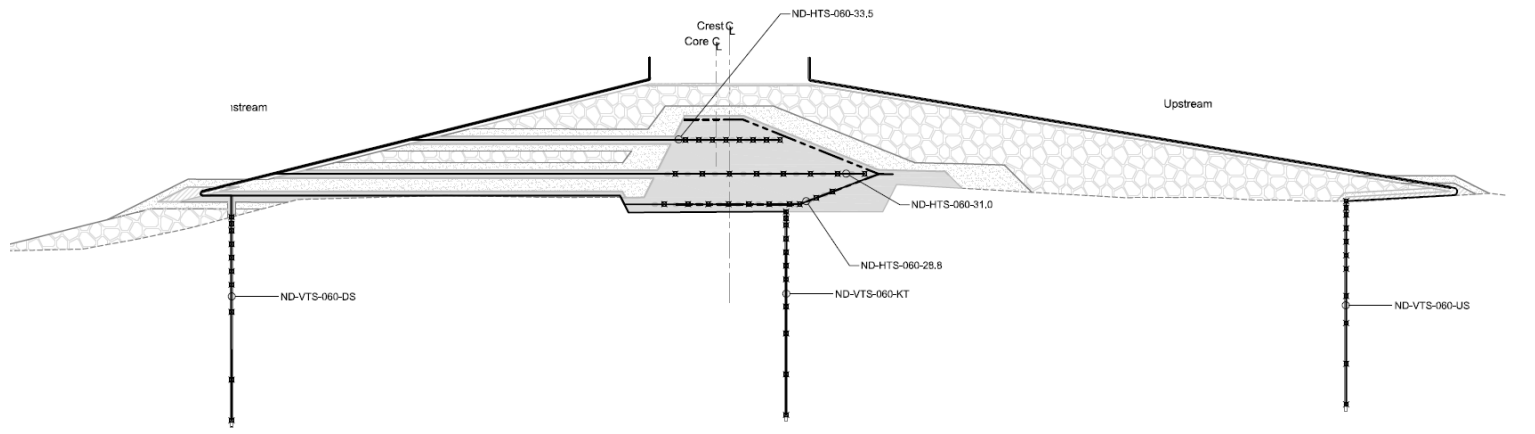
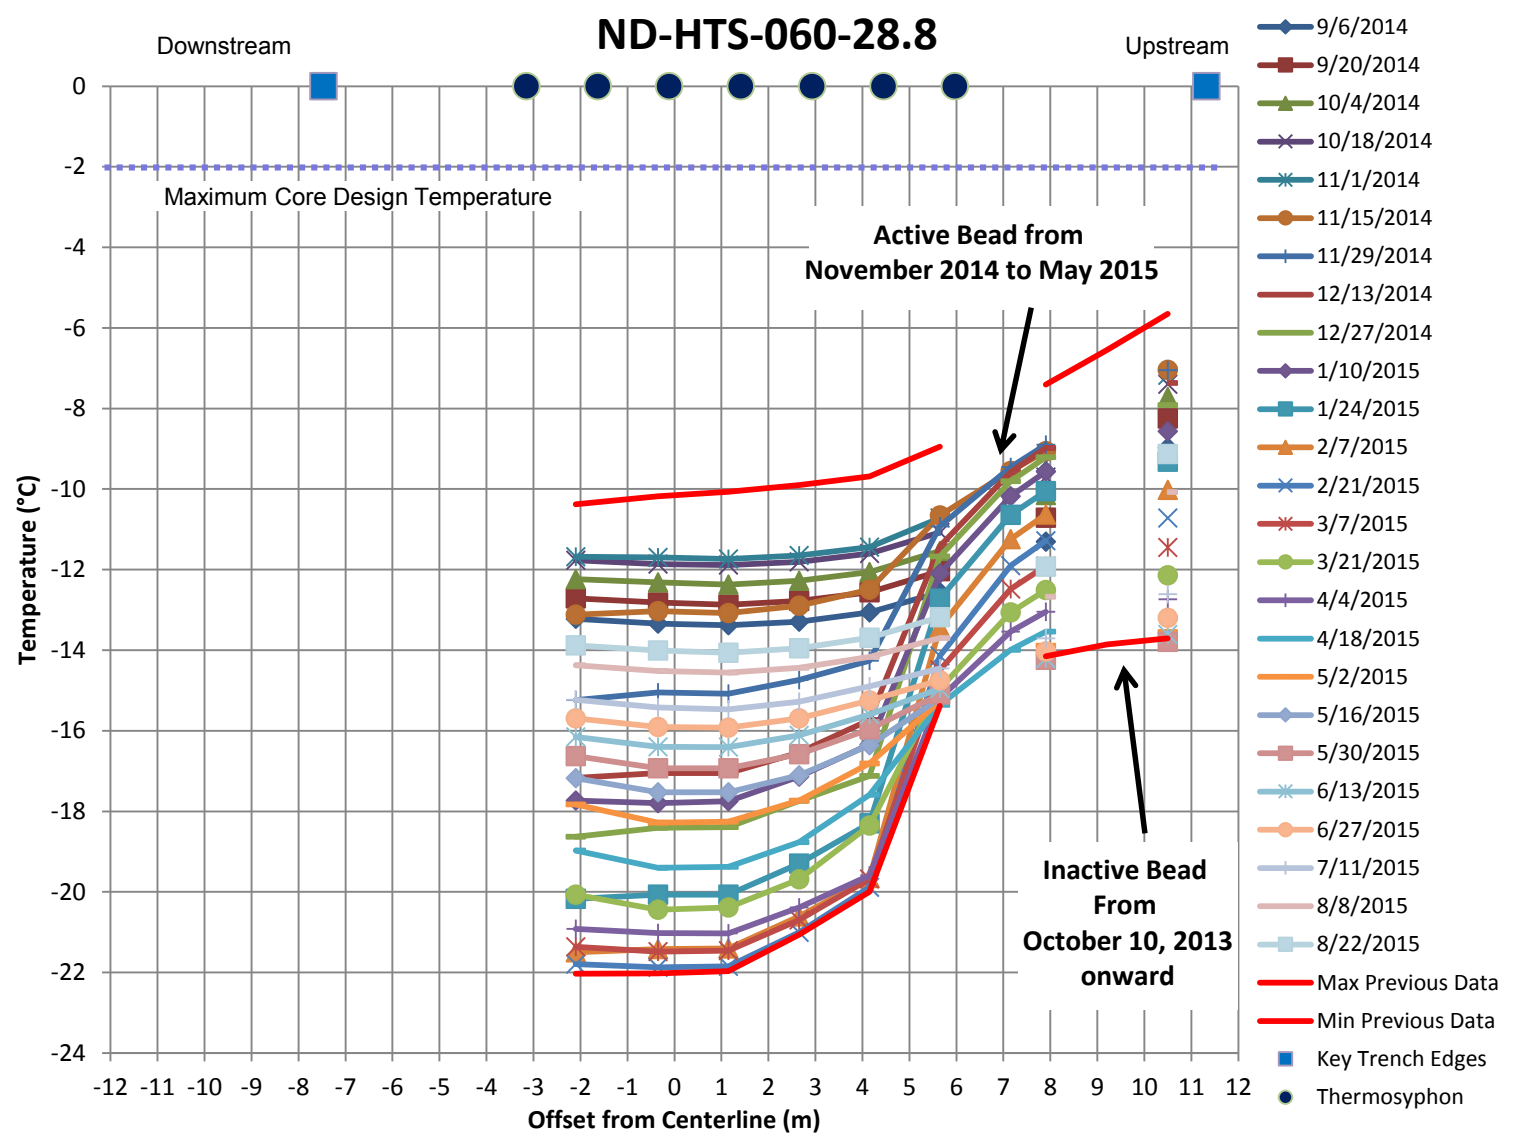
- Previous Data was recorded between August 2012 and September 2014

- Notes:**
- Bead numbers increase from downstream to upstream (horizontal) and top to bottom (vertical)
  - (A) Variation in Ground Temperature Cable readings during winter months due to close proximity of Ground Temperature Cable beads to thermosyphon pipes.

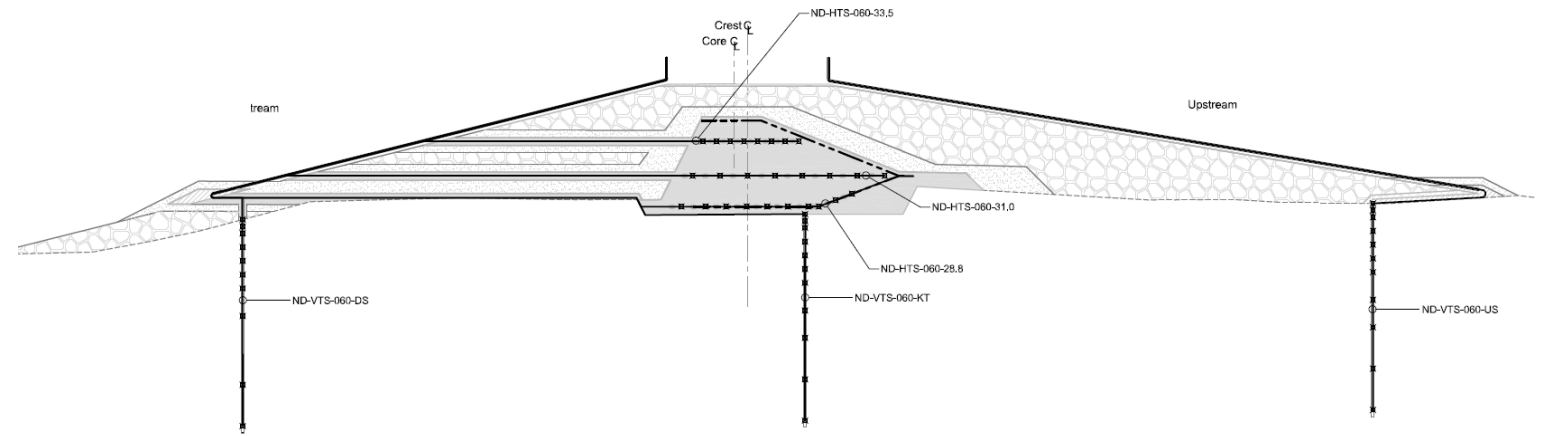
**Station 0+60 Vertical Ground  
Temperature Cable Readings  
by Location**

**ND-VTS-060-DS**

- Previous Data was recorded between August 2012 and September 2014

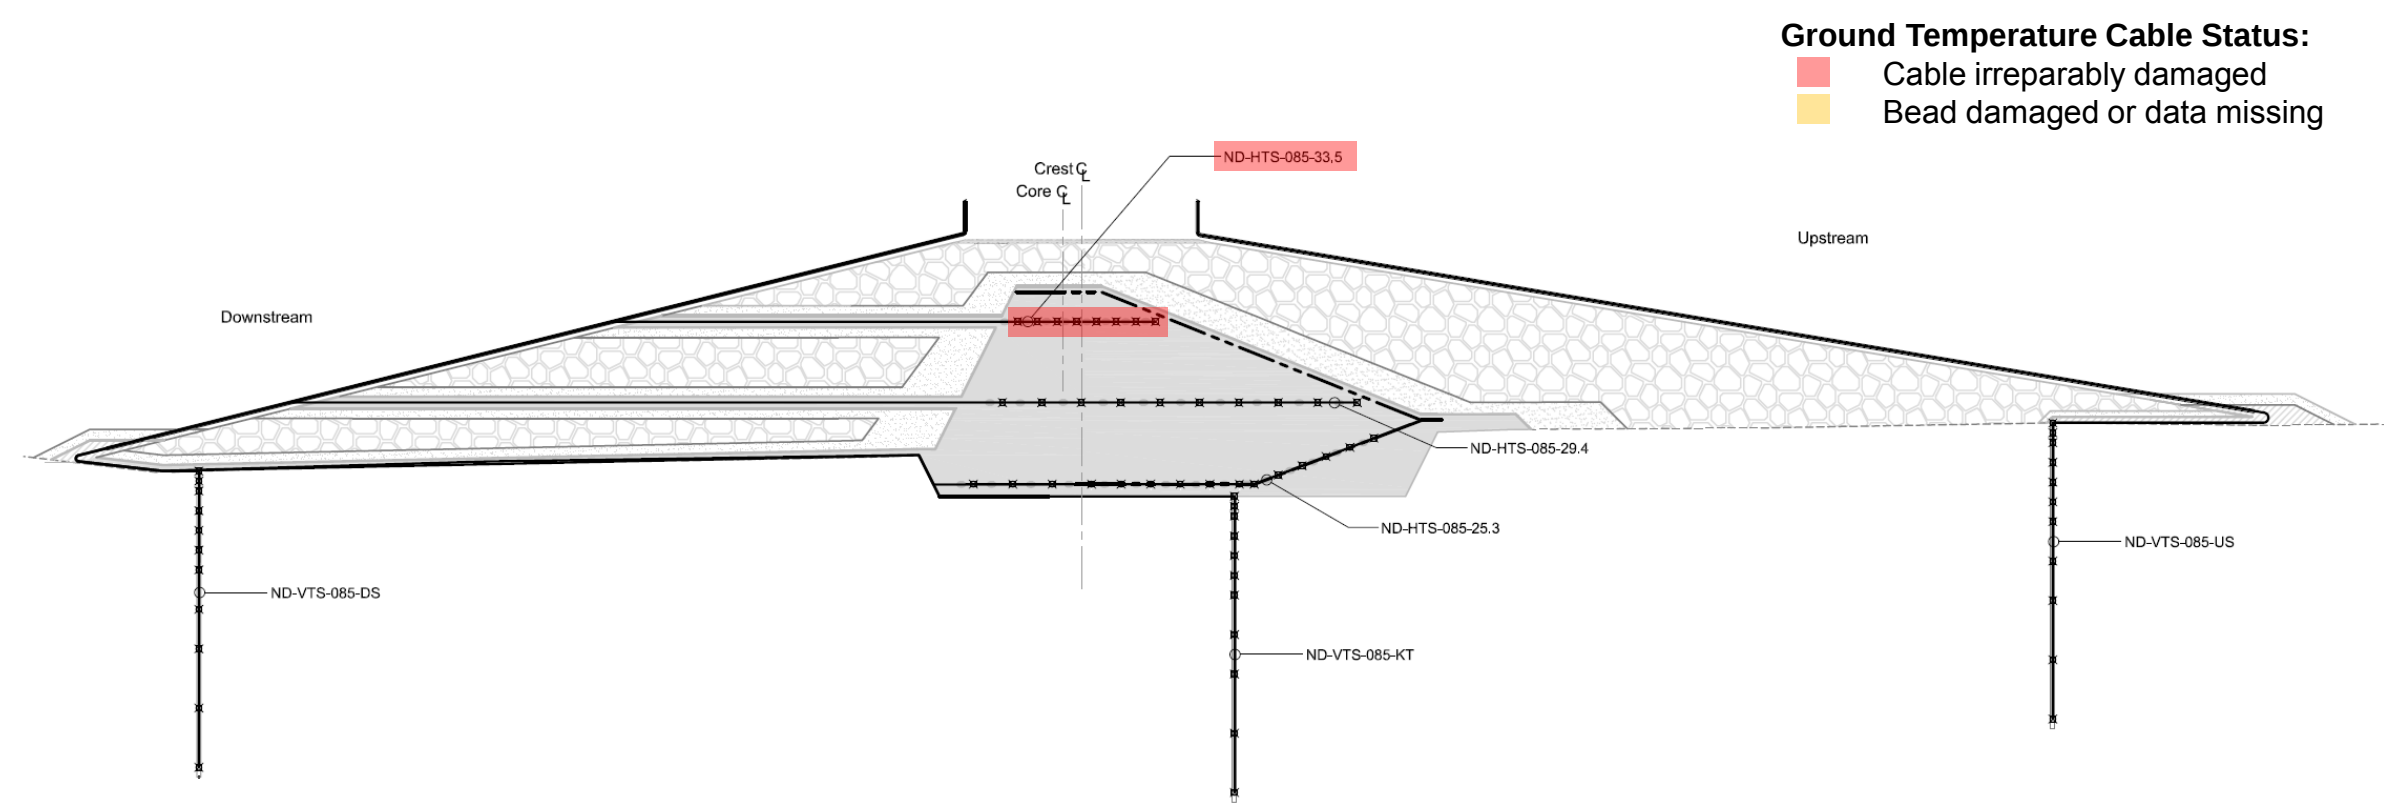
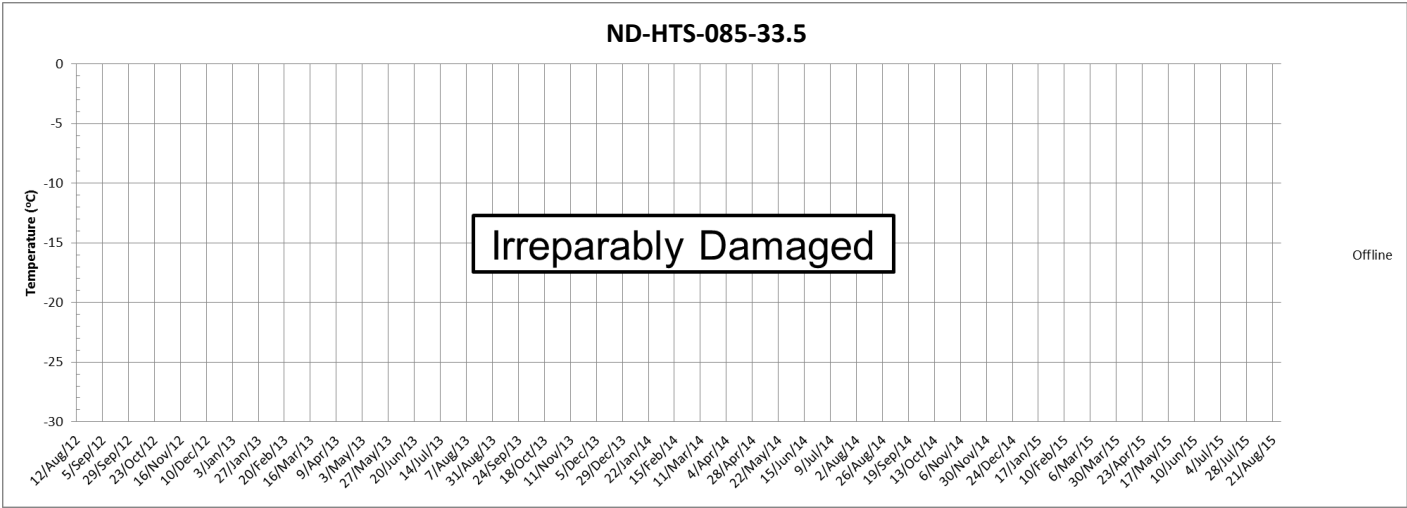
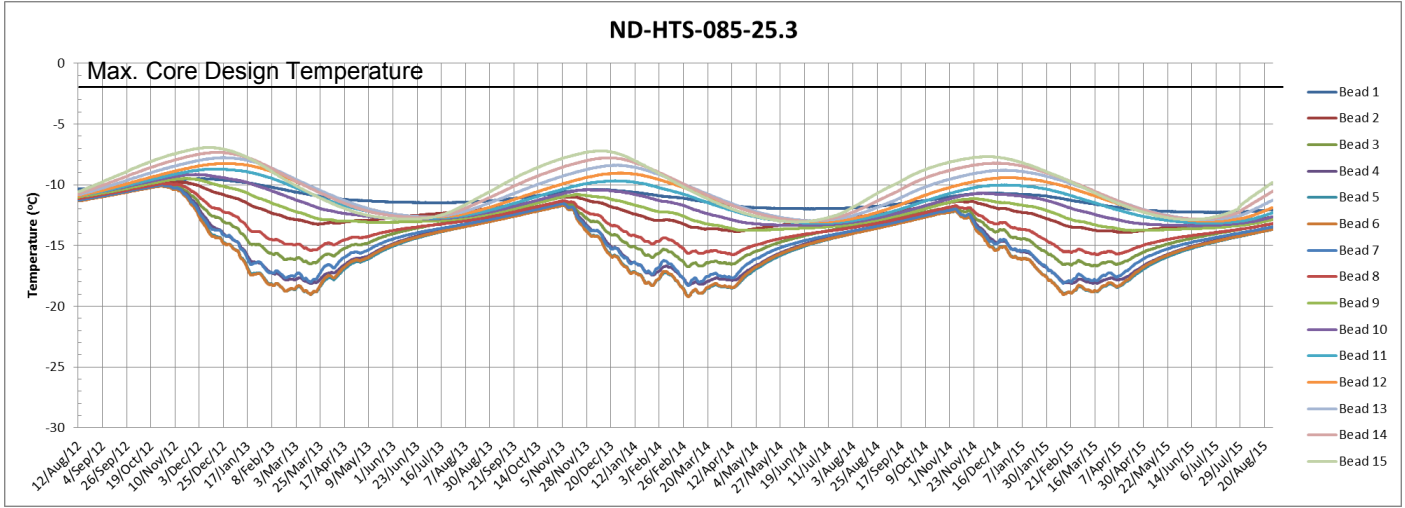
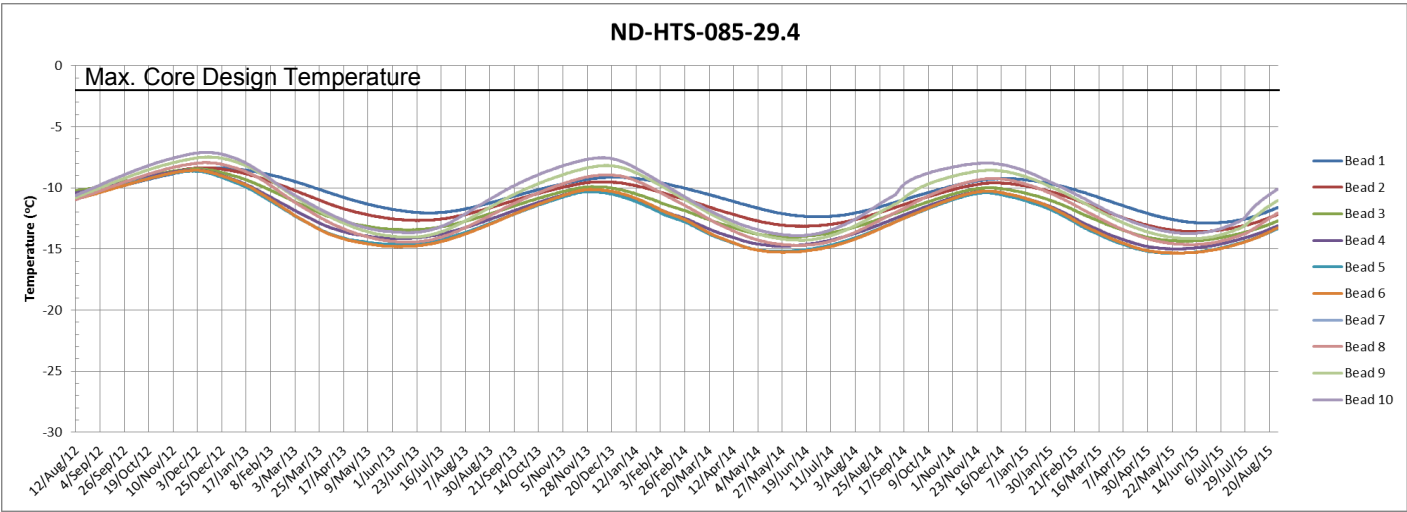
| Date:<br>Oct. 2015 | Approved:<br>PL | Figure:<br><b>A.6</b> |

- Notes:**
- Bead numbers increase from downstream to upstream (horizontal) and top to bottom (vertical)
