CONTINGENCY MANAGEMENT PLAN
JERICO DIAMOND MINE, NUNAVUT

DAM EMERGENCY INUNDATION MAP

Figure 14

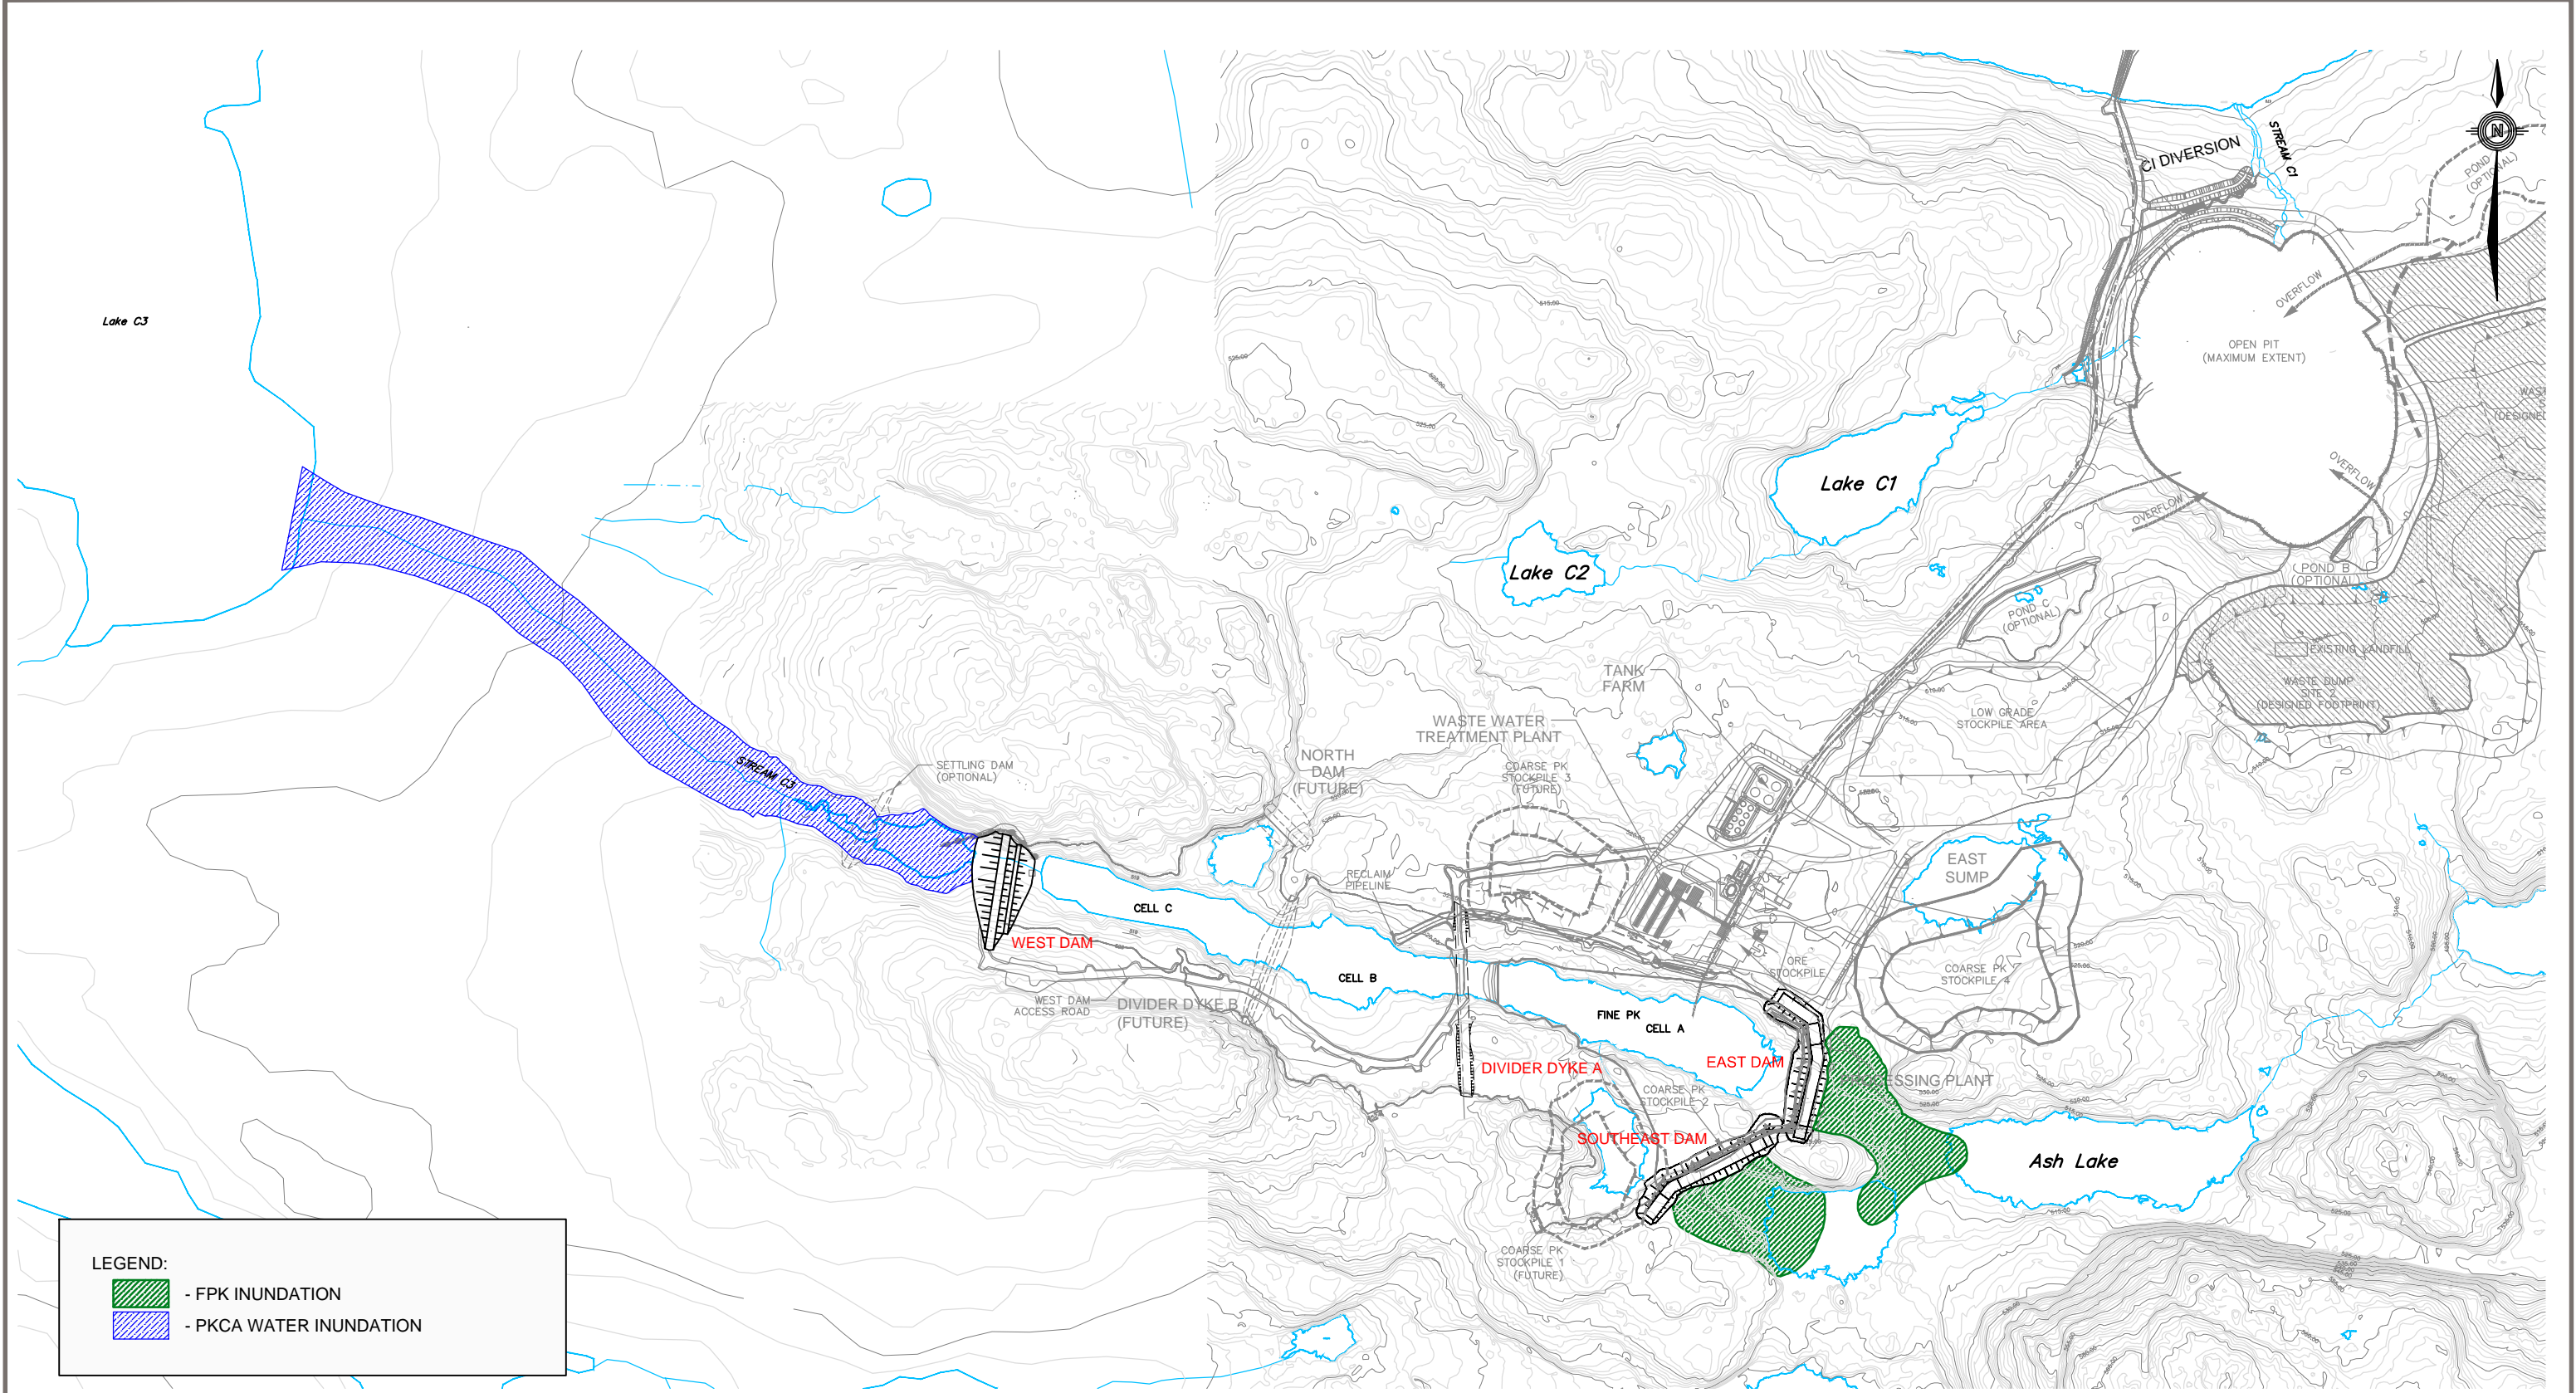
1. LAYOUTS ARE APPROXIMATE, AND MAY NOT REFLECT ACTUAL SIZE AND LOCATIONS
2. FOOTPRINTS OF WASTE ROCK PILES, COARSE PK STOCKPILES, AND ORE STOCKPILES ARE SHOWN IN MAXIMUM LIMITS, ACTUAL FOOTPRINTS MAY VARY
3. INUNDATIONS ZONES ARE ESTIMATES AND WILL BE REFINED BY SHEER DURING CARE AND MAINTENANCE ACTIVITIES IN 2011
