**GEOTECHNICAL, SEEPAGE  
AND WATER BALANCE**

**SEEPAGE AND WATER QUALITY  
FOR RECLAIMED  
TAILINGS CONTAINMENT AREA  
Lupin Operation**

**Kinross Gold Corporation**

**March, 2006**

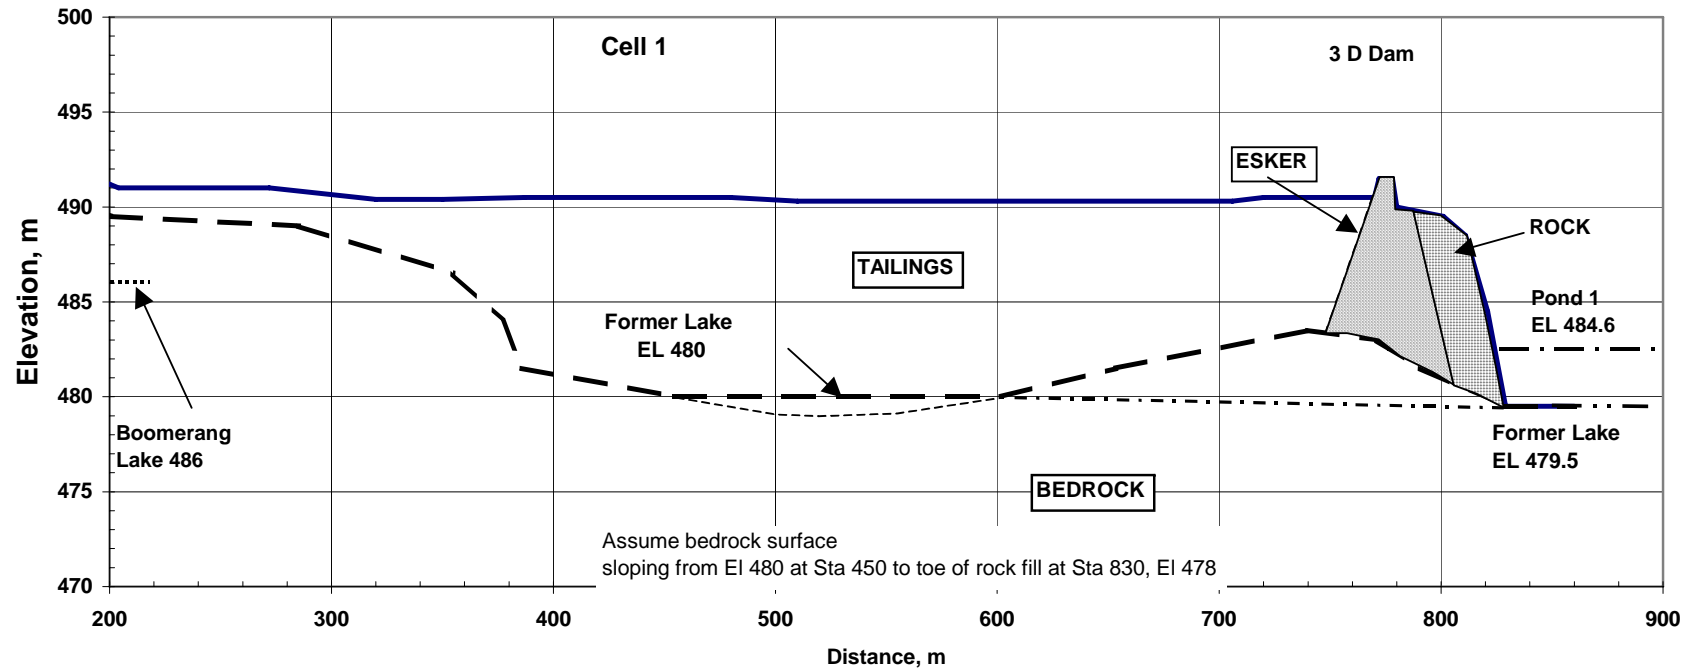
Figure 4. Representative tailings cross section at Cell 1

A section through Cell 1 (Figure 4) was taken as a representative for seepage analyses discussed in the next Chapter.

The cross section for the seepage model was taken from the Cell 1 section shown in Figure 4. In this model the sand/gravel cover and the silty sand till over the bedrock zone were neglected. The reasons being:

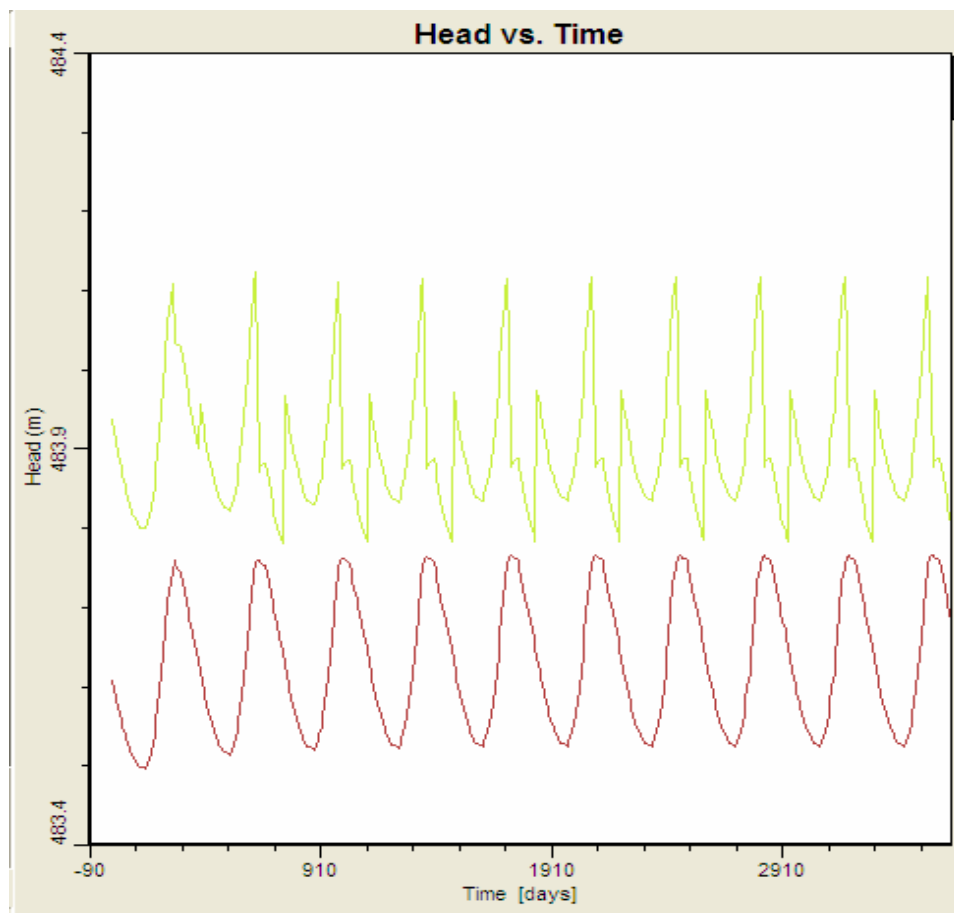
**Figure 7. Groundwater fluctuation for Case 1 at steady state.**

*Note.. Head fluctuations represent groundwater surface changes as measured by the head of water at two depths. Upper curve (yellow) represents head (groundwater surface) and the lower curve (red) as measured about 1m and 4m below the mean groundwater surface respectively.*

The fluctuation of the groundwater during the yearly cycle was determined for higher tailings permeability Case 1. The groundwater fluctuations during the years, after the steady state was reached, are illustrated in Figure 7. This is shown by the upper curve that corresponds to the groundwater surface. Results in this figure indicate that the groundwater fluctuates about 0.3m during the year.

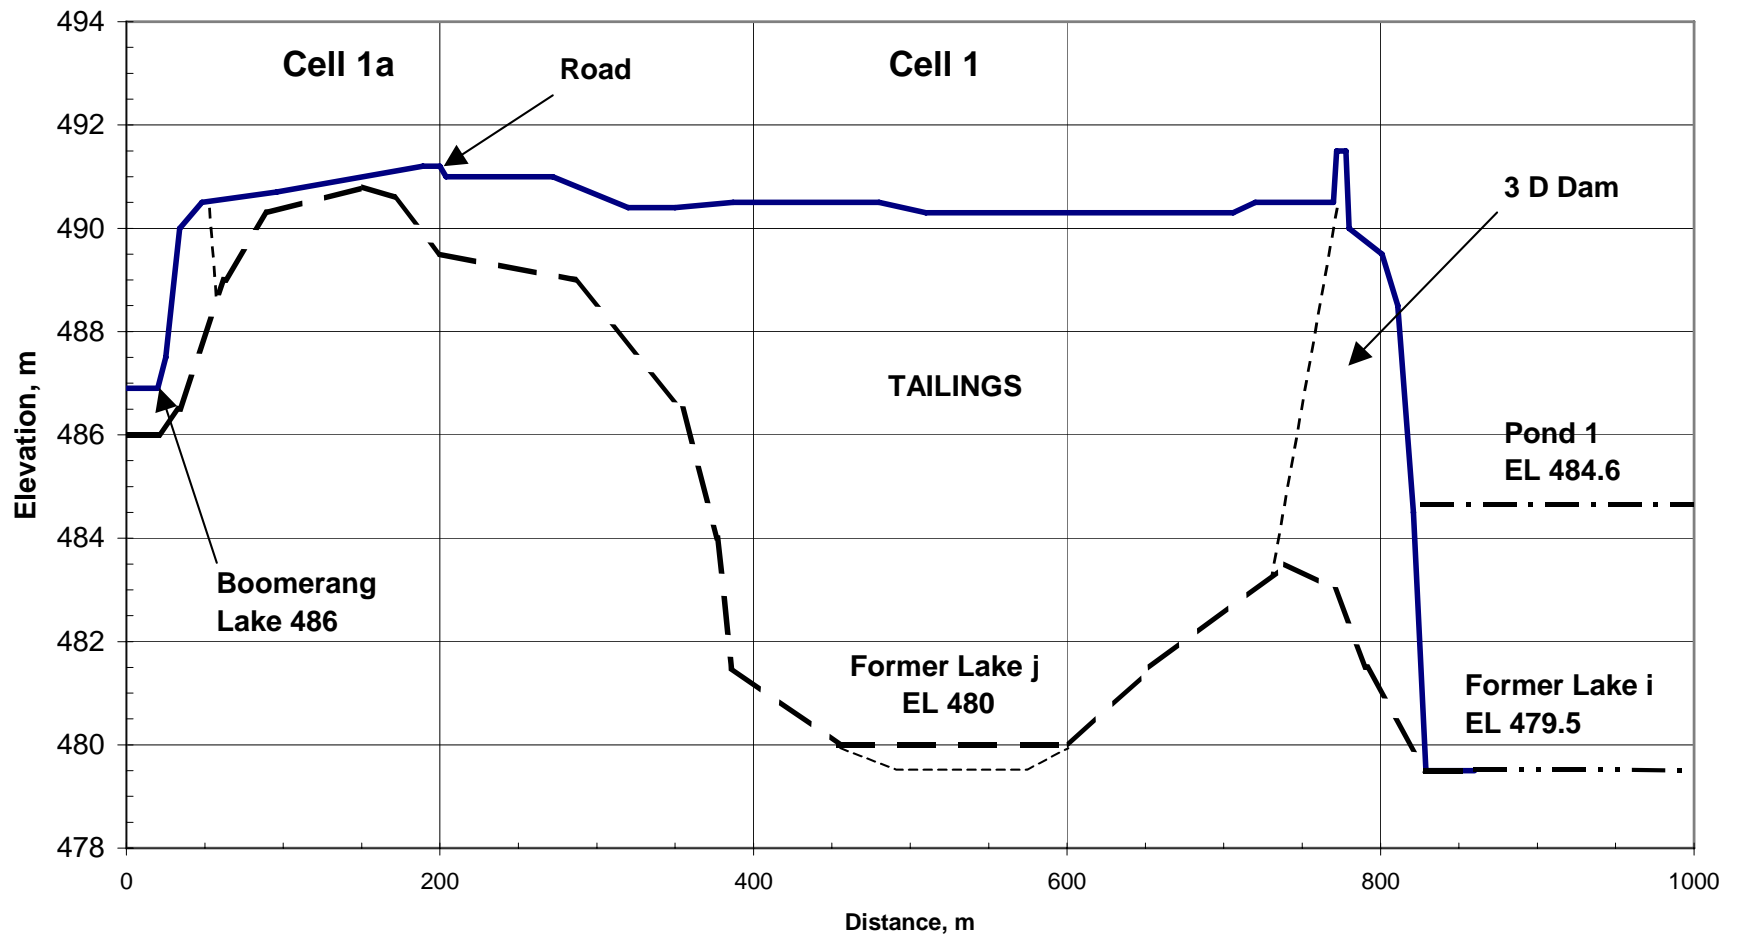
**Figure A1. Tailings contained by Dam 3D, section normal to dam**

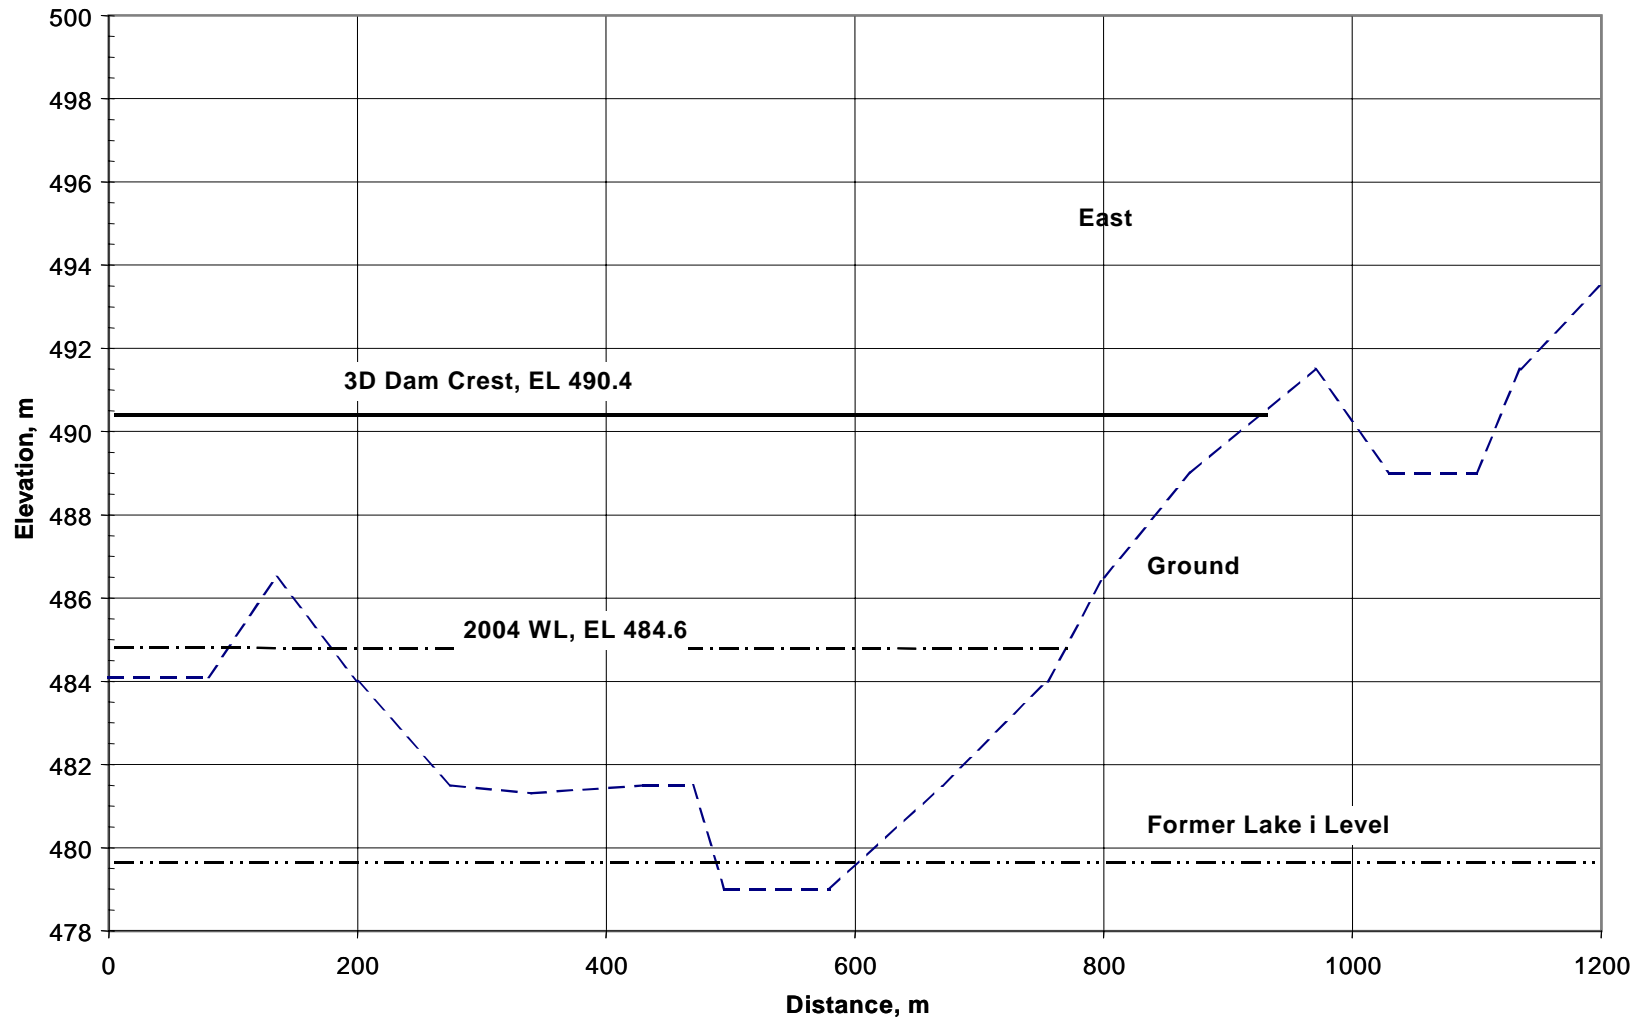
**Figure A3. Dam 3D foundation profile (against Cell 1)**

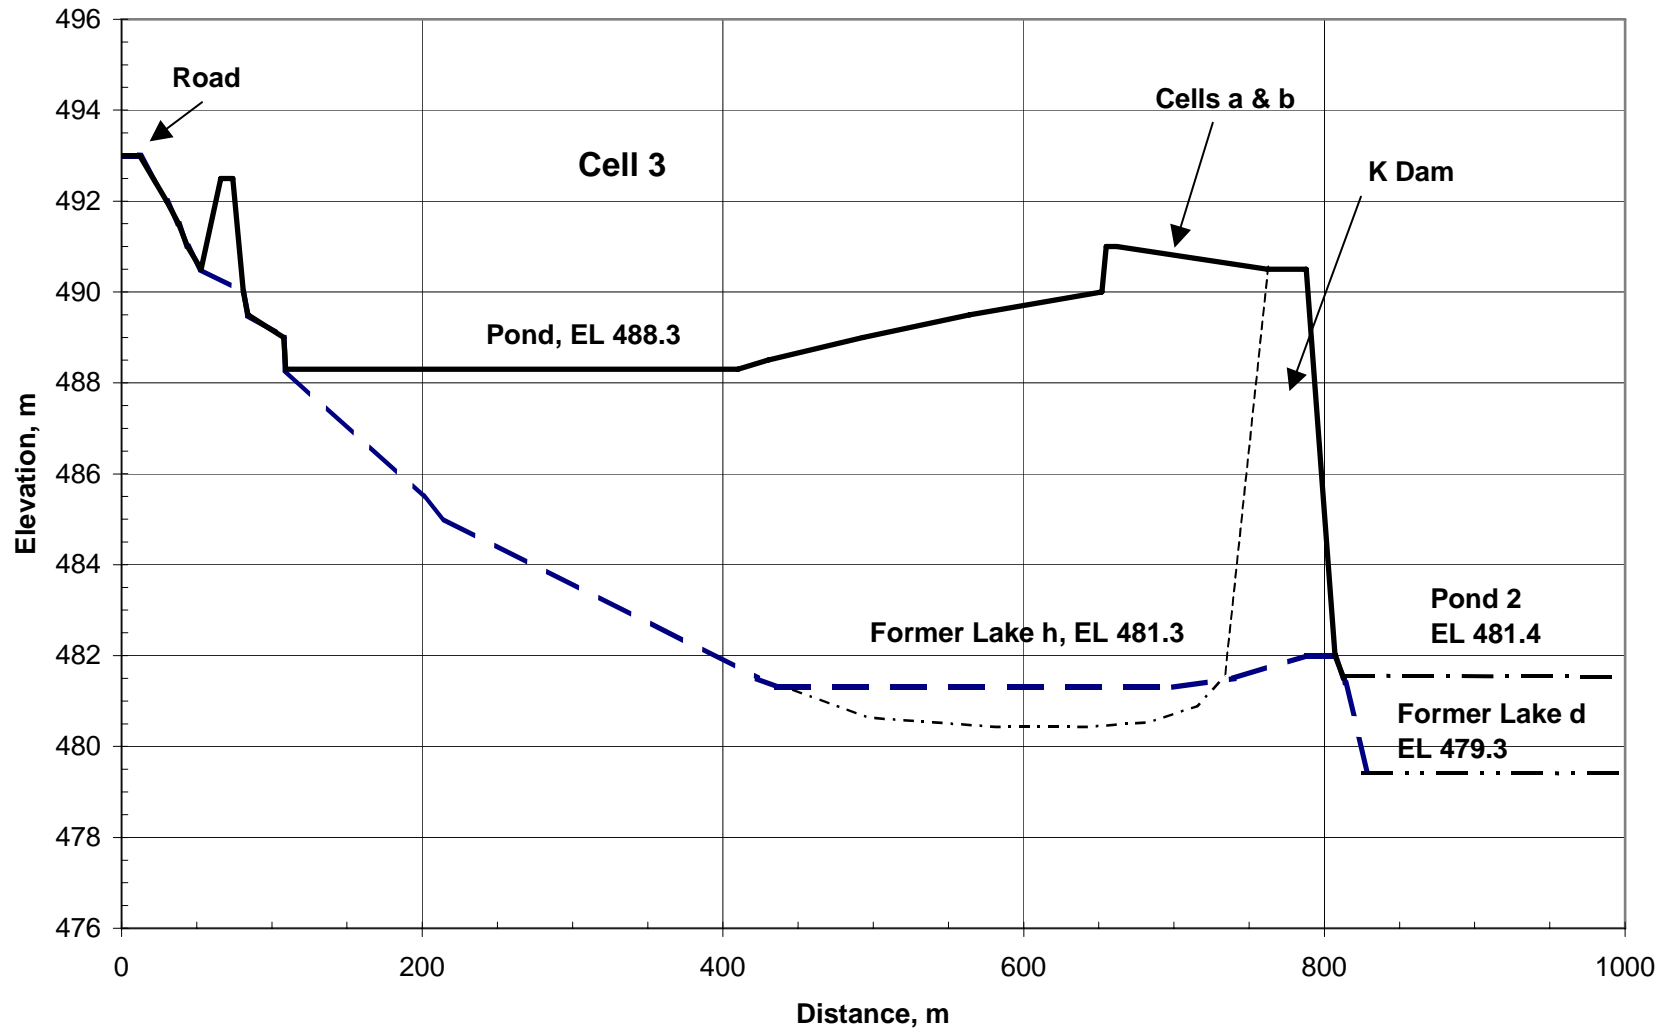
Figure A4.Tailings contained by K Dam , section normal to dam

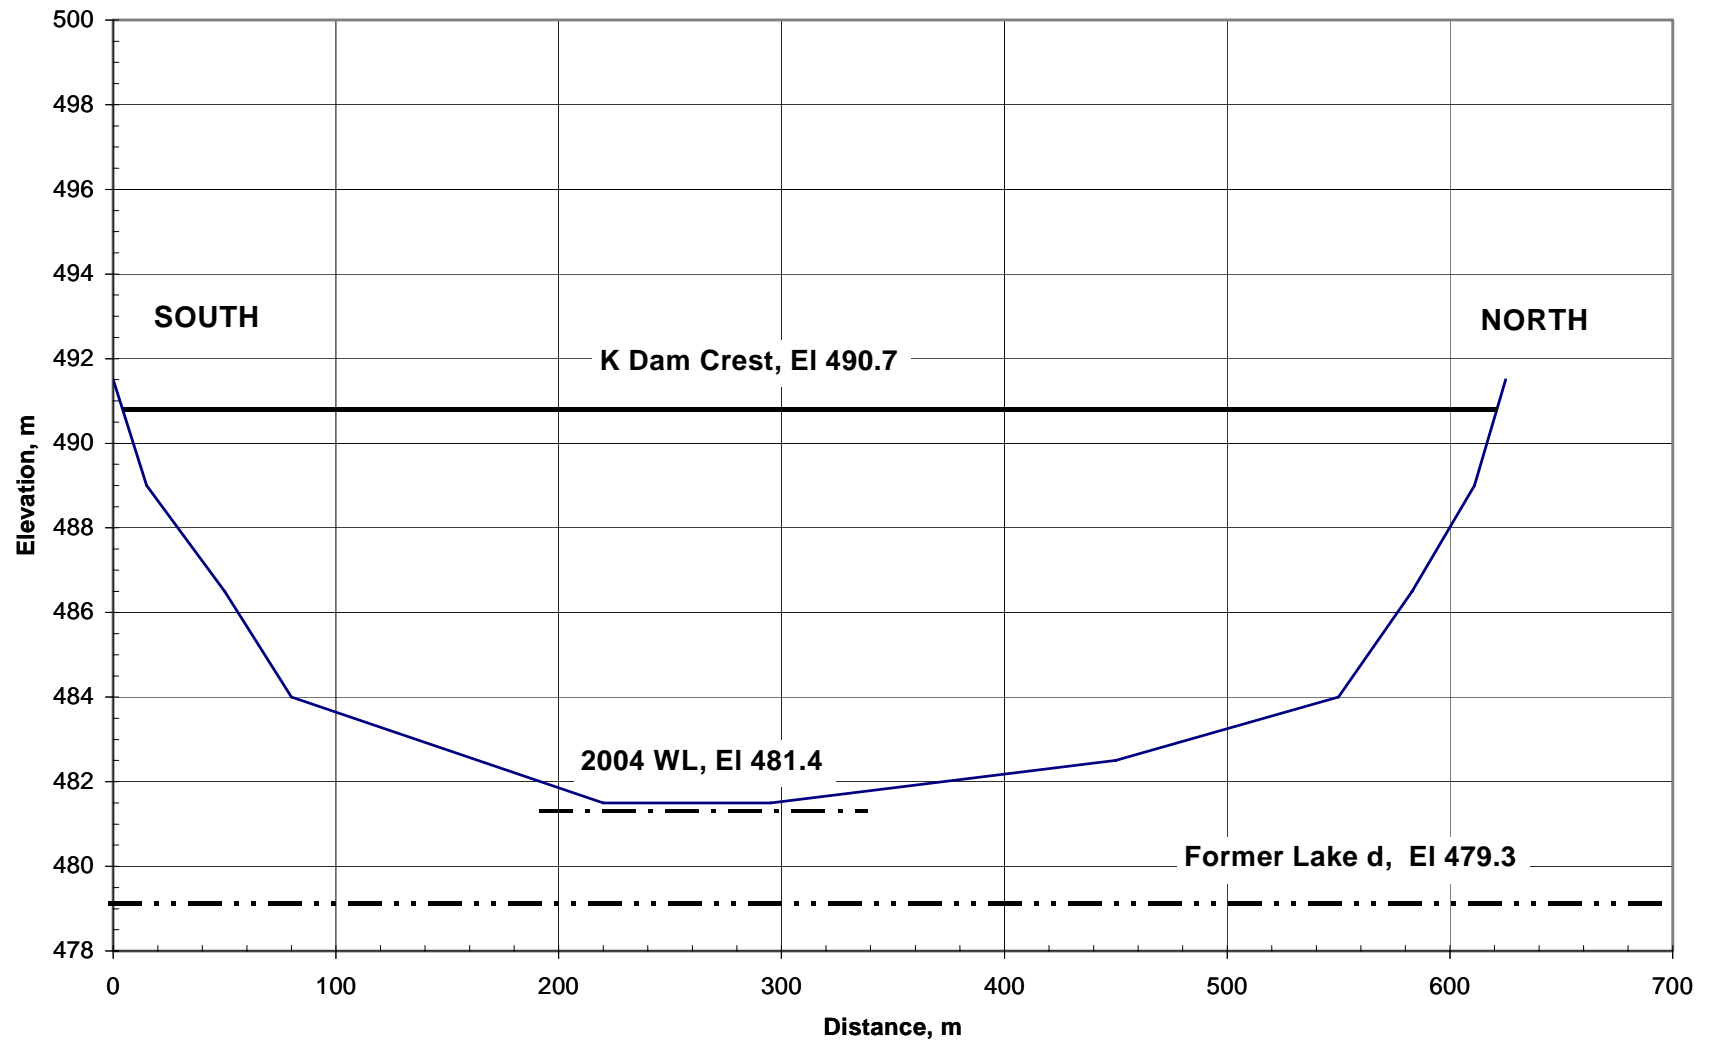
Figure A5.K Dam foundation profile, looking west

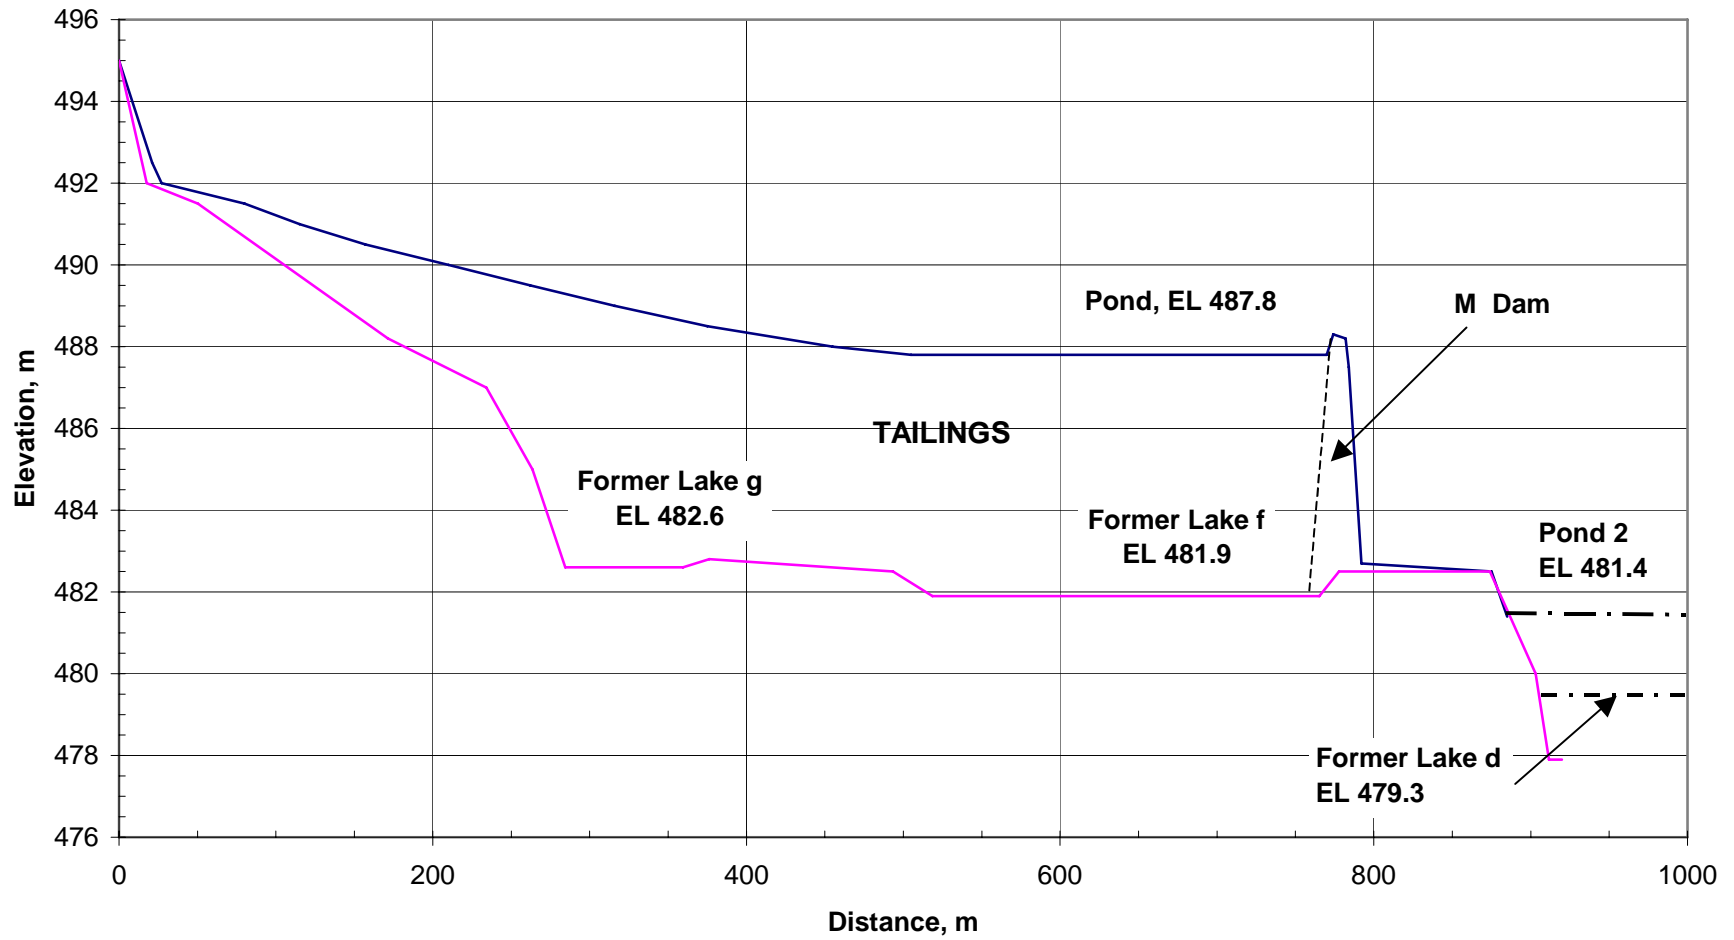
Figure A6.M Dam section with contained tailings, looking east

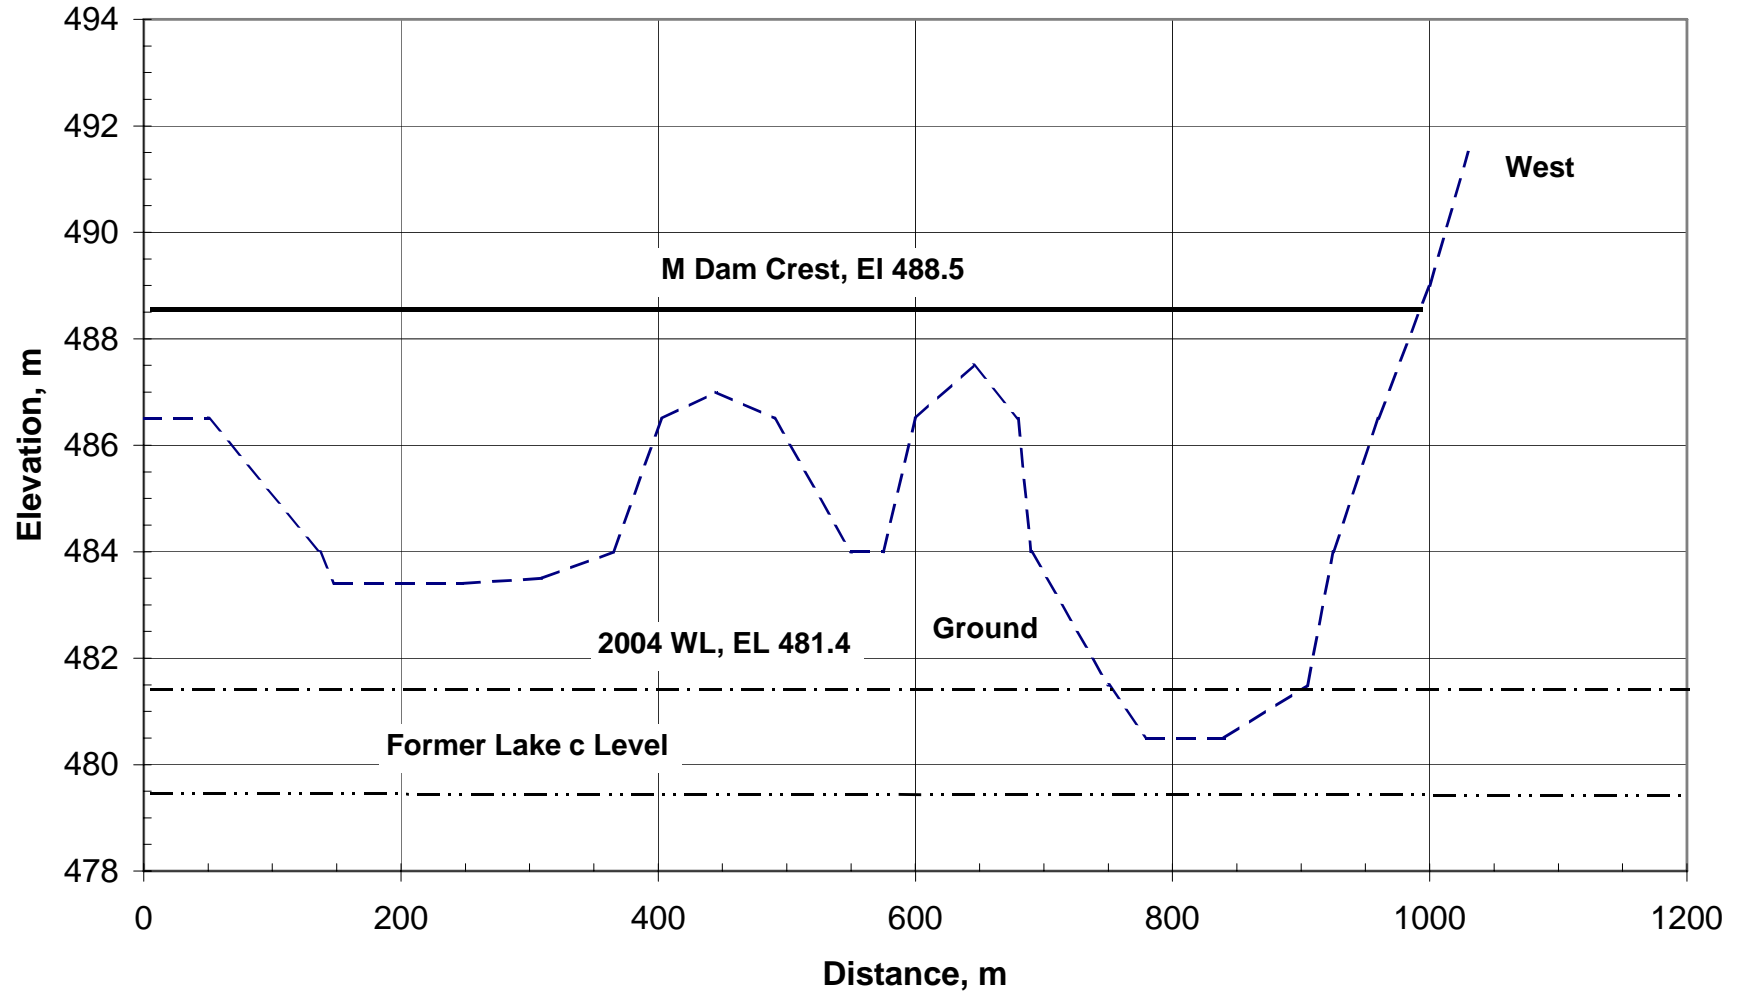
Figure A7.M Dam foundation profile
