RE: Kinross Gold Corporation, Lupin Mine, Contwoyto Lake, NU.

Water License NWB1LUP0008

Response to 2006 Annual Geotechnical Report

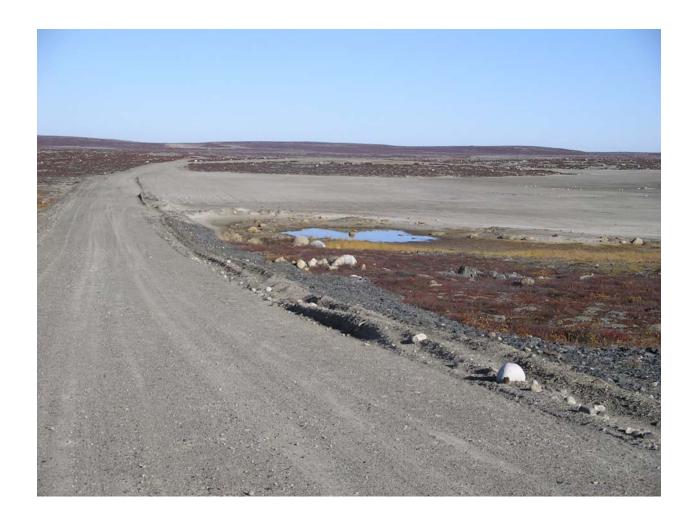
Dam 6: No maintenance required. The photo below shows the small pond noted in the

inspection report. With the spring freshette or heavy rain, it will not overtop Dam 6 but, rather, run to the north (right) onto the covered Cell 3. There has been no

evidence of overtopping since the south edge of Cell 3 was contoured in

September 2005.
