### ***Report: Preliminary AEM Report Seepage Water from Waste Rock Storage Facility – Sample Location ST-16***

**MEADOWBANK MINE**

# **Preliminary AEM Report – Seepage Water From Waste Rock Storage Facility – Sample Location ST-16**

**SEPTEMBER 2013**

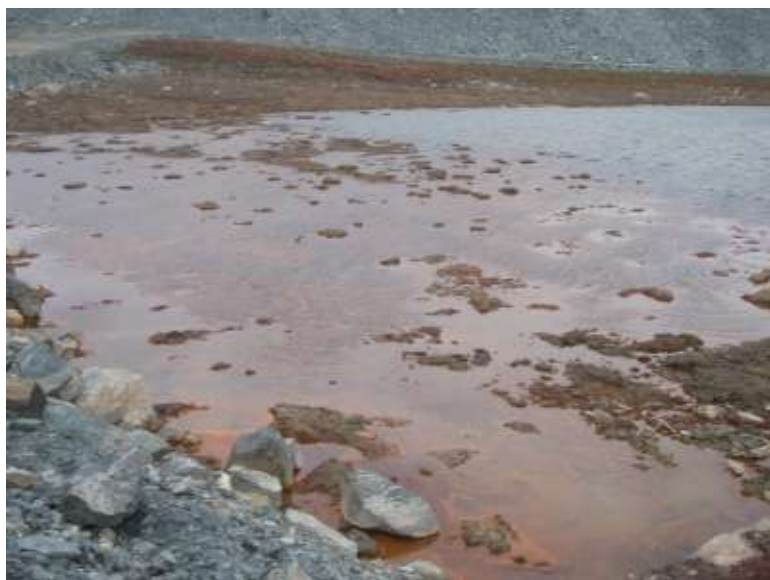
*Photo 1 – Shore of NP-2*

During an AANDC Water License inspection on July 29<sup>th</sup> and 30<sup>th</sup> 2013 it was observed that “red” colored seepage from the south - east side of the Waste Rock Storage Facility was seeping through the road perimeter into Lake NP-2. Samples were taken by both the Inspector and AEM staff (split sample). Analysis results from this sampling were received by AEM on August 16<sup>th</sup>, 2013. See Photos 1 and 2 below and Table 1.

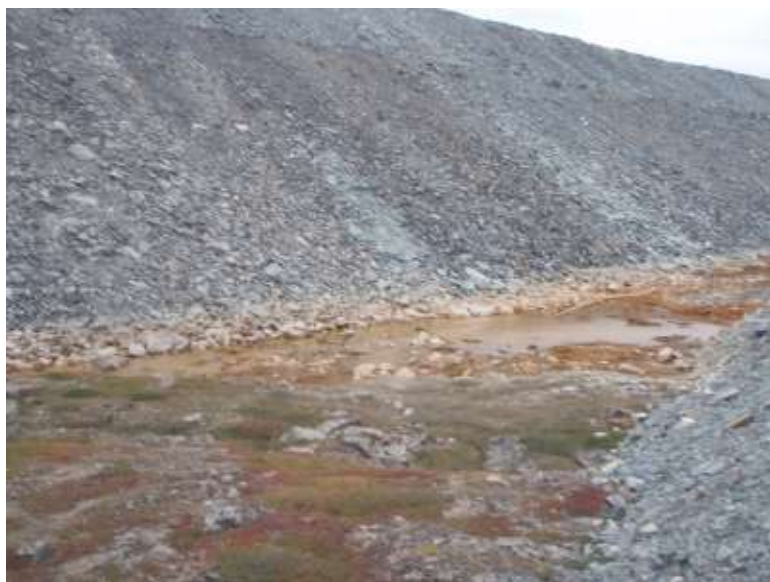
*Photo 2 – ST-16 Waste Rock seepage.*

In June 2013 we observed the normal brown color in the seep area initially up until approximately July 26<sup>th</sup> and 27<sup>th</sup> when the colour had changed to “red”. This is indicative of iron precipitate. The normal procedure is to have site water trucks pump out the seepage and deposit either in the TSF or use as dust suppressant in the mine pit only. Sample results from July 4<sup>th</sup> indicated that copper and nickel were elevated. This was an anomaly and our plan was to verify with the next sampling results (August 4<sup>th</sup>). There was no confirmed indication of actual seepage migrating through the perimeter road to Lake NP-2 until the red coloured seepage appeared around July 26<sup>th</sup> and 27<sup>th</sup>. At that point the red could be observed along the shoreline in NP-2. This was confined to the near shore and not in the main part of the lake. It was not observed at the exit of Lake NP-2. Removal of the seep water had previously commenced and was continuing at this point in time. **There was and has been no fish mortalities observed to date.**

- Upon first noting the “red” seep water in NP-2 Lake (approximately July 26<sup>th</sup>) and after the initial AANDC inspection of July 30<sup>th</sup> AEM increased pumping of the seep water to prevent migration through the road. The seeps will be monitored daily and pumped out accordingly – daily if necessary;

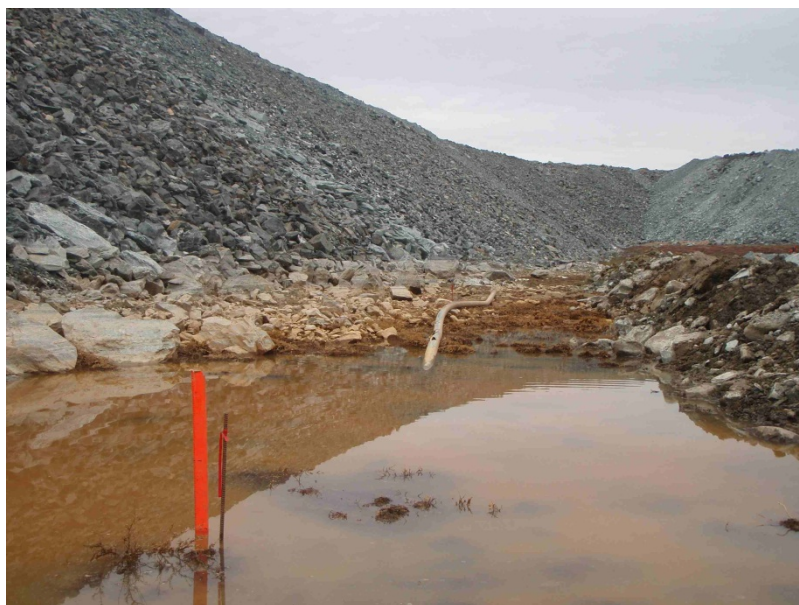
*Photo 5 – Seepage Staff Gauge*

A staff gauge has been placed at the seepage to determine the water level increases more definitively – see photo 5 below.

- A staff gauge was placed in the seeps to better determine the seepage inflow;
- An internal SOP was completed (see Appendix 2) to ensure that seeps are pumped in a timely manner at the commencement of freshet and kept at a low level;

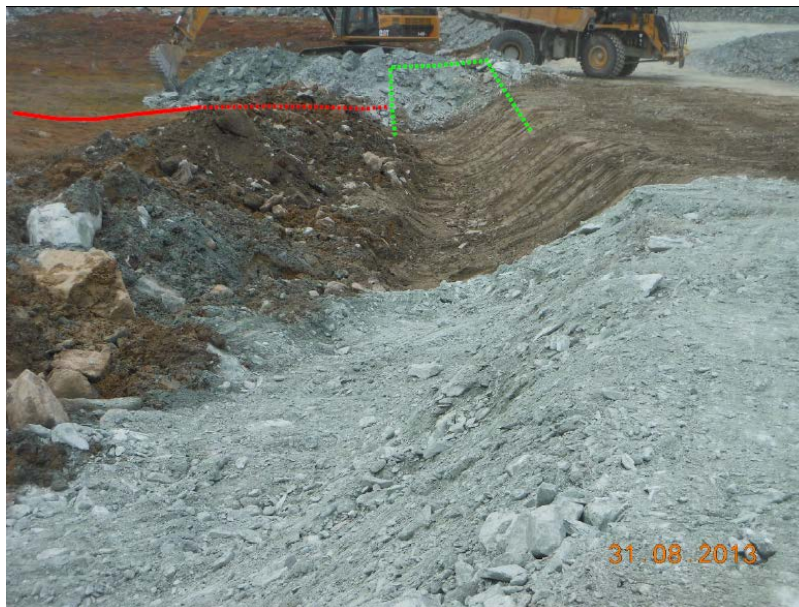
*Photo 7 – Construction of Waste Rock Plug*

Construction of the Waste Rock Plug was completed on September 1<sup>st</sup>. The seep areas are segregated and have been kept at low levels – see photo 7 below.

- A Waste Rock Plug/Dike was designed and constructed (commencing August 26<sup>th</sup>), under the supervision of the AEM Engineering Department, along the perimeter road to prevent any further seepage to Lake NP-2. This was completed on September 1<sup>st</sup>. A complete construction report and as-built drawing will be prepared;

Measures were implemented to stop the seepage to NP- 2 Lake and prevent it from re-occurring (Waste Rock Plug installation). Tailings deposition was changed on September 2<sup>nd</sup> to an area where the seepage is thought to be migrating. This action will also assist in pushing the water away from the rockfill perimeter structure and act as an additional “plug”.
