**Underground Ore Stockpile Saline Ditch
Photographic Log**

IVR Diversion Channel Photographic Log

DIKES DETAILS AND INSTRUMENTATION

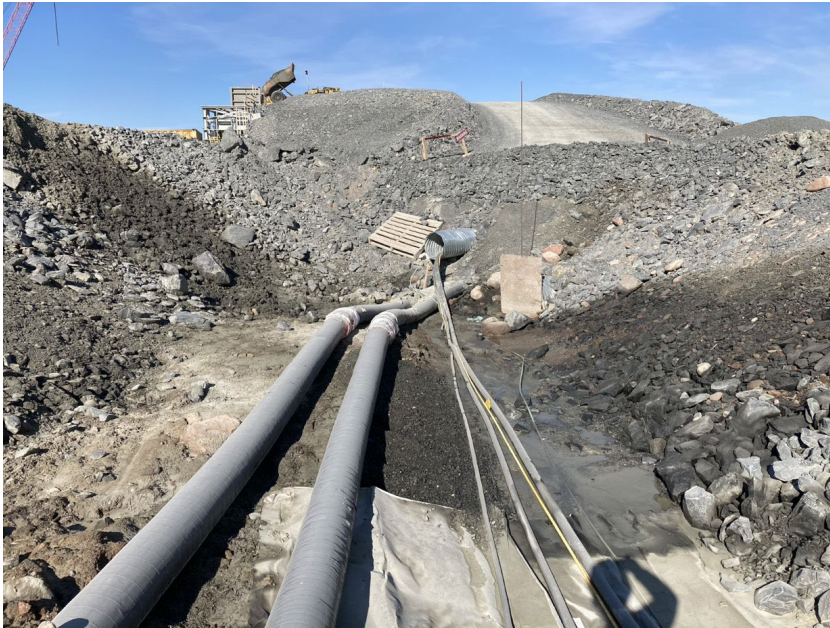
Photograph H11-13 Saline Ditch

Description: From the southwestern extremity of the Saline Ditch, looking northwest. Presence of boulders and debris in the ditch.
