**MEADOWBANK MINE**

# **Preliminary AEM Report – Seepage Water From Waste Rock Storage Facility – Sample Location ST-16**

**SEPTEMBER 2013**

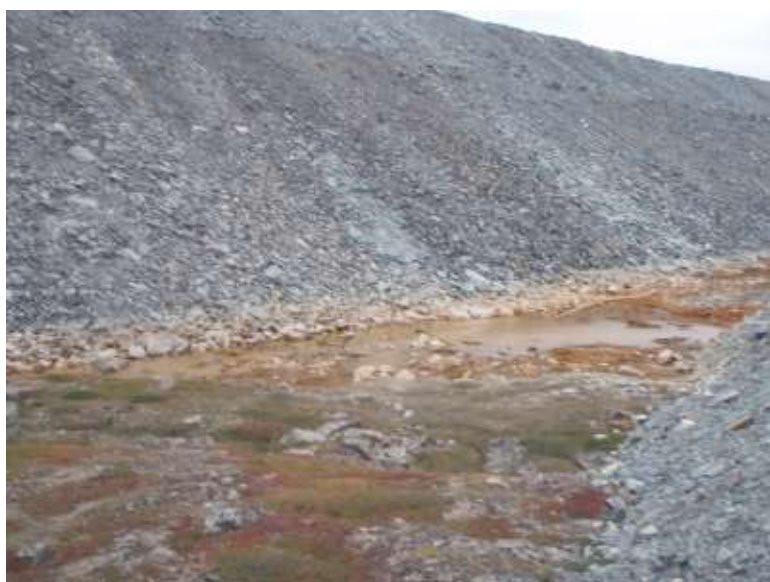
*Photo 2 – ST-16 Waste Rock seepage.*

During an AANDC Water License inspection on July 29<sup>th</sup> and 30<sup>th</sup> 2013 it was observed that “red” colored seepage from the south - east side of the Waste Rock Storage Facility was seeping through the road perimeter into Lake NP-2. Samples were taken by both the Inspector and AEM staff (split sample). Analysis results from this sampling were received by AEM on August 16<sup>th</sup>, 2013. See Photos 1 and 2 below and Table 1.

In June 2013 we observed the normal brown color in the seep area initially up until approximately July 26<sup>th</sup> and 27<sup>th</sup> when the colour had changed to “red”. This is indicative of iron precipitate. The normal procedure is to have site water trucks pump out the seepage and deposit either in the TSF or use as dust suppressant in the mine pit only. Sample results from July 4<sup>th</sup> indicated that copper and nickel were elevated. This was an anomaly and our plan was to verify with the next sampling results (August 4<sup>th</sup>). There was no confirmed indication of actual seepage migrating through the perimeter road to Lake NP-2 until the red coloured seepage appeared around July 26<sup>th</sup> and 27<sup>th</sup>. At that point the red could be observed along the shoreline in NP-2. This was confined to the near shore and not in the main part of the lake. It was not observed at the exit of Lake NP-2. Removal of the seep water had previously commenced and was continuing at this point in time. **There was and has been no fish mortalities observed to date.**

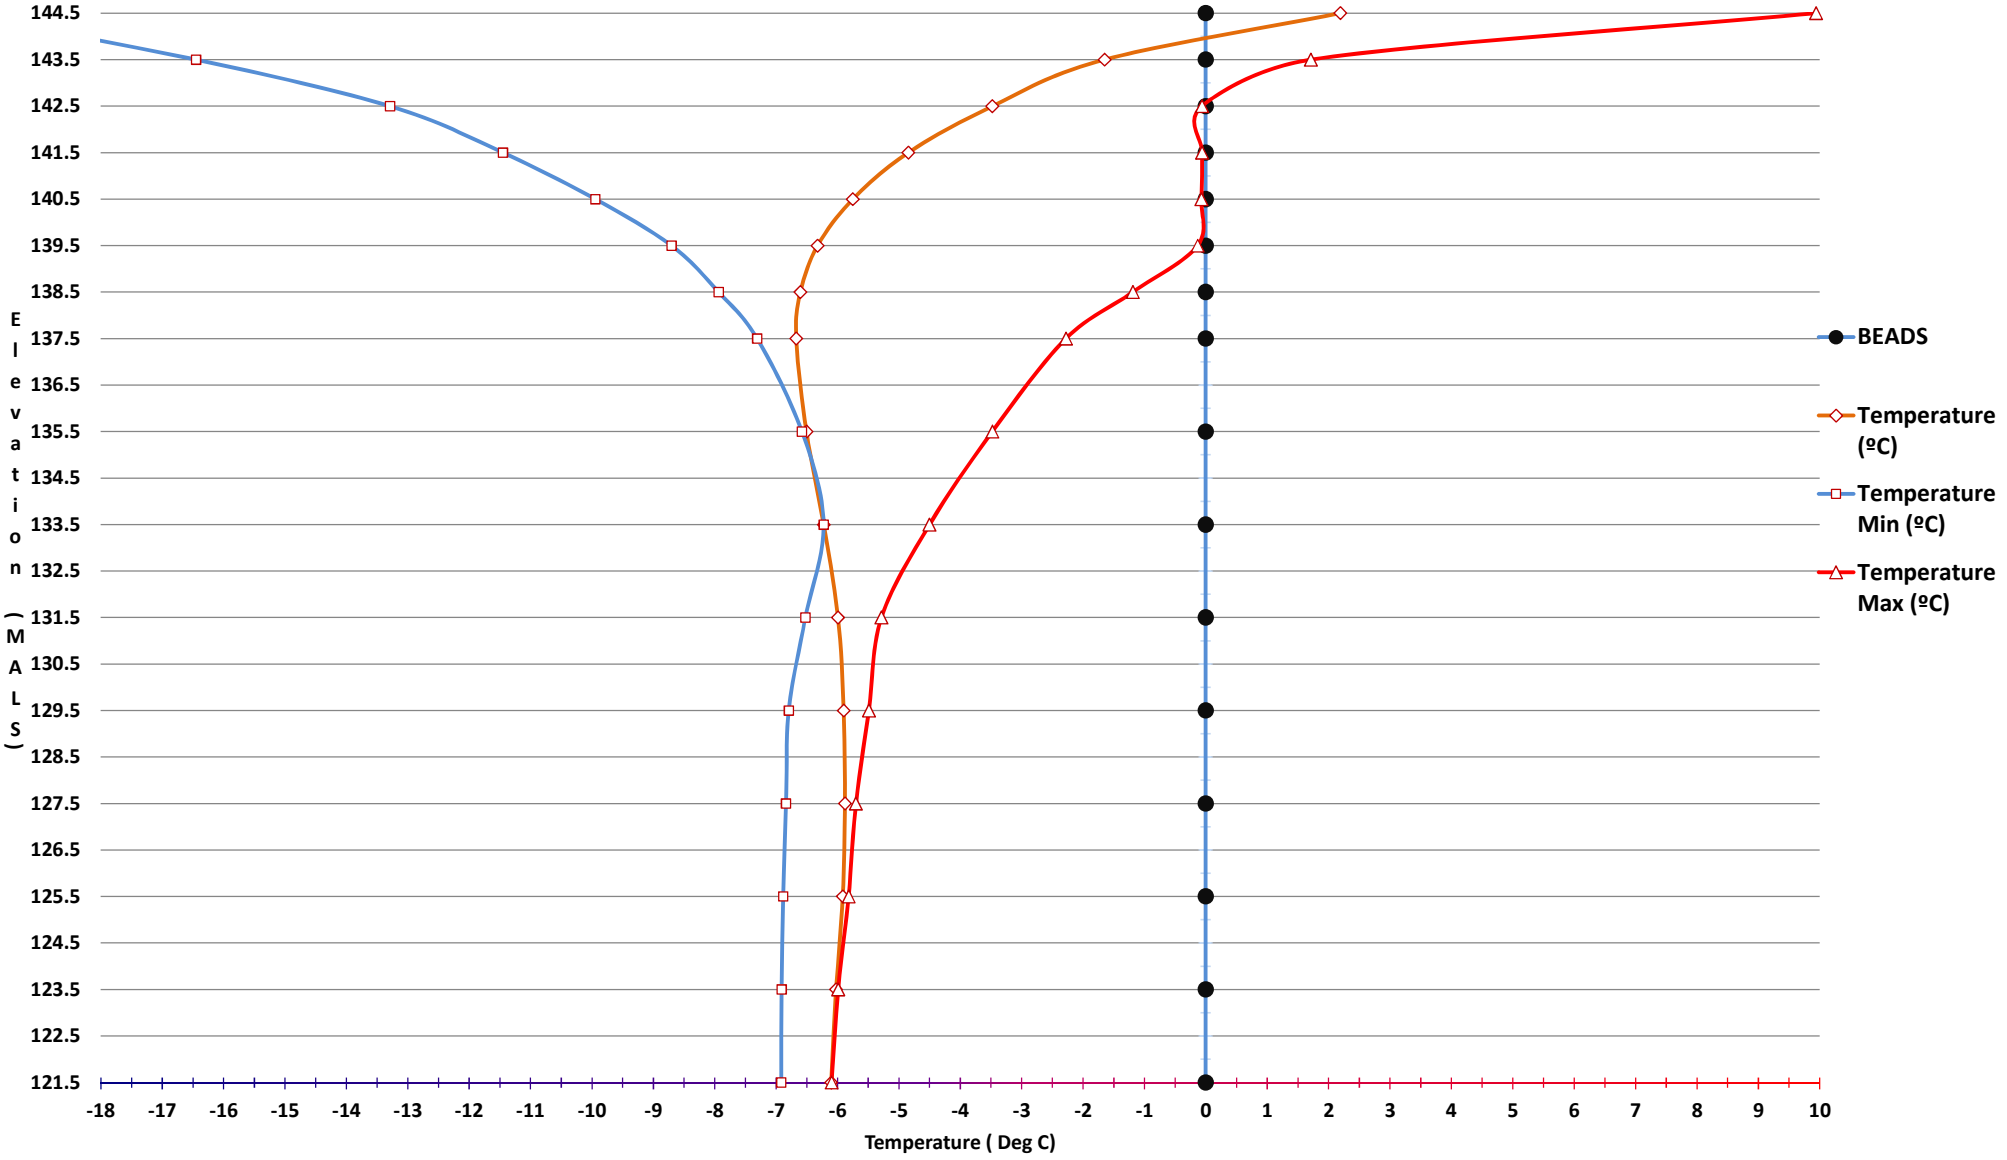
SD2-T4 (Saddle Dam 2) SUMMARY OF VERTICAL  
Elevation vs Temperature - String # 73-4
