DANGEROUS OCCURRENCE POSTER

Incident Description: a Dangerous Occurrence occurred on 28 November-2016 -
On the morning of November 28, 2016– an Artic Fuel tractor # 89 and trailer # 36
transporting 2 Nitrate sea-cans fell on the passenger side of unit while in the curve at
km 65– No Spill of product -driver sent to clinic for full precautionary assessment only.

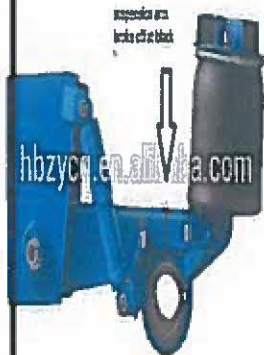
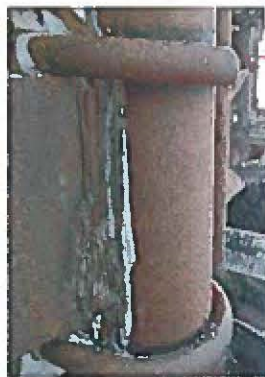
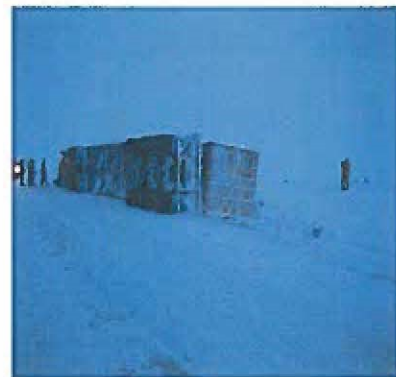
- The first axle on the trailer had a major structural failure on the right side. The trailer was only supporting the load on the right side by the rear two axles.
- Heavy load 44,600 kg. Load capacity of the trailer #36 is 54,000 kg.
- The suspension arm has been welded couple time in the past.

- Random inspections of AFS equipment will be performed to insure adequate maintenance of their fleet.
- An official communication will be sent to AFS to that effect. For the first 3 months, a weekly random inspection will be done; following compliance to good maintenance results, we will move to a monthly random inspection.
