November 16th, 2016 sewage pipe leak

Please find the following information as a follow up to the Spill report submitted November 17th, 2016 by Agnico Eagle Meadowbank division. This detailed report is submitted to the Inspector in compliance with the conditions under the Nunavut Water Board License 2AM-MEA1525, Part H, Item 8c.

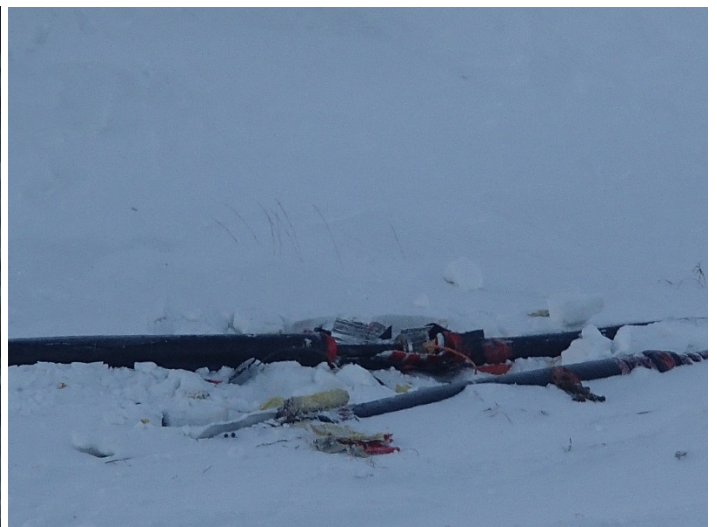
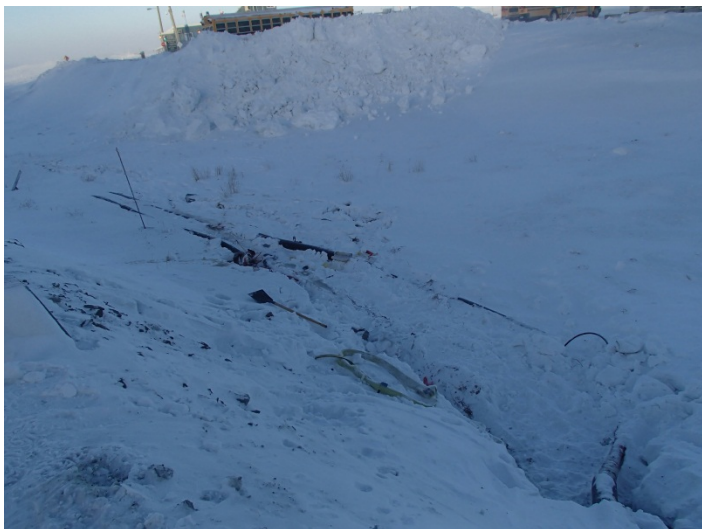
On November 16th, during a daily visual inspection, sewage from a leaking pipe going from the Nova camp to the sewage treatment plant was discovered.

The spill was caused by a broken coupling on the sewage line

The valve allowing the sewage to go through that pipe was turned off as soon as the spill was discovered. The sewage was transferred with the sewage truck while the pipe was getting repaired. Sewage on the ground was pumped with the sewage truck and hand shovel were used to pick up the contaminated snow. All material was brought to the sewage treatment plant. No heavy machine was used as electrical wires were right next to the sewage pipe. The coupling was change for a Victaulic one to prevent for future failure. The area will be reassessed next spring
