# **Amaruq exploration project**

Fuel farm spill 1500 L

Situation report on

**April, 2017**

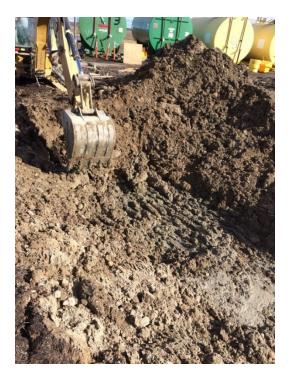
Figure 1: Backhoe excavating contaminated soil

- Contaminated soil was removed progressively using sampling results to locate remaining contamination.
- Absorbent material continued to be used.
- Berm extension was built to store additional contaminated soil.
- Sampling continued to be done in the excavation to detect contamination.
- Decontamination continued until winter weather stopped works.

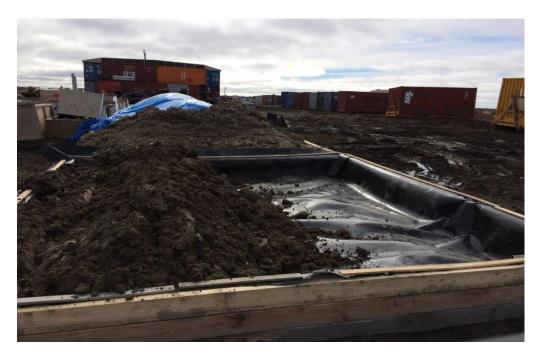
Figure 2: Temporary contaminated soil storage

Around 250 m³ of soil were excavated and stored in 2016 from the spill area for a total of 300 m³. The temporary contaminated soil storage berm was extended to store additional contaminated soil. Progress was made in 2016, but the results showed a residual contamination. Rehabilitation is planned to be finalized in 2017 and additional sampling will be done to confirm closure of this file.

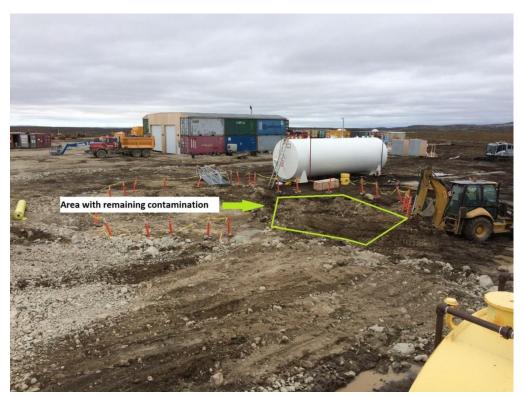
Figure 3: Remaining contamination area
