2019-05-08 MBK South Cell Tailings Spill

GN reference # : 2019-193

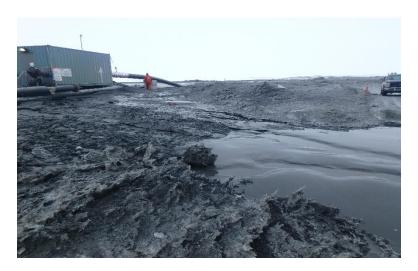
Spill location: N 65 01'27.3" W 096' 03'43.1"

A planned electrical shutdown of the Tailings storage facility "pig launcher" station occurred on the morning of May 8th. During restart of the system that afternoon, the wrong valve was opened remotely by the Mill Control room, discharging tailings at the top of Saddle Dam 4 by the pig launcher station.

There were no off site impact or discharge to any receiving watercourses. The distance to the closest lake is estimated at 900 meters.

The spill occurred due to miscommunication in the control room and the workers on the field. The discharge pipe should also have been locked out so that in the event a wrong valve was opened, a spill could not occur.

An improvement in the communication with the control room, ensuring lock out/tag out on valves will help to prevent a spill in the future.

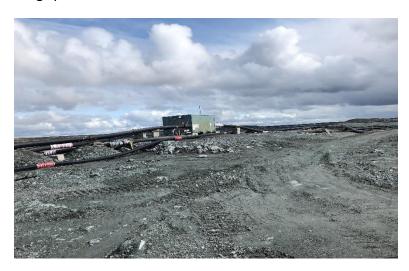
Upon discovery of the spill, the valve was immediately closed. The tailings were contained within the existing berm surrounding the area. A second berm was created around the access ramp with clean material to ensure the tailings did not seep outside the existing berm. The contaminated material was then removed and placed back into the South Cell tailings pond.
