2022-04-23 MBK 100L Diesel

GN reference #: 2022-141

Spill Description

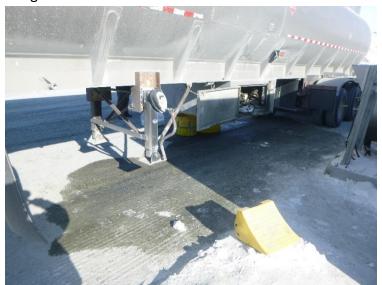
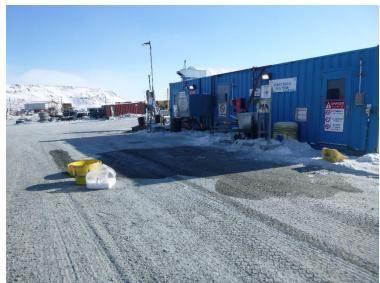
During operations at Meadowbank, an Arctic Fuel driver had finished unloading his tanker to the Meadowbank Tank farm. The driver initiated its departure while the docking station was still attached on the equipment, causing the tanker connector to rupture. The damage caused the remaining fuel of the reservoir to leak onto the ground.

The spill was caused by human error. After offloading the driver failed to disconnect the arm.

An investigation into the root causes of the spill has been completed. The procedure for offloading is being updated to ensure drivers perform a circle check before leaving tank farm. This procedure will then be communicated to all Arctic Fuel drivers. Furthermore, the incident will be reviewed with both crews on site.

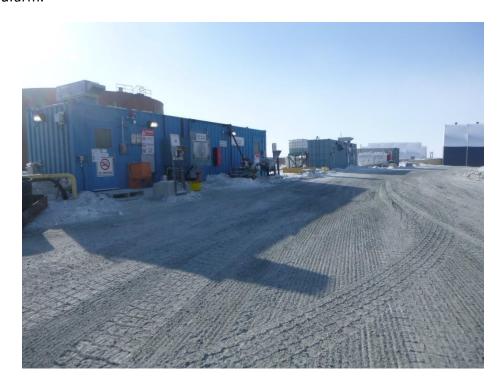
Spill pads were placed on the ground and an excavator was immediately brought at the tank farm to scrape the contaminated snow and material. Approximately 5m3 was collected into a roll off and was brought to the Meadowbank landfarm.
