2022-06-25 MBK 200L Diesel Exhaust Fluid

GN reference #: 2022-342

Please find the following information as a follow up to the Spill report submitted June 25, 2022 by Agnico Eagle Meadowbank division. This detailed report is submitted to the Inspector in compliance with the conditions under the Nunavut Water Board License 2AM-MEA1530, Part H, Item 8c.

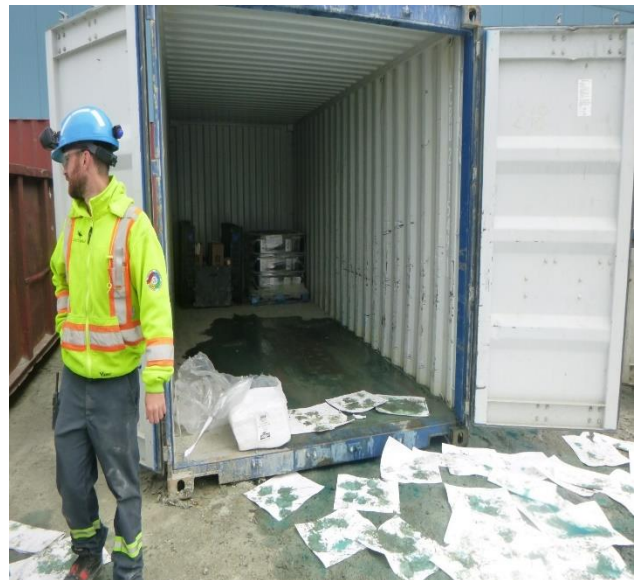
During operations at the Meadowbank site, an operator was placing a tote into a shipping container near the Maintenance shop and did not notice the metal support bracket around the tote was damaged. When the tote was placed into the shipping container, the damaged bracket punctured the tote next to it causing diesel exhaust fluid to spill onto the floor of the container as well as the ground.

A visual inspection of the tote was not completed prior to loading it into the seacan.

An investigation into the root causes of the spill has been completed. The procedure for offloading is being updated to ensure drivers perform a circle check before leaving tank farm. This procedure will then be communicated to all Arctic Fuel drivers. Furthermore, cameras will be procured and installed on the telehandlers, allowing for additional visibility for the operators.

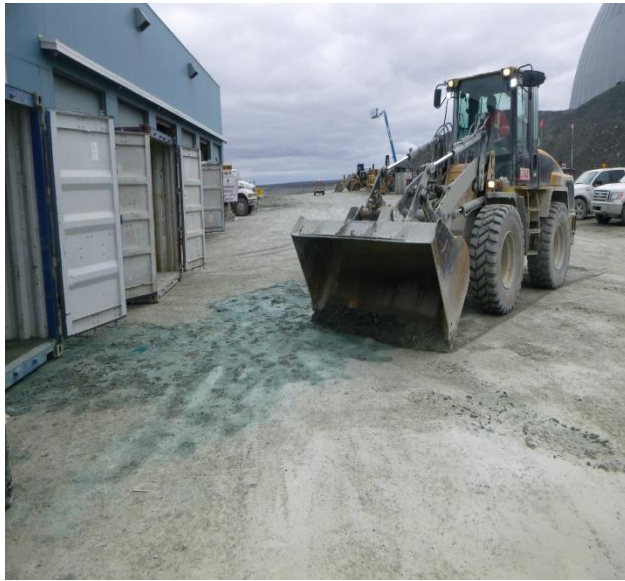
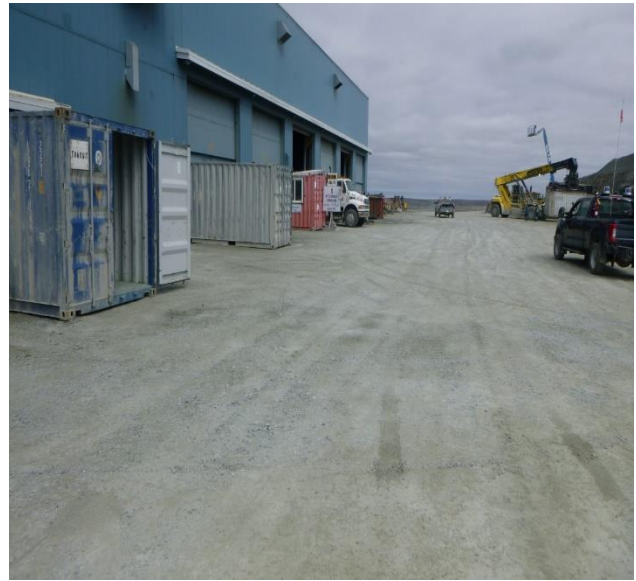
Spill pads were placed on the ground and a loader was immediately brought at the maintenance shop area to scrape the contaminated material. Approximately 1m³ was collected into a roll off and was brought to the Meadowbank landfarm.
