2023-02-04 MBK 250L Washer Fluid

GN reference #: 2023-036

Spill Description

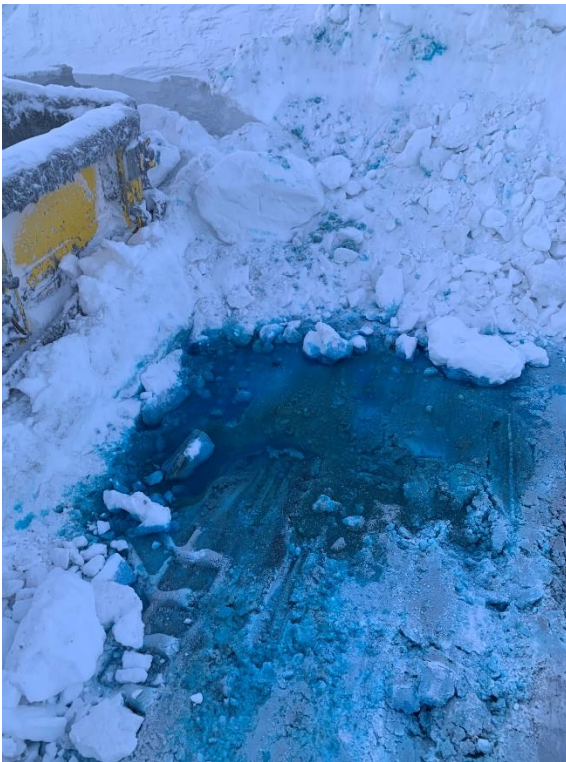
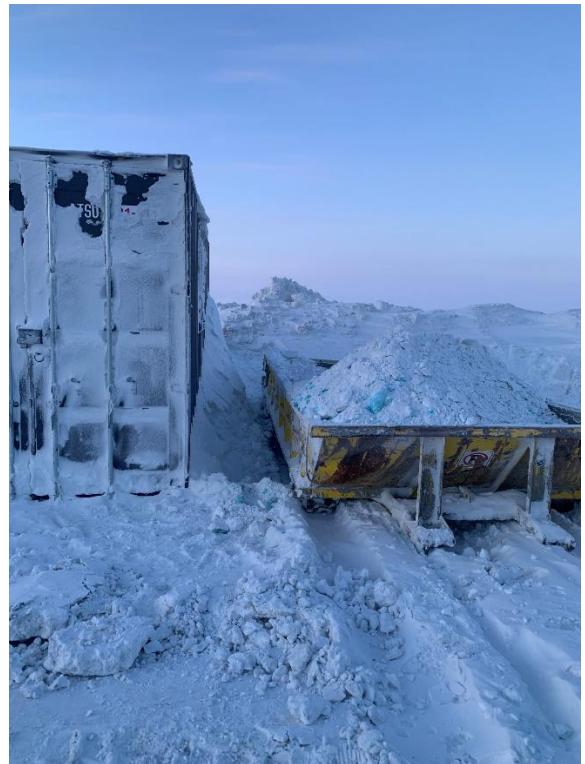
During operations at Meadowbank, a tote with a damaged valve was being transferred into a new tote. During the transfer, the worker observed a leak coming from the new tote. Upon investigation, the new tote had a small puncture near the bottom of the tote. The new tote containing approx. 250L of washer fluid was placed into a roll off bin. The operator left the damaged tote in the roll off bin and the tote emptied itself through the puncture and spilled onto the ground.

A visual inspection of the new reservoir was not completed prior to the transfer.

An investigation into the root causes of the spill has been completed. The procedure for the transfer of fluids from damaged reservoir is being updated to ensure the visual inspection phase of the new container is included and captured in the process. This procedure will then be communicated to the department's workers.

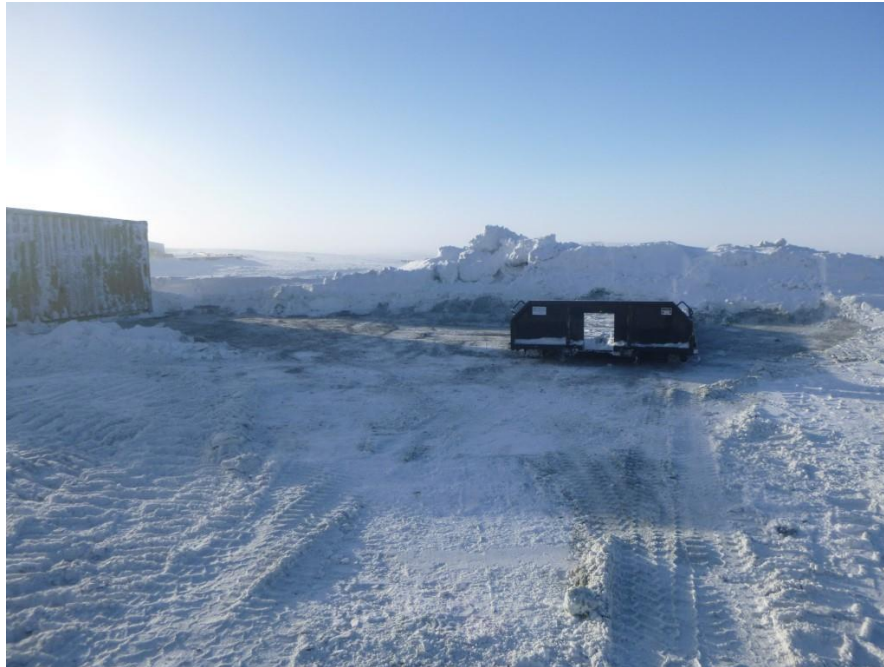
Upon discovery of the spill, a loader was mobilized to scraped clean the area. Approximately 4m³ of contaminated snow and material was collected and brought to the South cell tailings area.
