2023-02-06 MBK 9m3 Tailings

GN reference #: 2023-042

Please find the following information as a follow up to the Spill report submitted February 6, 2023, by Agnico Eagle Meadowbank division. This detailed report is submitted to the Inspector in compliance with the conditions under the Nunavut Water Board License 2AM-MEA1530, Part H, Item 8c.

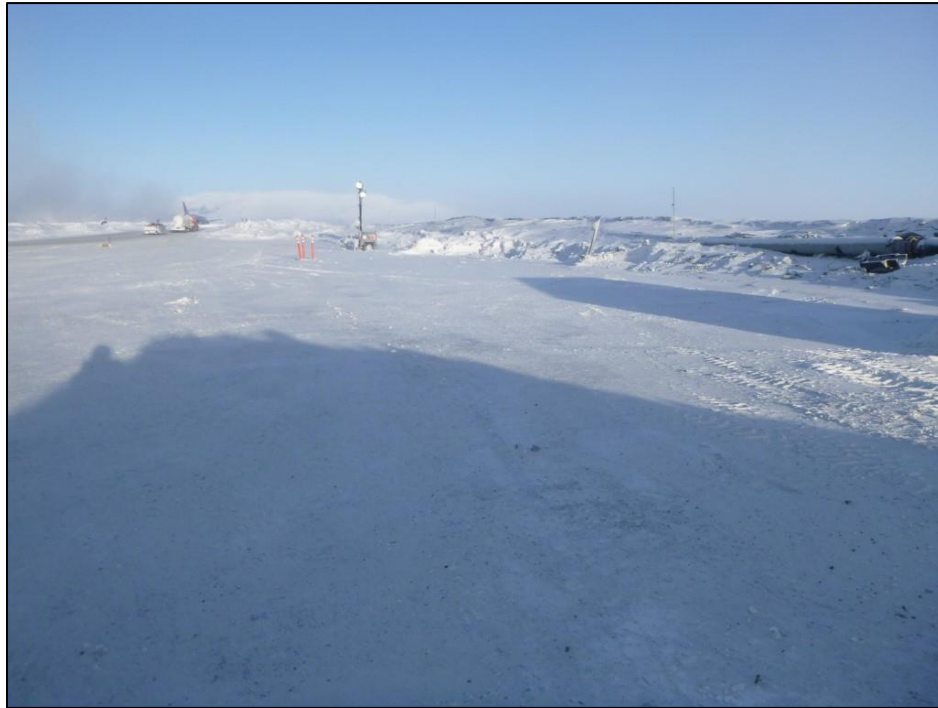
An excavator was mobilized to excavate the contaminated material. Approximately 92 m³ of contaminated material was brought to the South cell tailings area.

An investigation into the root causes of the spill has been completed. The procedure for descaling of tailings/contact water is being updated to include areas along the tailings line where un-flanging could occur inside the tailing's footprint. In addition, a flow monitoring system will be installed on each anti-scale distribution system as an additional control measure.
