2023-02-10 MBK 150L Diesel

GN reference #: 2023-046

Please find the following information as a follow up to the Spill report submitted February 10th, 2023, by Agnico Eagle Meadowbank division. This detailed report is submitted to the Inspector in compliance with the conditions under the Nunavut Water Board License 2AM-MEA1530, Part H, Item 8c.

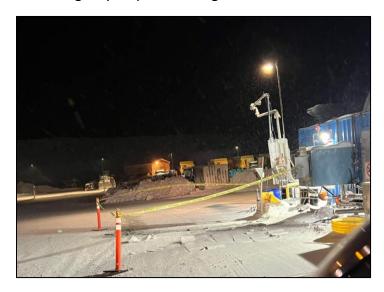
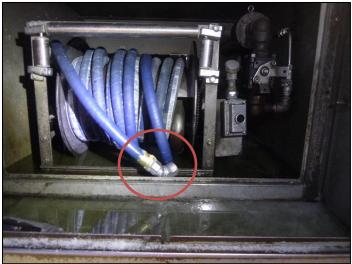
During operations at Meadowbank, the diesel fuel nozzle was dropped onto the ground breaking the swivel adapter. The damaged resulted in a spill of approximately 150L of diesel fuel from the fuel line onto the ground. The operator was unable to immediately stop the flow using the standard stop switch and had to use the emergency stop switch to gain control.

The standard stop switch was modified and the fuel line was repaired. In addition, the fueling procedure was reviewed by crews and an audit was performed on all fuel stations to ensure all stop buttons are compliant as per operational standards.

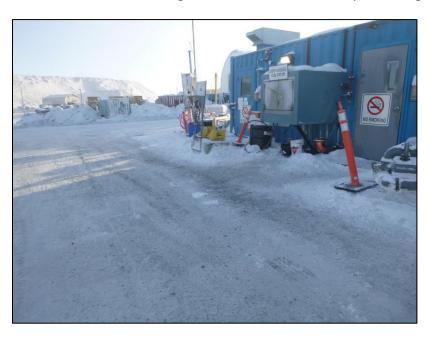
The operator utilized the emergency stop switch. Absorbent material was placed down, and a loader was called to clean the area. Approximately 4m3 of contaminated snow/soil material was brought to the Meadowbank Landfarm. Absorbent material was collected brought to the Hazmat area for processing.
