# 2023-03-22 MBK 300L Sewage Water

GN reference #: 2023-115

Please find the following information as a follow up to the Spill report submitted March 23<sup>rd</sup>, 2023, by Agnico Eagle Meadowbank division. This detailed report is submitted to the Inspector in compliance with the conditions under the Nunavut Water Board License 2AM-MEA1530, Part H, Item 8c.

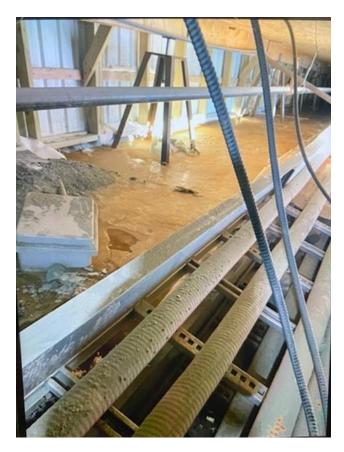
During process of investigating issues in the sewage drain line of the Meadowbank Camp, the sewage pipping under the arctic corridor was found to be cracked and frozen. As a result of the break, approximately 300L of sewage water was spilled under the building and onto the frozen ground.

Broken Joint on piping.

New conduit was installed as a replacement for the deteriorated piping, and a comprehensive visual inspection of all sewage infrastructure within the campgrounds is scheduled to take place during the upcoming summer season.

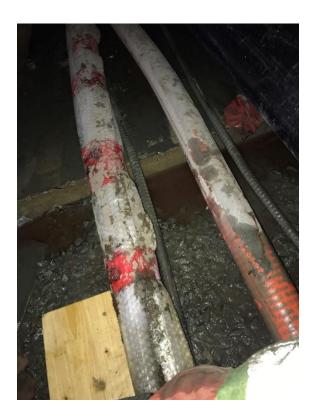
Heating equipment was utilized to thaw the frozen sewage in the contaminated area, enabling the vacuuming of the liquid using a sewage truck. About 0.3 cubic meters of contaminated material were transported to the Tailing Storage Facility. Additional remediation efforts will be undertaken during warmer temperatures when the ground has thawed to facilitate the recovery of the contaminated material, considering the spill's location, timing, and nature.
