# MEADOWBANK GOLD PROJECT

## Meadowbank Interim Closure and Reclamation Plan (ICRP) - Update 2018

Meadowbank, Agnico Eagle Mines Limited

Report > Final Report > Rev. 00  
Internal ref. 654769-5000-4EER-0001\_00

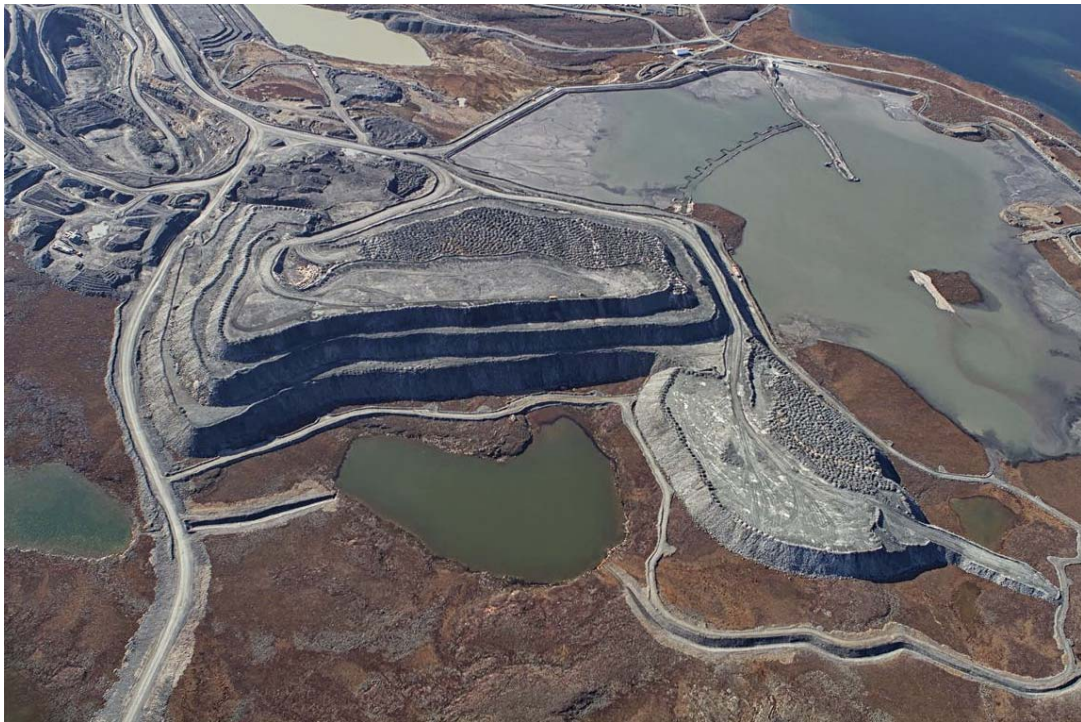
Photo 2 : Meadowbank Portage RSF, summer 2014

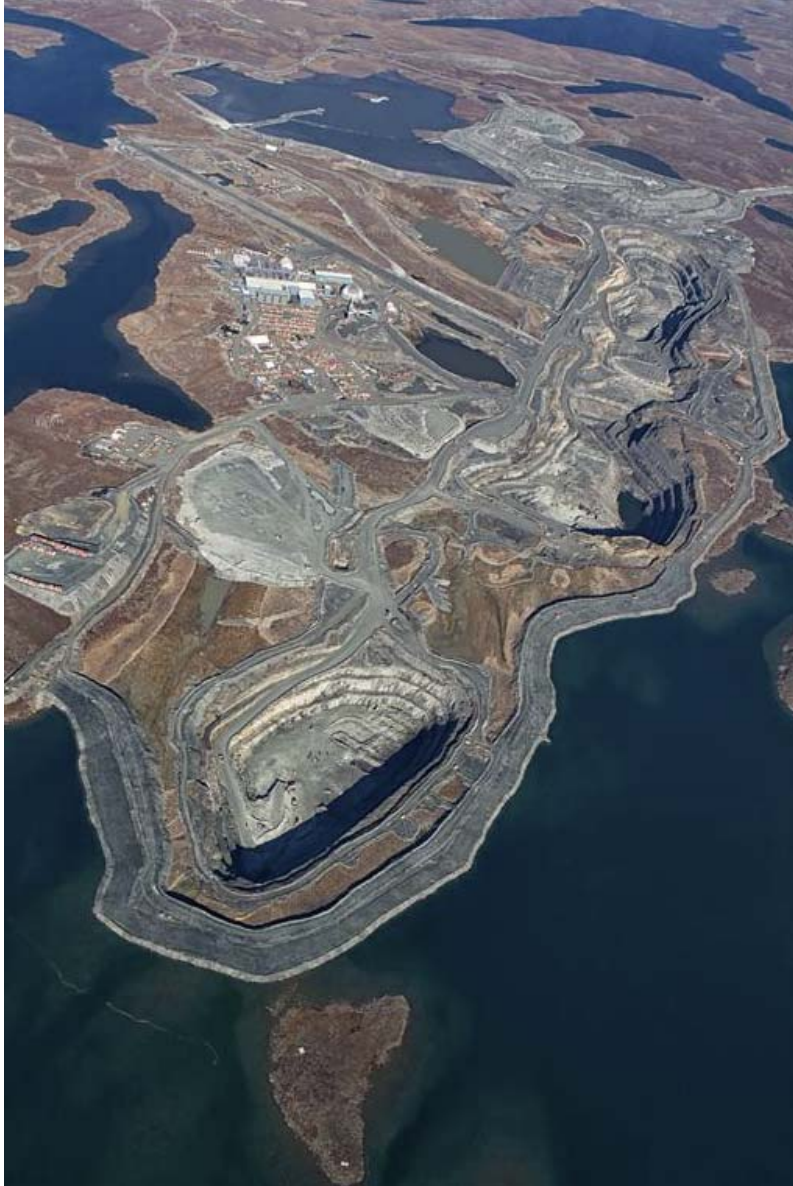
Photo 3 : Meadowbank Portage and Goose Pits, summer 2014

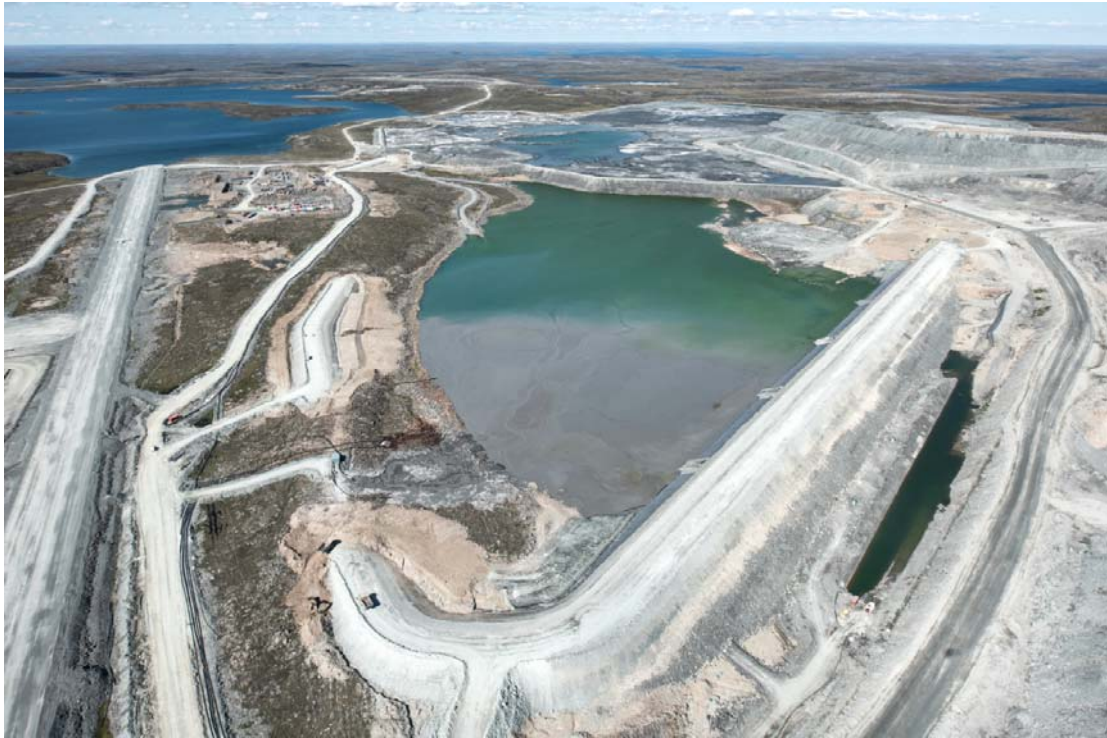
Photo 4 : Meadowbank TSF area, summer 2016

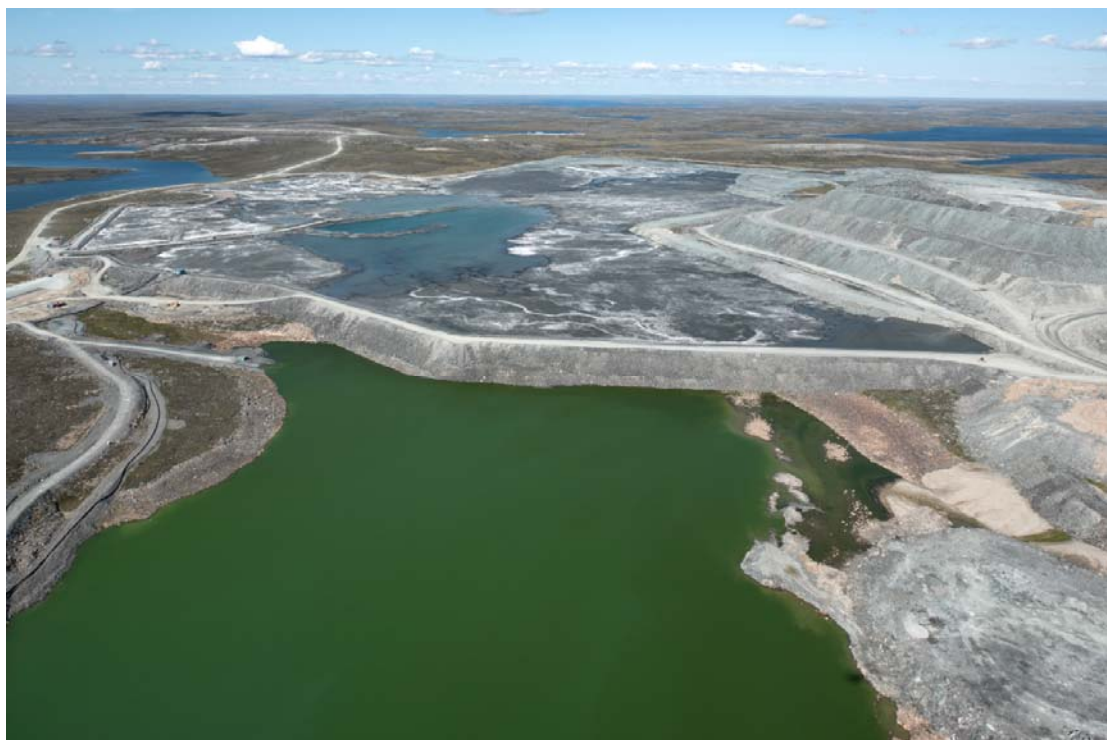
Photo 5 : Meadowbank TSF area, North and South Cell, summer 2016

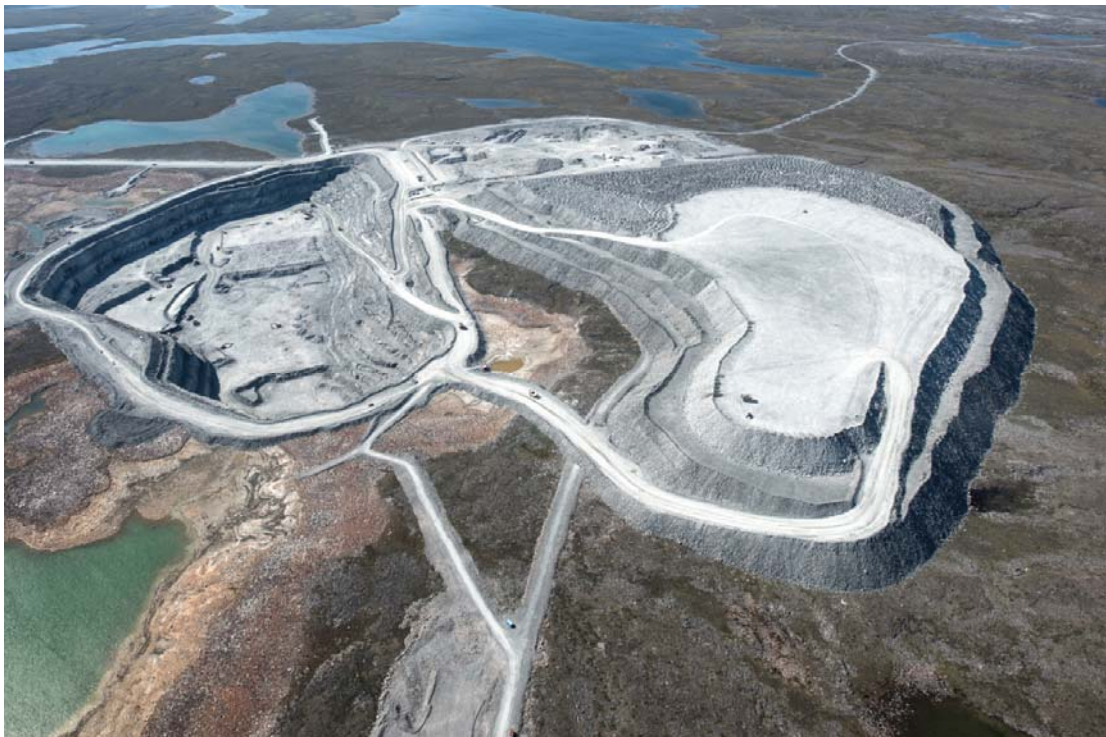
Photo 7: Vault Pit and RSF, summer 2016

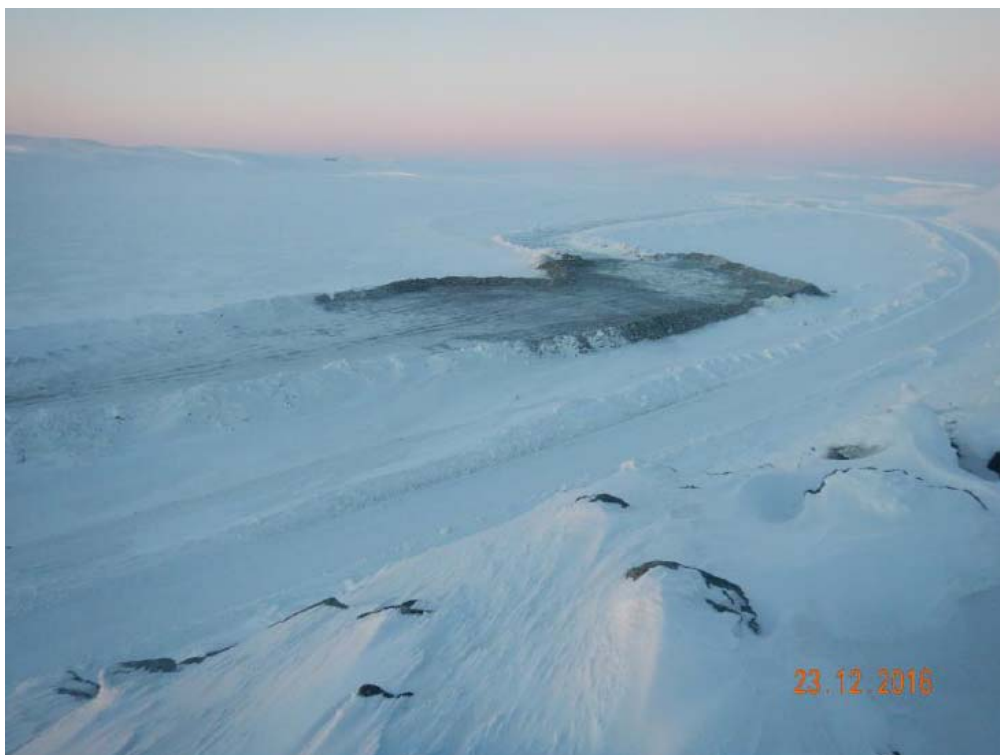
Photo 8: TSF North Cell, NPAG Cover construction, winter 2016

Preliminary design work was completed for the TSF cover in 2015 and 2016. The tailings cover will consist of non-acid generating granular material (NPAG) and ensures that the active layer remains within the NPAG layer. The objective for the cover system is to keep the tailings under 0°C in most conditions and to maintain saturation above 85%. Progressive reclamation of the North Cell has started in 2015 and continued to 2017 with the NPAG cover placement. The progressive cover is expected to continue in 2018 and 2019. The TSF North Cell is instrumented for thermal monitoring with thermistors installed in the tailings or the NPAG cover.

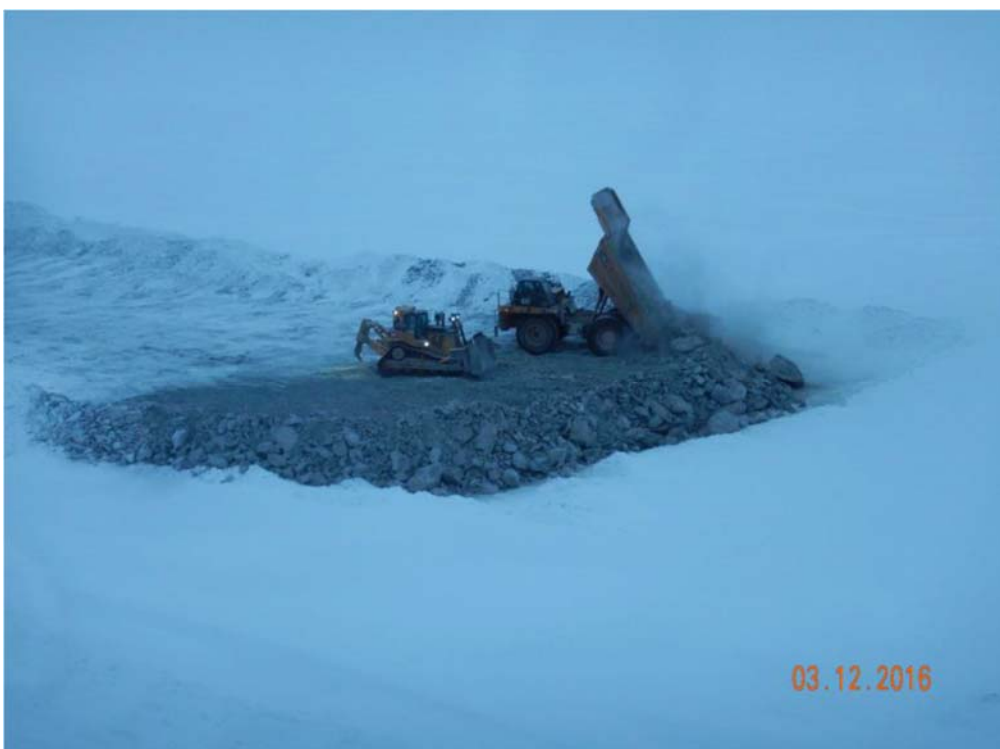
Photo 9: TSF North Cell, NPAG Cover construction, winter 2016
