Appendix F-2

Mock scenario report

On August 4, 2018 the AEM Environment Department conducted a mock spill event at the Itivia refueling station/tank farm with AEM emergency response (ERT) members, Orbit Garant Environmental/health and safety AEM warehouse staff, AEM Site Service/HTO vice president and AEM community relations personnel., Spill Training contractor, Nunatta Environmental was on site to assist and provide advice/training, The Rankin Inlet Fire Chief also attended the event as an observer.

The mock scenario involved a broken fuel line fitting at the onshore receiving manifold during refueling (from offshore ship) of the fuel storage tanks at Itivia.

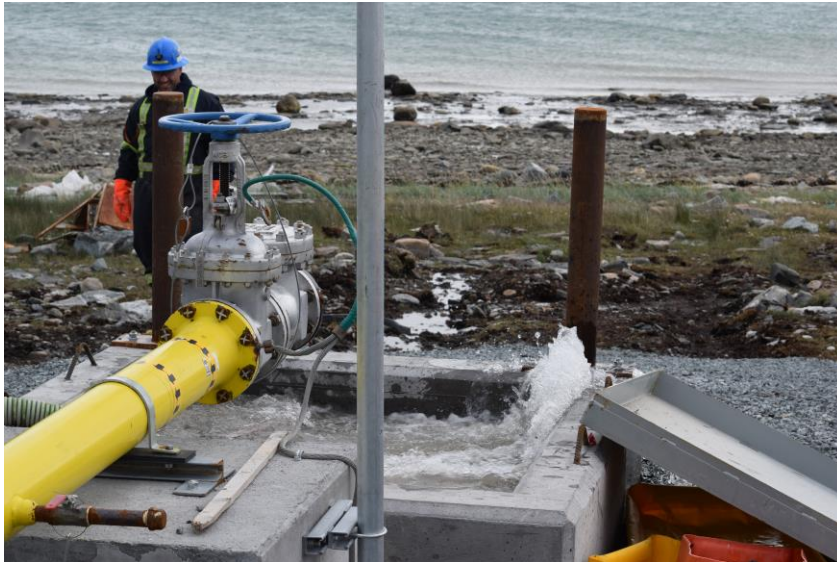
14:12 – Spill occurs (4000 L of leaking fuel towards the shoreline) Dave Loder spotted fuel leaking from the broken fitting/line

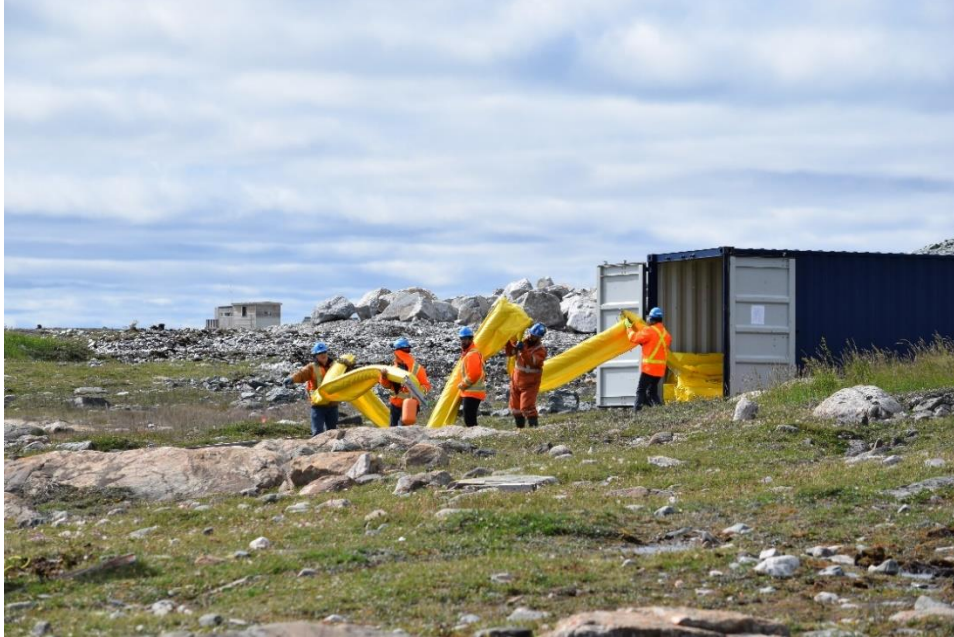
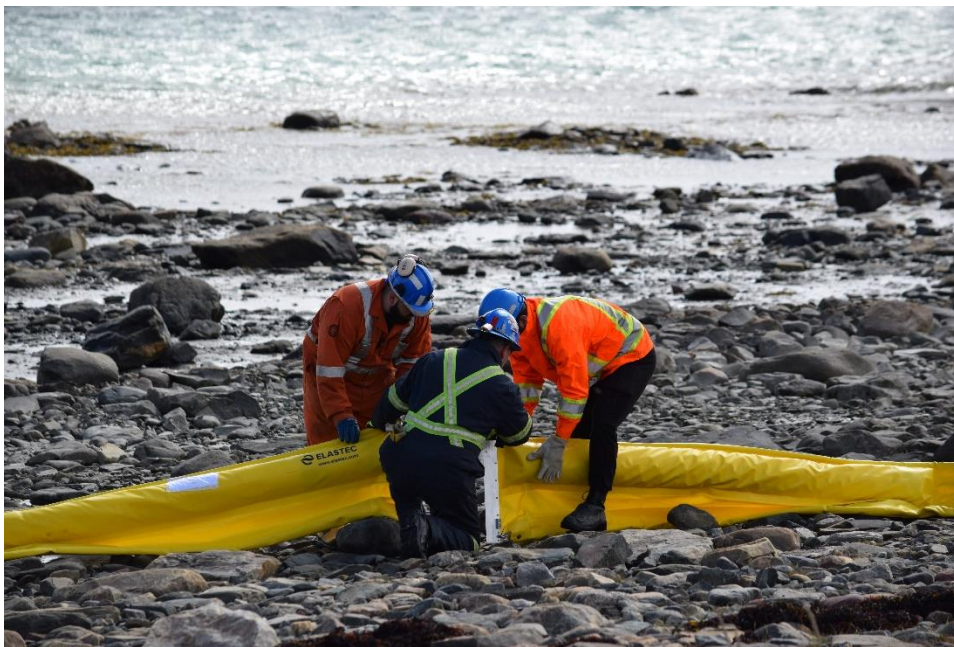
15:50 – full ERT team arrived for assistance- First ERT responder (Commander) instructed immediate deployment of marine curtain (water was too rough 80 km/hr winds- did not want to put anyone's safety at risk; deployed on shore)

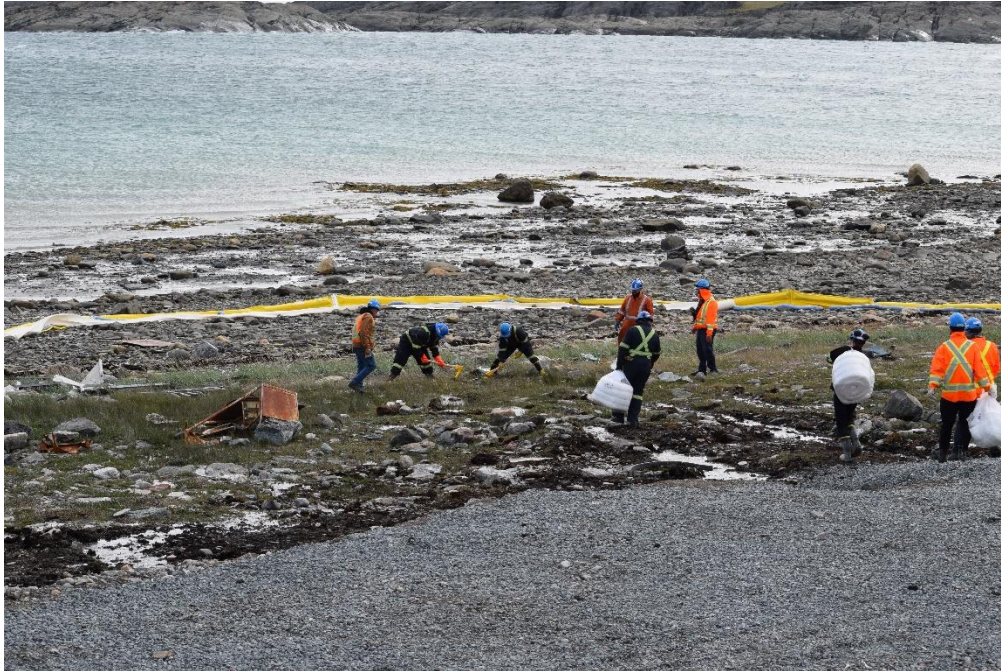
16:00 – More absorbent booms are placed in front of the marine barrier to collect spill and prevent it from going under marine barrier- no operators present for heavy equipment; ERT and environment staff attempted to make a trench – did not succeed due to bed rock

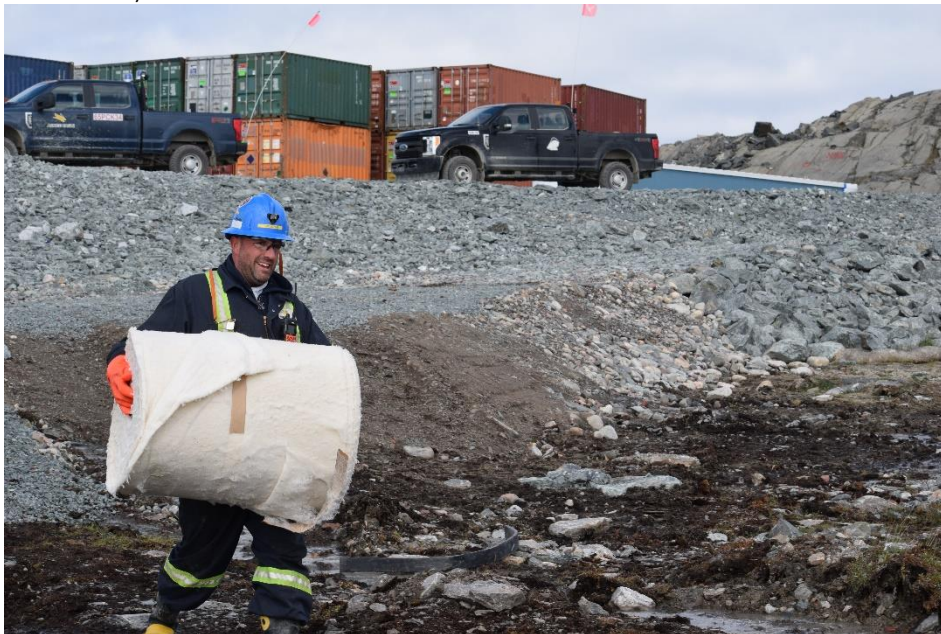
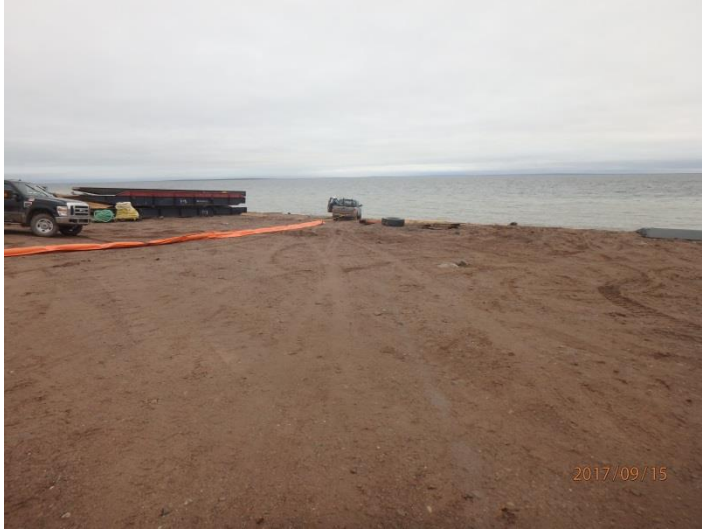
16:04 – Absorbent padding was placed on top of spill where visible product was observed behind marine barrier (wind blowing toward shore)
