Follow Up Report: #19-398

September 25th, 2019 – TDS Exceedance at Final Discharge Point MEL-14

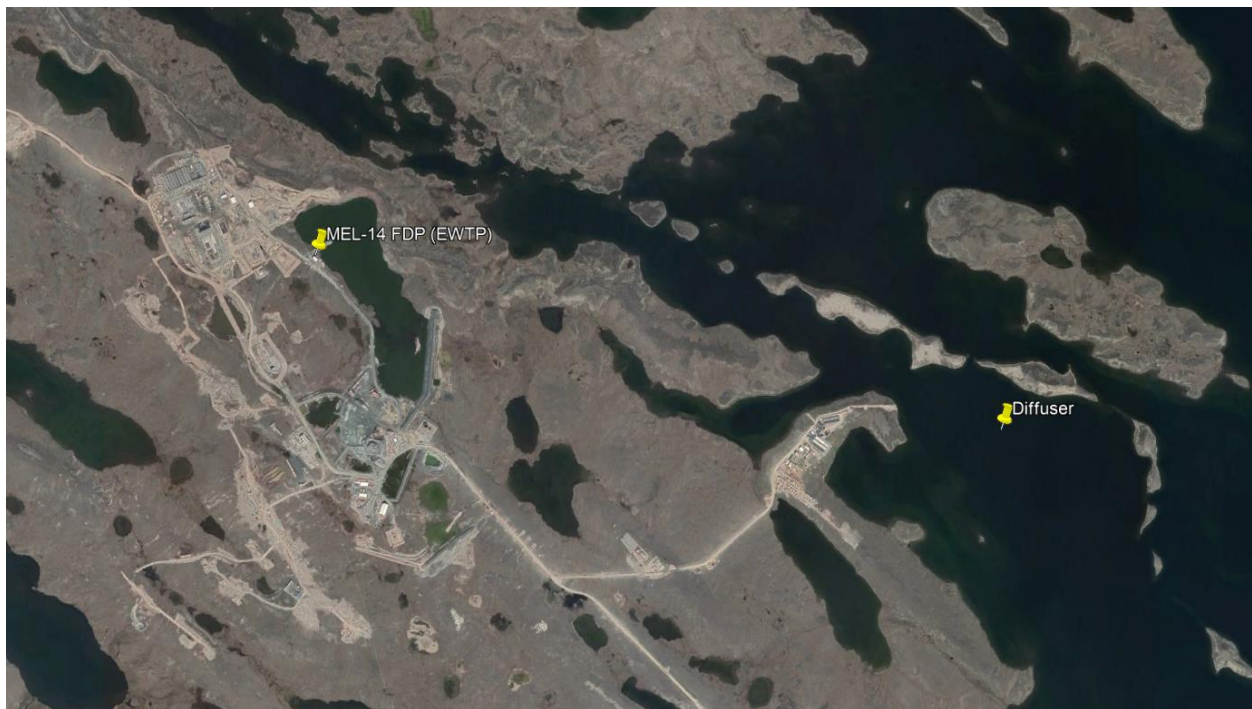
Figure 1: Location of effluent water treatment plant and diffuser in Meliadine Lake.
