Follow Up Report: #2022045

February 18, 2022 – 80 L Untreated Sewage

Description of Incident

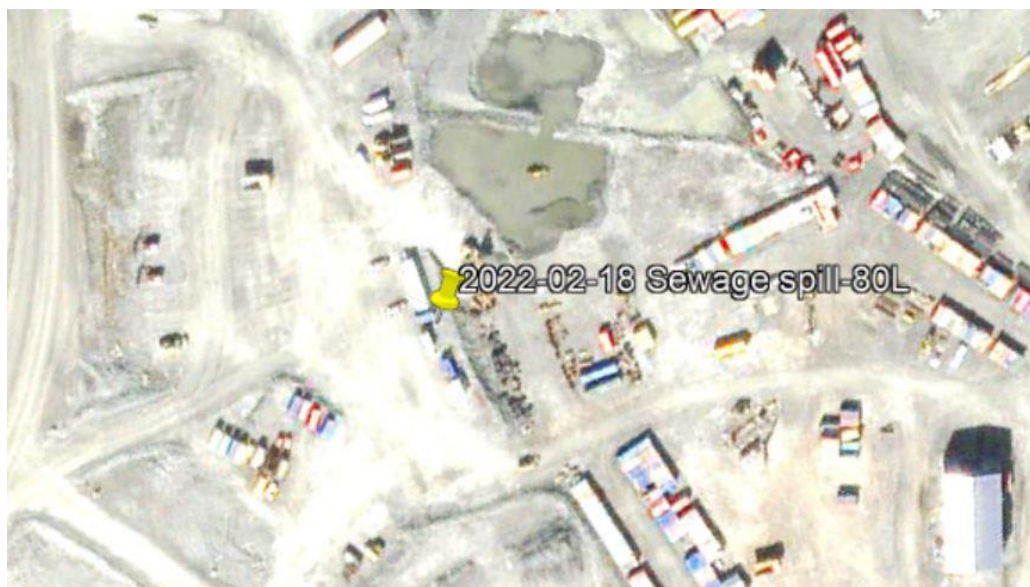
The coordinates of this spill are 63° 1' 42"N, 92° 12' 47"W. No water bodies were impacted by this spill. The nearest water body (B7) is 880 m west.

Figure 1: Location of the spill at KCG lift station

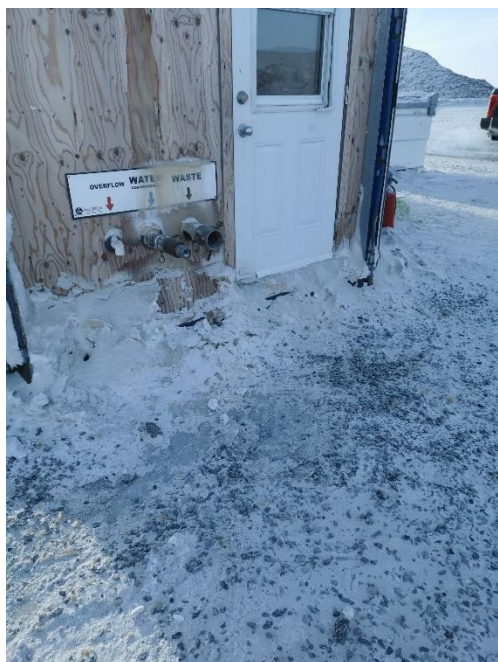
The lift station was shut down to stop the spill. The topography of the area and the freezing conditions prevented the sewage from migrating off site, facilitating spill recovery. Mobile equipment was used to recover the spilled material which was placed in the Waste Rock Storage Facility 3, as per the Mine Waste Management Plan.

Figure 2: Spill cleanup area (contaminated ice removed and material put down to prevent slipping)

After an investigation, it was discovered that the Fernco fitting on the downstream side of the lift station pump was not the correct fitting for a pressurized service. This resulted in the fitting pulling away from the piping and causing the spill. The fitting has since been replaced with a more appropriate fitting for the service and an inspection of each lift station (wings 1-14) will be conducted to ensure all other fittings are replaced with the appropriate fittings for pressurized service.
