Follow Up Report: #2022045

February 18, 2022 – 80 L Untreated Sewage

The following information refers to an incident # 2022045 reported by Agnico Eagle Mines Ltd. February 19, 2022, and is being provided in accordance with:

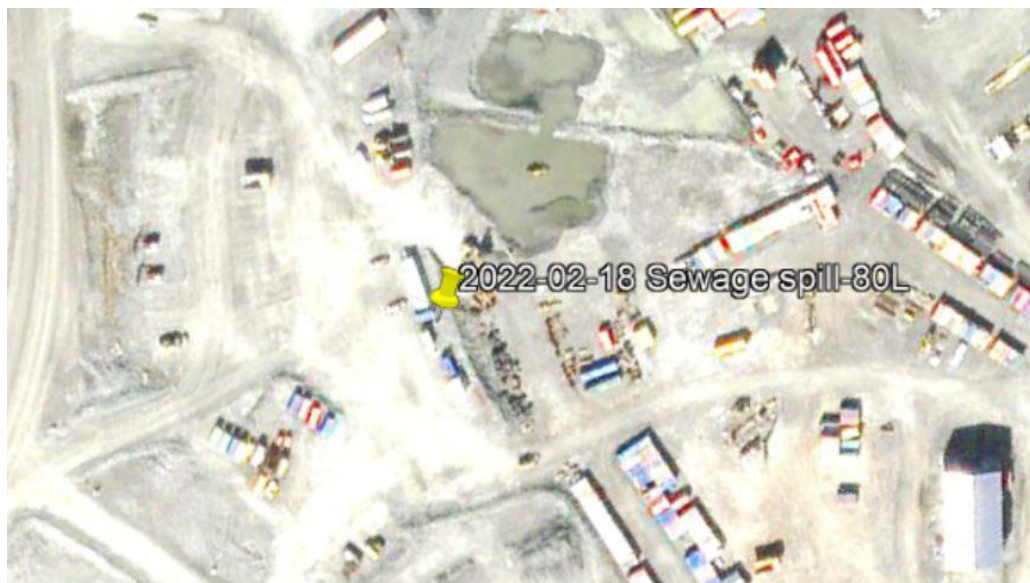
The coordinates of this spill are 63° 1' 42.70"N, 92° 12' 47.81"W. No water bodies were impacted by this spill. The nearest water body (B7) is 880 m west.

Figure 1: Location of the spill at KCG lift station
