Follow Up Report: #2022055

February 26, 2022 – 1500 L Sewage

The following information refers to an incident # 2022055 reported by Agnico Eagle Mines Limited February 26, 2022, and is being provided in accordance with:

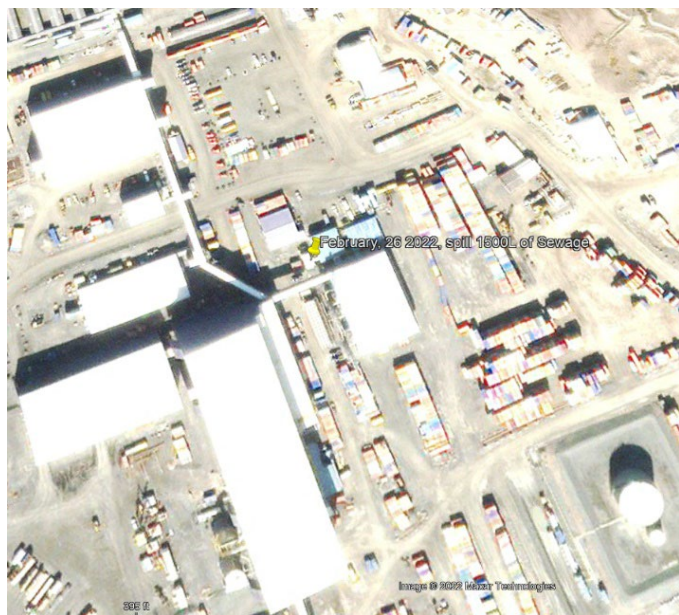
Figure 1: Location of the spill by the power plant lift station

At approximately 9:00 on February 26, 2022, the Environment department was notified of a spill of approximately 1500 L of sewage. The power plant lift station overflowed resulting in a spill of 1500 L of sewage on the industrial pad.

The coordinates of this spill are 63° 2' 17"N, 92° 13' 32"W. No water bodies were impacted by this spill. The closest water body (G2) is 500 m North.

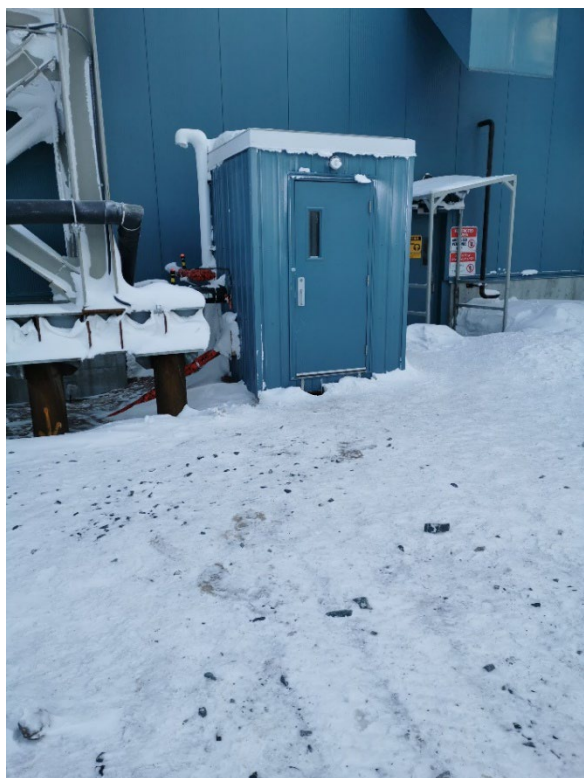
The lift station was shut down to stop the spill. The topography of the area and the freezing conditions prevented the sewage from migrating off site. Easily accessible unfrozen material was cleaned by a vacuum truck. The location of the spill (in an area with several electrical cables) limited the quantity of spilled material that could be recovered immediately and Agnico Eagle is evaluating different options to safely remove the contaminated material.

Figure 2: Power plant lift station spill clean up

A malfunction on the pump discharge line caused wastewater from the process plant to backfill into the power plant lift station, causing an overflow.

Following this event, a plumber was sent to inspect and repair the line. The check valve on the pump discharge line was replaced and the high-level float preventing the pump from continuously running was also serviced. Furthermore, daily lift station checks are being conducted by the Energy and Infrastructure Department.
