Follow Up Report: #2022140

April 22nd, 2022 – Thickener Process Water Spill

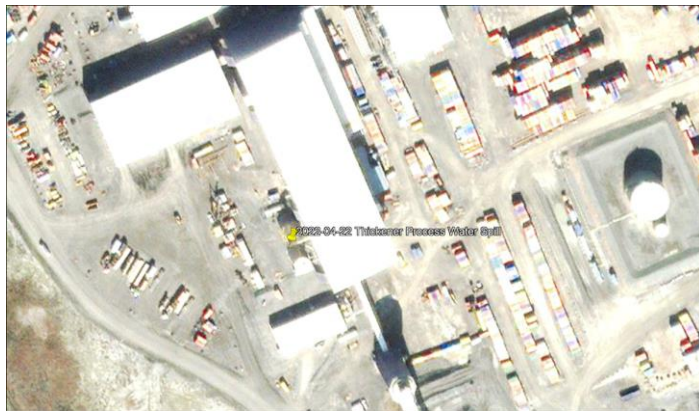
On April 22nd, 2022, a shutdown of the clarifier in the process plant caused process liquids to backup, resulting in an overflow of thickener. 10 cubic meters of thickener process water flowed onto the ground outside of the process plant.

The coordinates of this spill are 63 2'11.5"N, 92 13'35.3"W. No water bodies were impacted by this spill; the closest water body (G2) is approximately 600 m northwest.

Figure 1: Location of the April 22nd, 2022, thickener process water spill.
