Follow Up Report: #2022143 April 24th, 2022 – 200 L Sewage

The following information refers to incident #2022143 reported by Agnico Eagle Mines Limited April 24th, 2022, and is being provided in accordance with:

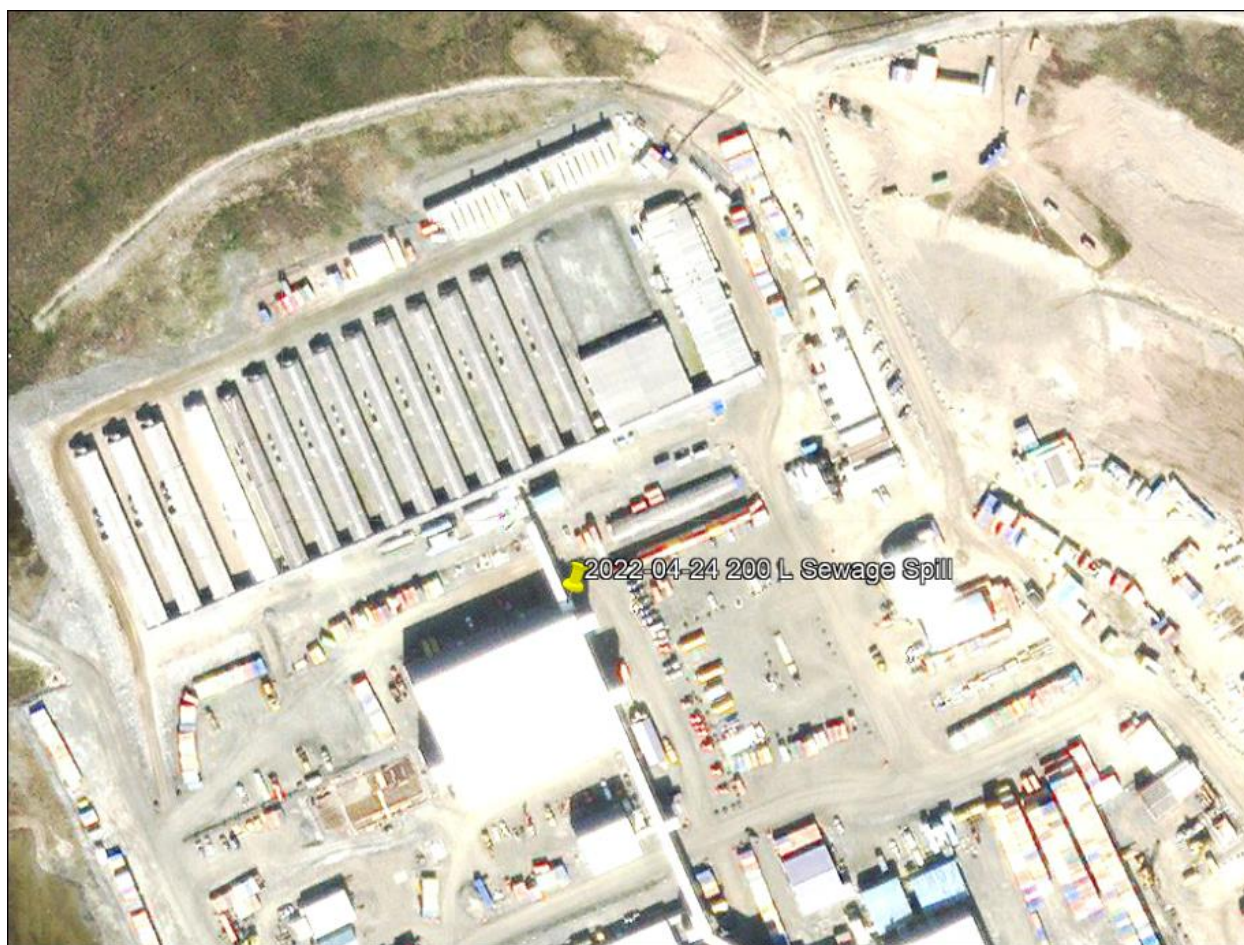
Figure 1: Location of the MSB lift station spill

At approximately 03:30 on April 24th, 2022, 200 L of sewage was spilled at the Multi Service Building (MSB) lift station when the lift station pump failed.

The coordinates of this spill are 63° 2' 21"N, 92° 13' 40"W. No water bodies were impacted by this spill. The closest waterbody (G2) is approximately 325 m north.

The spill was contained to a low area behind the MSB lift station. The freezing conditions prevented the sewage from migrating off site. Infrastructure (structural steel, pipes and electrical) in the area made cleanup activities during winter month hazardous. As the material melts the vacuum truck will collect the melted material. The contaminated matrilateral collected with the vacuum truck will be returned to the MSB lift station.
