Re.: Follow-up Report Spill #2022469 – Fine grain material investigation Meliadine Gold Project - UPDATE

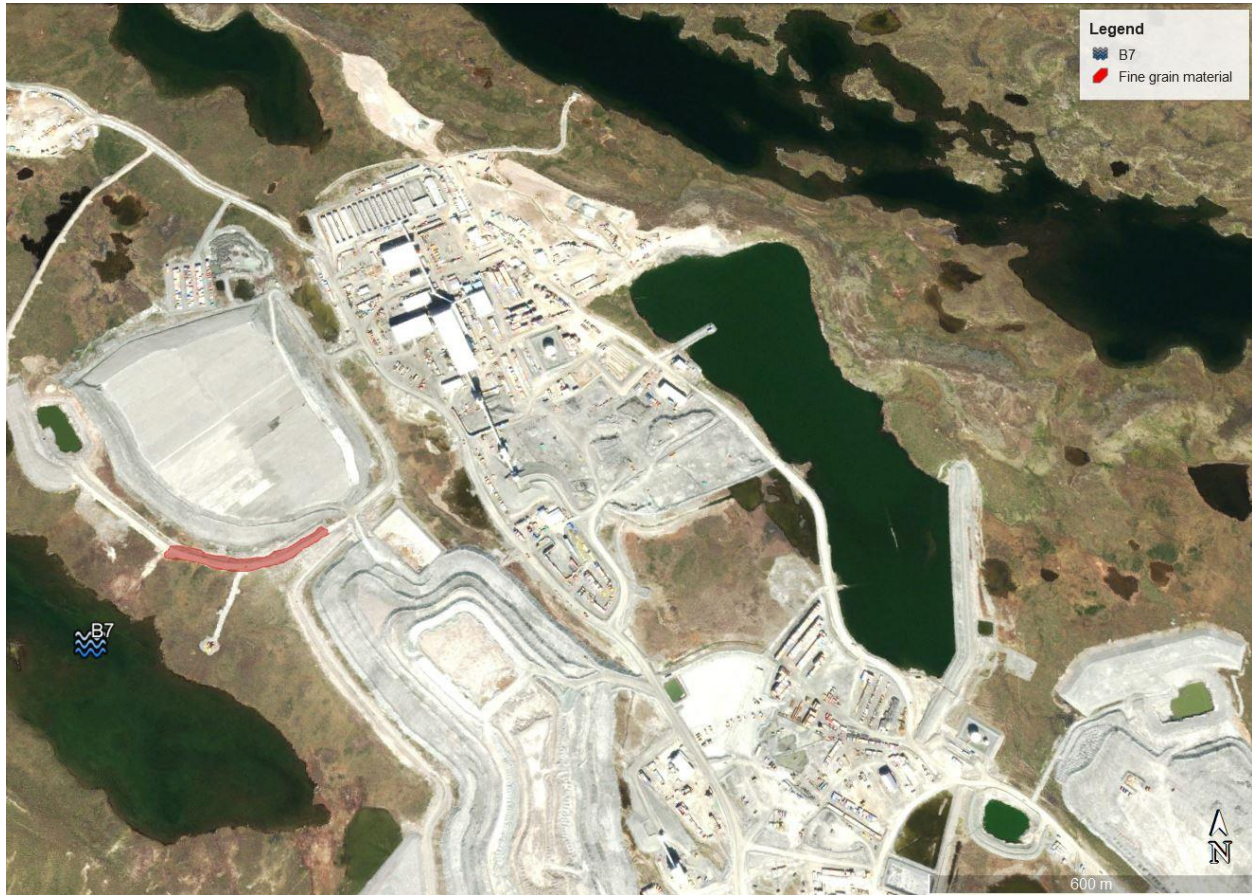
A deposit of fine grain material was identified around the perimeter access road southwest of the TSF and Agnico Eagle initiated an investigation into the source of the fine grain material. No water bodies are impacted by this event. The closest water body (B7) is approximately 130 meters south, as seen in Figure 1.

Figure 1: Location of the fine grain material and proximity to water bodies.

Qualitative observations of the material are indicative of potential drill cuttings, potential TSF material brought by snow removal operations and/or from the wind and after further assessment and discussion, it also became apparent that the material could likely be partially composed of road material pulverized by haul truck traffic and relocated during maintenance and snow clearing activities.

To assess its source, the fine grain material adjacent to the access road has been profiled and sampled. Geochemical and granulometry analysis are ongoing.
