Baffinland Iron Mines Corporation
Mary River Expansion Project
Rail Bridge Design - Hydraulic Report

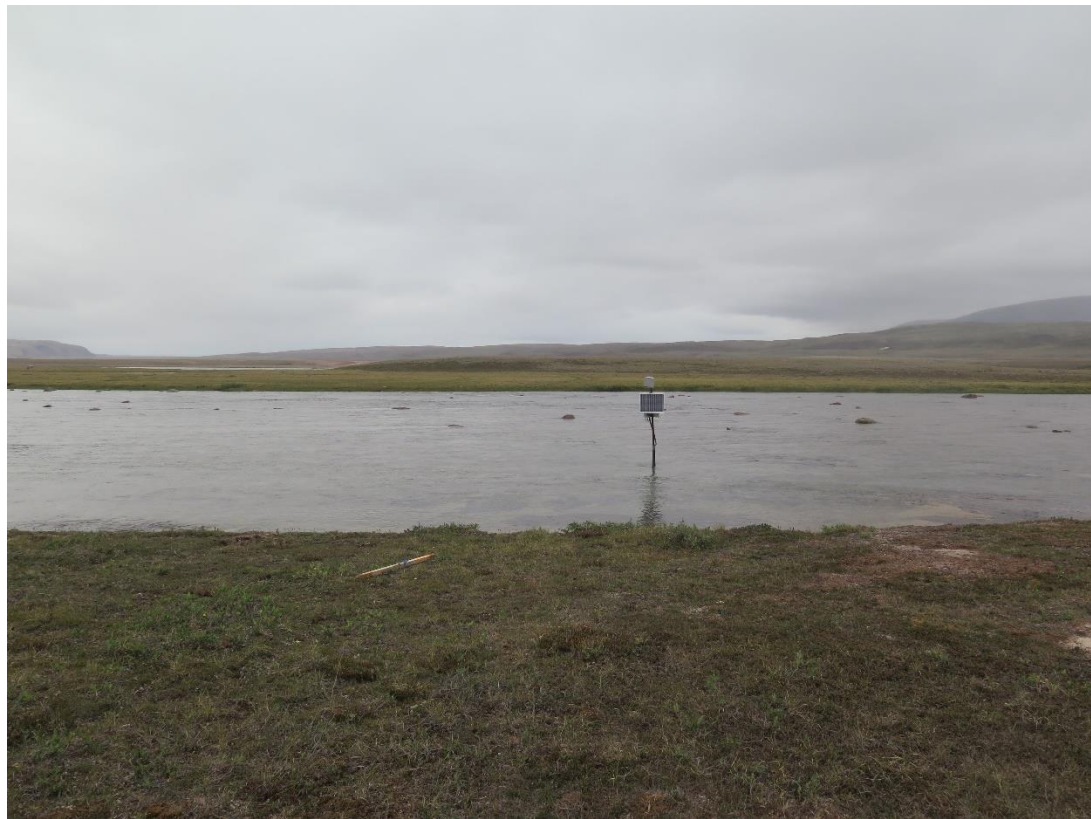
Figure 2-3: Site Photo of Proposed Bridge 1 Crossing Area

The stream width between the steeper banks near the proposed crossing are approximately 100 m before flattening out over the floodplain, and the bank depth is between 1.0 m to 1.5 m. The Geotechnical Investigation Factual Data Report [Ref. 1] reports that investigations for the Bridge 1 abutments encountered primarily sand and silt. Boulders or cobbles were intersected in all investigations. Boulders and cobbles are also observed at the riverbed surface in the site photos. The site photos also show that the floodplain is vegetated (grass) and therefore experience reduced sediment erosion or deposition during flood events. Details regarding the hydraulics of Bridge 1 are described later in Section 8.

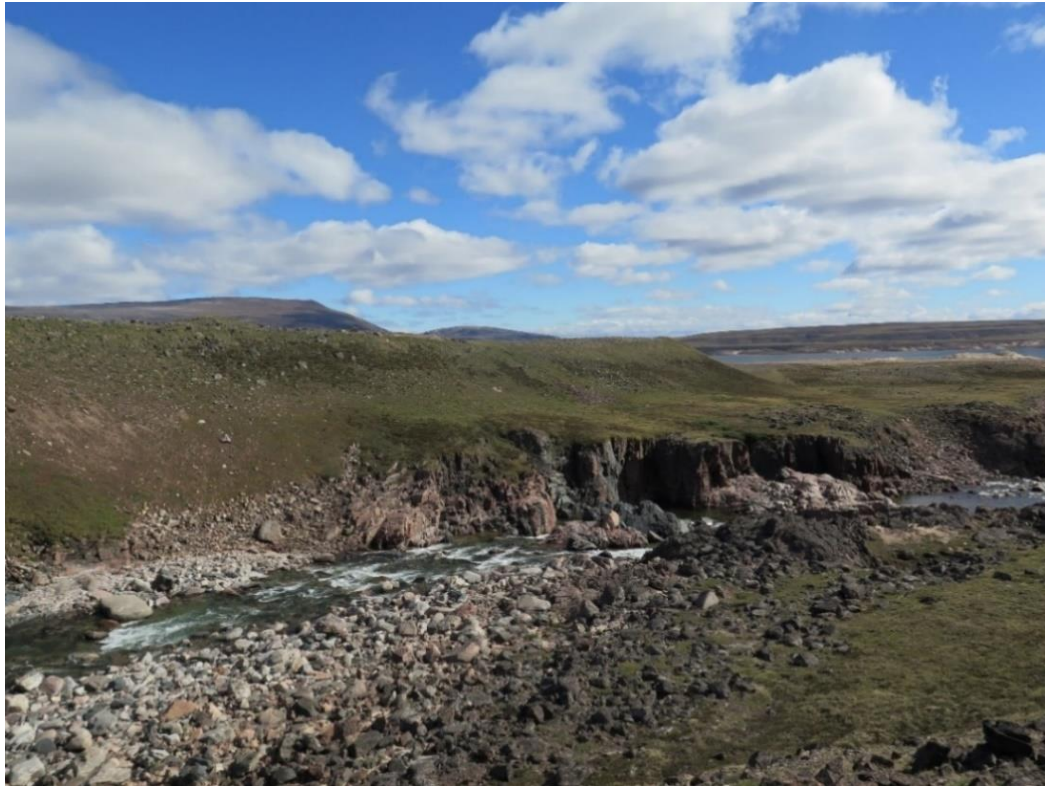
Figure 2-11: Site Photo of Proposed Bridge 4 Crossing Area

The stream width between the steeper banks near the proposed crossing are approximately 65 m before flattening out on a higher shelf. As shown in Figure 2-11, the stream near the crossing consists of a steep and shallow rapid water section. The Geotechnical Investigation Factual Data Report [Ref. 1] reports that gravel, and gravel/sand are generally encountered at both abutment locations, and that the bedrock was outcropped at the surface of both edges of the river, but dips below the surface moving away from the abutments. As shown in the site photos, the riverbed consists of coarser rock such as cobbles and boulders. Details regarding the hydraulics and potential erosion of Bridge 4 are described later in Section 8.

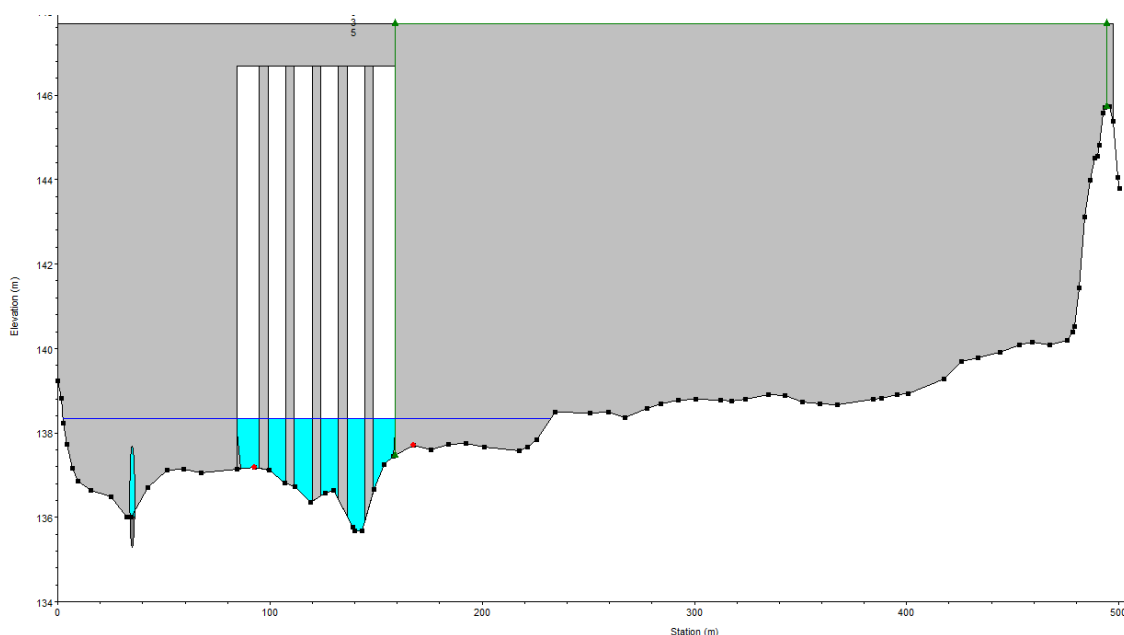
Figure 8-2: Bridge 2 Representation in HEC-RAS (200-year Flood Event)

As shown in Table 8-2, the channel velocities increase significantly with the bridge compared to the baseline condition. This is due to the proposed bridge blocking a significant portion of the wide floodplain, particularly the left side of the cross-section, resulting in higher velocities due to the constriction (compared to the baseline condition).

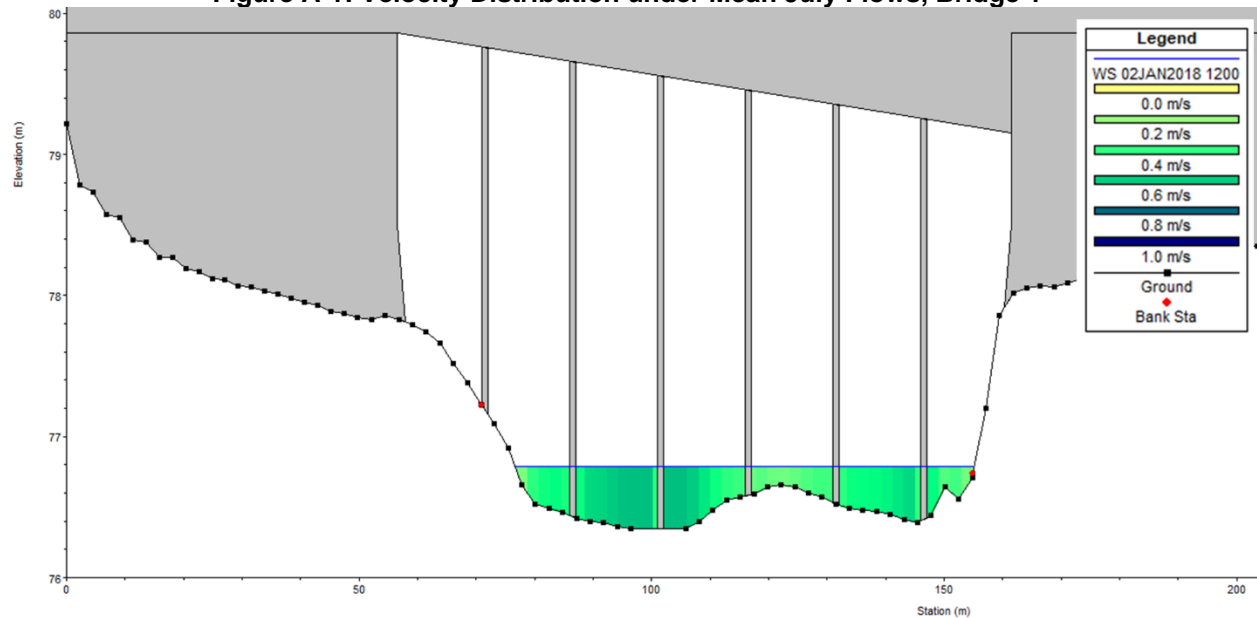
Figure A-2: Velocity Distribution under Mean August Flows, Bridge 1

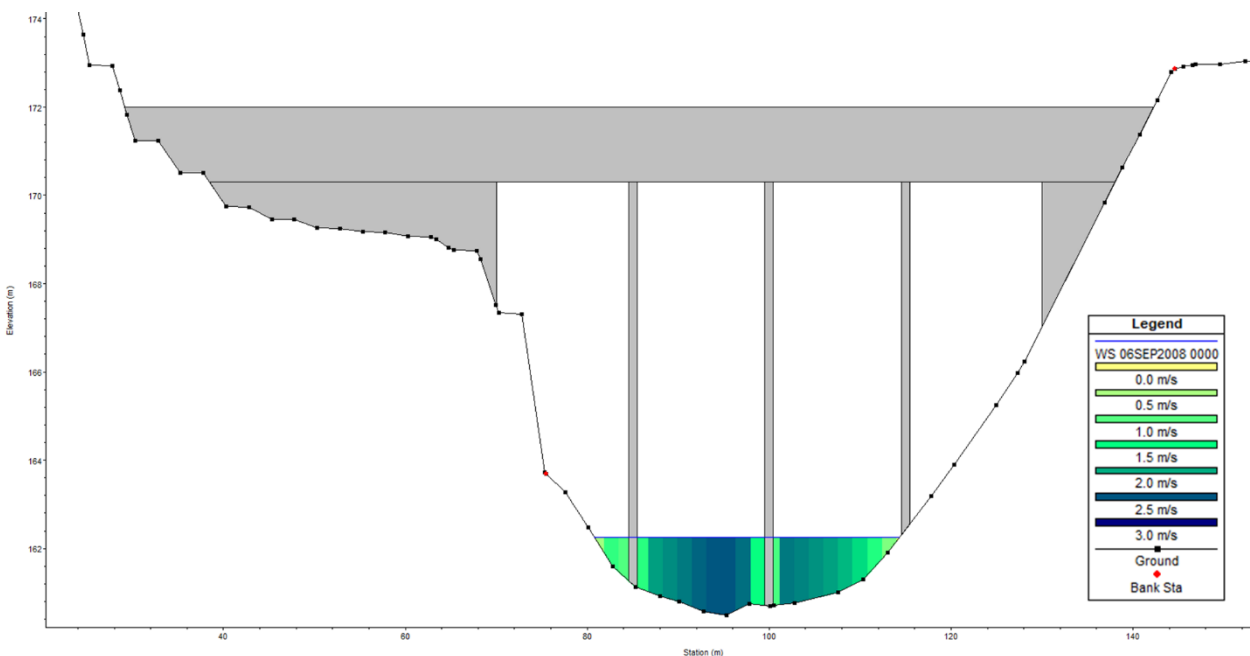
Figure A-7: Velocity Distribution under Mean July Flows, Bridge 4

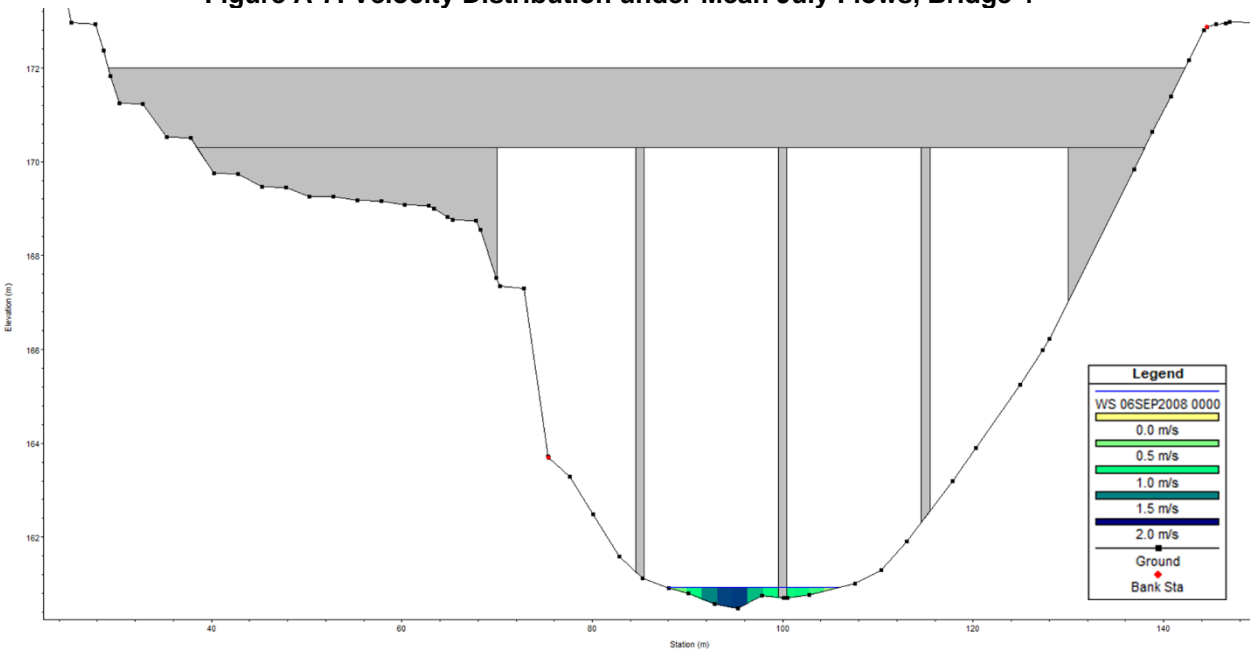
Figure A-8: Velocity Distribution under Mean August Flows, Bridge 4
