Attachment 1 - Baffinland Response to NIRB Recommendations - Dec 8, 2018 Responses

Table 1: Baffinland Responses to 2017-18 NIRB Monitoring Report Request for Information to Recommendations due in 30days

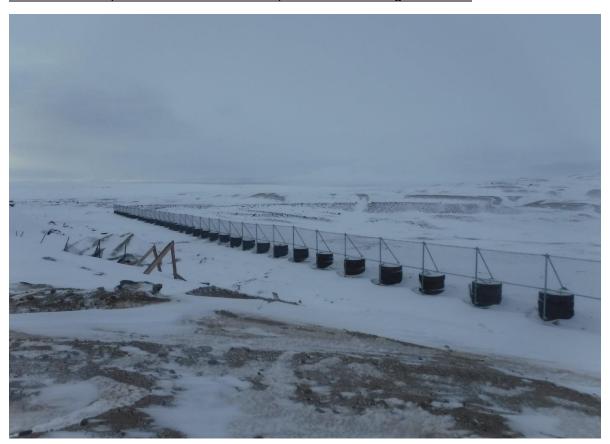
Photo 1: Landfill perimeter fence installed September 2018 facing south-west

| NO. | NIRB Comment | NIRB Recommendation | Baffinland Response |
|---|--|---|---|
| | upgraded litter fence around the active areas | Impact Review Board moving forward. | September 18, 2018. The installed fence is 215 |
| | of the landfill in the light of changing environmental conditions at site. | | meters in length, eight feet tall and made up of two-inch galvanized chain link heavy gauge |
| | environmental conditions at site. | | meshing with a tire base (see Photo 1 and 2). |

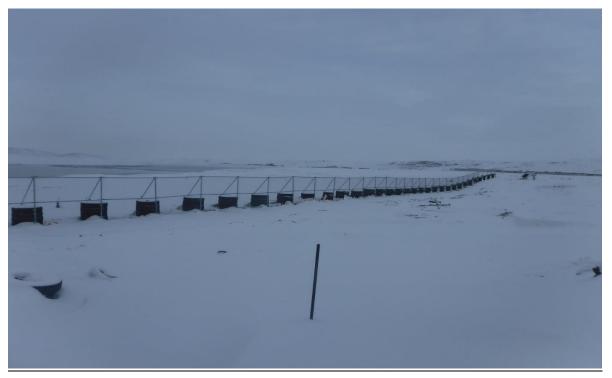
Photo 2: Landfill perimeter fence installed September 2018 facing north-east
