RAIL CV-16-2

LOCATION AND CROSSING DESCRIPTION

Site ID: CV-16-2 24-Jun-19 **Dates Surveyed:** Waterbody Type: Pond **Centreline UTM Coordinates:** 17W 514751 E 7965084 N **Project Interaction:** Pond Infilling Culvert Length (m): N/A **Number of Barrels:** N/A Culvert Diameter/Span (mm): Slope (%): N/A N/A

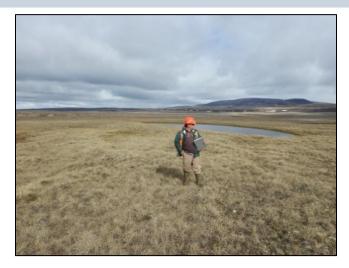
A

Photos 1. Photos of crossing: (A) looking north along the rail centerline to the shallow isolated pond infill site; (B) looking east across the centerline with the larger pond in the background; (C) looking southeast along the centerline; and (D) looking west across the centerline.
