# **Appendix D: Borrow Source Management Plan – Km 97 (BAF-PH1-830-P16-0032)**

## Borrow Source Management Plan – Kilometre 97 BAF-PH1-830-P16-0032 Rev 0

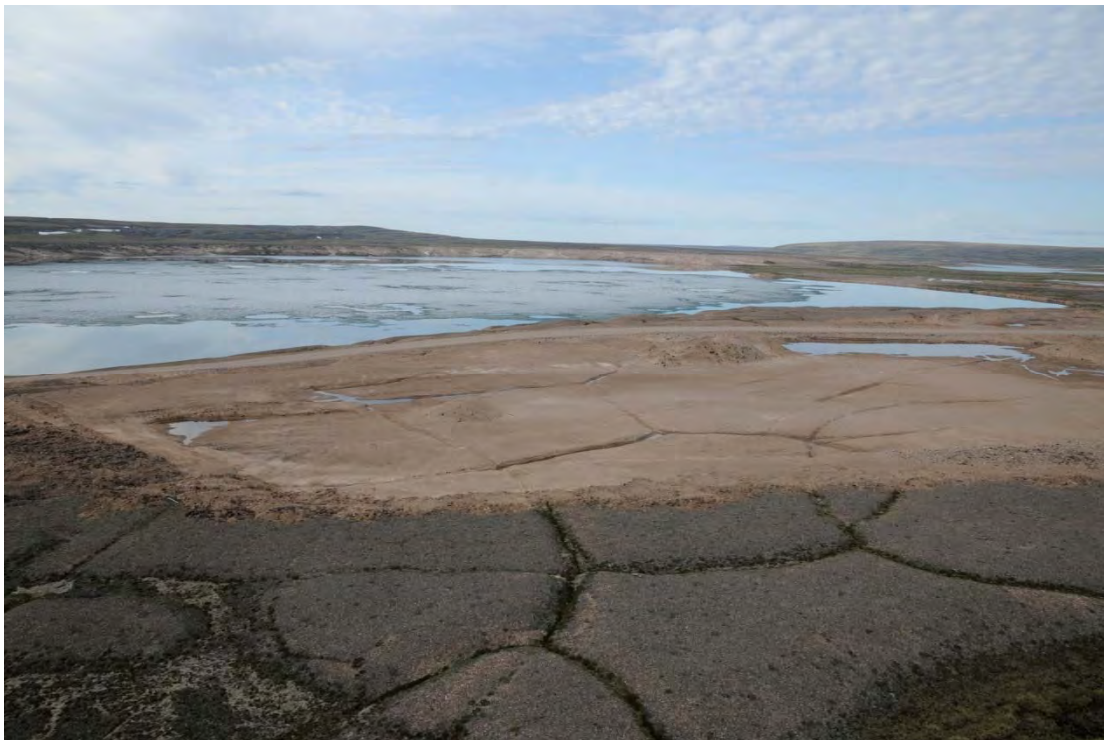
**FIGURE 2-1: BORROW SITE KM97 ALONG TOTE ROAD SHOWING GRAVELS (0557)**

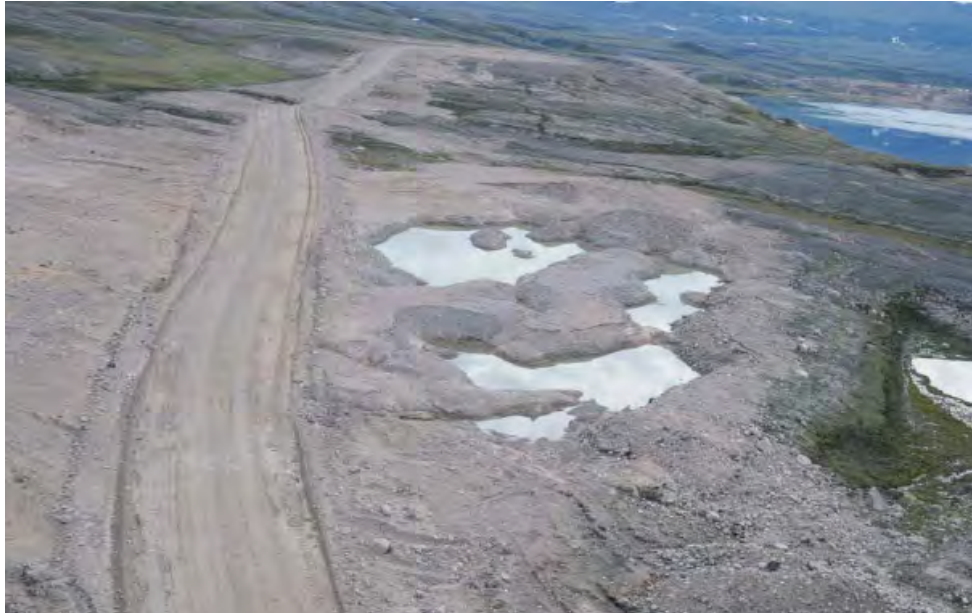
**Photo 3-1: Km97 Borrow Source: Typical depression formation from thaw of massive ice**

Ponded water within borrow pits insulates the local material which in turn retards winter freeze-back of the active layer. This results in retrogressive thickening of the active layer. Shallow ponding (less than 0.5m deep) that is short-lived following the freshet does occur at Km97 Borrow Source, although this is not deemed a present concern as it does not impact long term stability of the site. If ponding is observed as remaining persistent throughout the open water season and depressions deepen with time, then specific strategies to address reclamation and rehabilitation of these depressions will be developed as these conditions are counter-productive to concerted reclamation efforts.
