AGNICO EAGLE MINES: MEADOWBANK DIVISION - WHALE TAIL PIT PROJECT

Terrain, Permafrost, and Soils Baseline Report

Report Number: Doc 038-1524321.1100 Ver 0

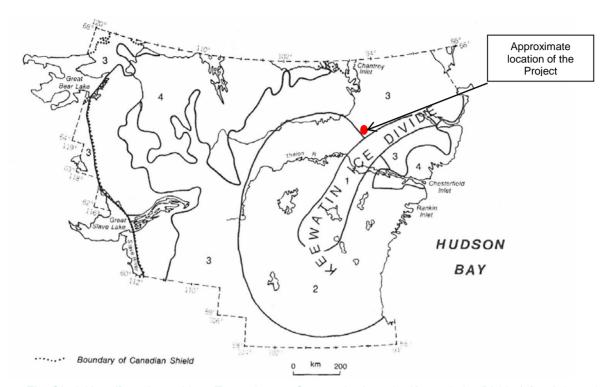
Figure 2-2: The Glacial Landform Assemblage Zones that are Concentric about the Keewatin Ice Divide (after Aylsworth and Shilts 1989)

A compilation of surficial geology maps and ground observations led Aylsworth and Shilts (1989) to produce a map showing the glacial features around the Keewatin Ice Divide. They refined the position of the ice divide based on interpreted zones or suites of glacial landforms that radiated outwards from the Keewatin Ice Divide. The study area lies within Zone 2 but is close to the boundary of Zone 3 (Figure 2-2). Zone 2 is an area characterised by well developed, linear trains of ribbed (rogen) moraine, which radiate from the Keewatin Ice Divide and extend along former flow lines. This zone also contains radiating esker-outwash systems and linear drumlin fields. Zone 3 is characterised by a dendritic pattern of eskers and drift cover (till) (Aylsworth and Shilts 1989; Aylsworth et al. 2012). More recent research by Utting and McMartin (2004) measuring small scale ice-flow indicators (e.g., striations, roches moutonnées) in the Meadowbank Mine area suggests that initial ice movement north of the Keewatin Ice Divide was to the north and then the ice turned towards the north-northwest. These small-scale features reflect the flow direction inferred by large scale features such as eskers in this area and presented by Aylsworth and Shilts (1989) and Aylsworth et al. (2012). The change in flow direction is due to the retreat of ice during deglaciation as the underlying topography started to have more control on the direction of ice flow. By about 8,000 years BP the Keewatin Ice had retreated beyond the study area and had entirely melted from the Keewatin area by approximately 7.8 ka BP (Dyke and Prest 1987a,b).

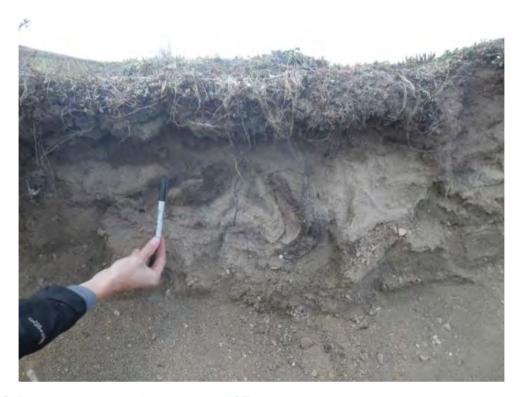
Photo 1: Soil cryoturbation exposed in a section at AQT04

The Project is located within the continuous permafrost zone. The presence of permafrost in soil is considered the main factor in the fluctuations between freeze and thaw conditions fundamental in periglacial processes and the main driver for cryoturbation in soil. Cryoturbation is frost heave due to the increase in volume from water to ice causing churning and considerable structural modification of the soils (Tarnocai and Bockheim 2011). The soil becomes churned, resulting in mixed, broken, displaced, and disrupted horizons (SCWG 1998) (Photo 1, Appendix A).

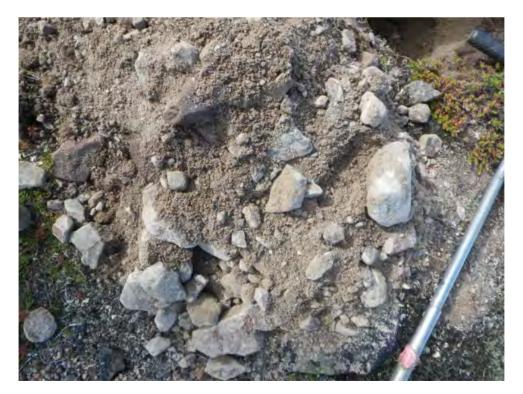
Photo 2: Silty sand till with numerous clasts

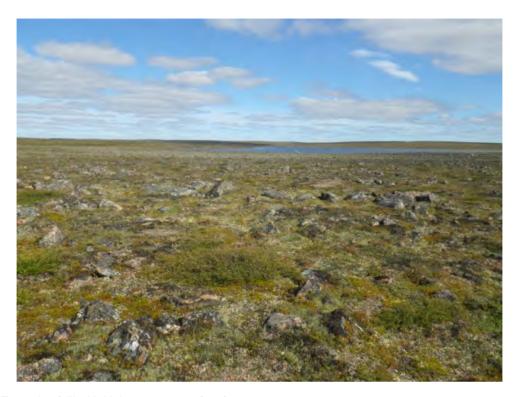
Photo 3: Example of till with high percentage of surface stones

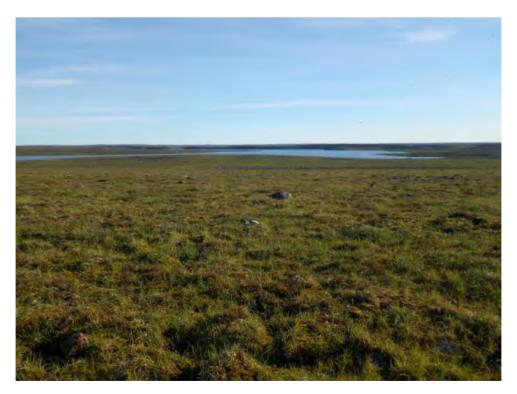
Photo 4: Example of till with low percentage of surface stones

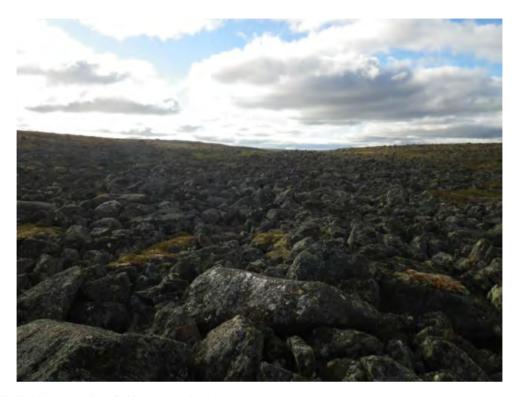
Photo 5: Well drained boulder field on a gentle slope

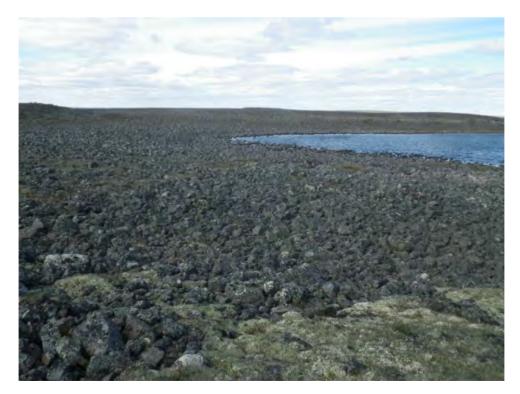
Photo 6: Boulder field adjacent to lake. Any fine-grained sediment has been washed away during spring melt

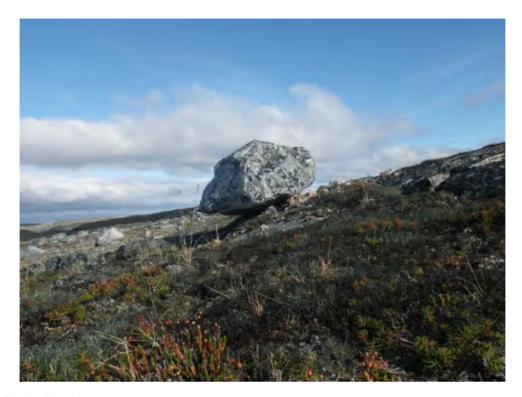
Photo 7: Perched boulder

Perched boulders (Photo 7, Appendix A) were also noted especially on bedrock ridges. These were let down by ice melt or ablation during deglaciation.

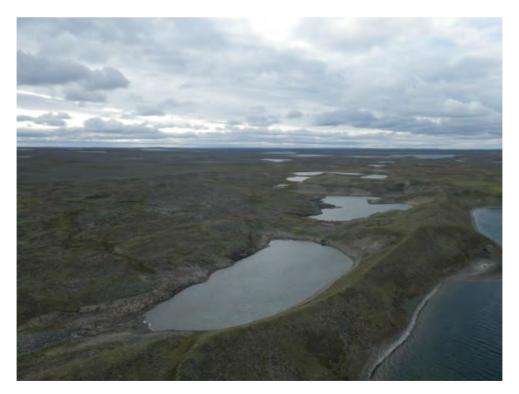
Photo 8: Part of the large esker and outwash terrace complex at Esker #3

Glaciofluvial deposits are found primarily in the northeast part of the Project study area (Appendix C) but they extend outside of the study area towards the southeast paralleling and intersecting the Haul Road. Approximately 6.3% of the satellite deposit study area and 3.5% of the Haul Road study area are characterised as having glaciofluvial deposits (Table 3-1; Appendix C); only 2.9% of the Haul Road crosses these sediments (Table 3-2). These deposits were transported and deposited by glacial meltwater rivers either directly in front of or in contact with glacial ice. As the ice melted, the large esker and outwash terrace complexes were revealed (Photo 8, Appendix A).

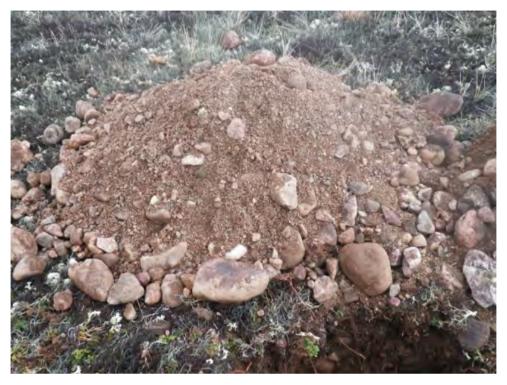
Photo 9: Glaciofluvial sediments

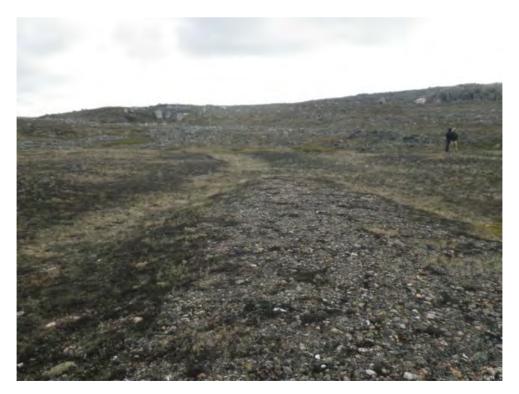
Photo 10: Channelled surface of glaciofluvial terrace at AQT16

Glaciofluvial outwash terraces with eroded channels and kettles (depressions in surficial materials resulting from the melting of buried or partially buried glacial ice) are commonly found adjacent to the eskers (e.g., AQT16, Photo 10, Appendix A). The terraces are also found around basins that currently occupy lakes (e.g., AQT26, Photo 11, Appendix A). These flat topped features are several meters thick and commonly are mantled with a cobbled pavement (Photo 12, Appendix A) suggesting that any fine-grained material was washed away. Aylsworth and Shilts (1989) suggest that the terraces were formed when the ice was thin (< 25 m) and was left behind in depressions as the ice front retreated. They suggest that the terraces are remnants of outwash that was deposited on inactive esker ridges or against valley sides by meltwater flowing across the stagnant ice. Where eskers protruded above the surface of the stagnant ice they were planed off or terraced by fluvial erosion or deposition to the level of the terrace or ice floor, leaving flat-topped esker segments. Once the ice completely melted, lakes formed in the depressions between the terraces.

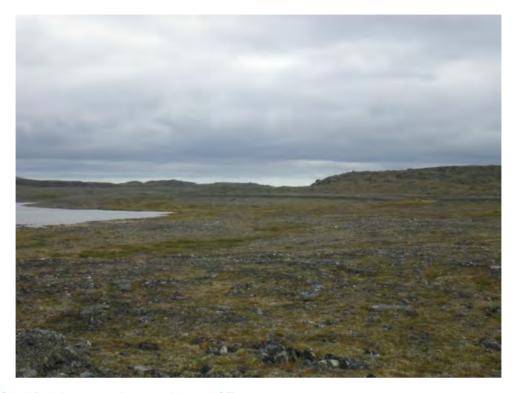
Photo 11: Glaciofluvial terrace adjacent to lake at AQT25

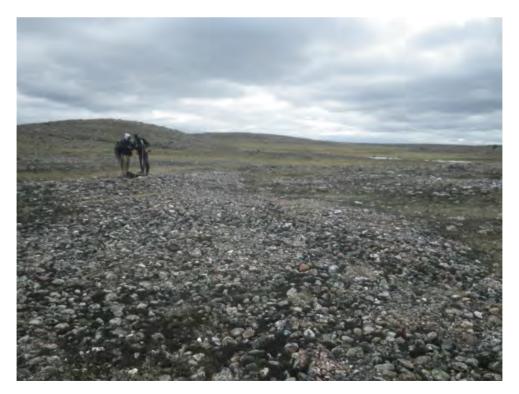
Photo 12: Glaciofluvial terrace with cobbled surface

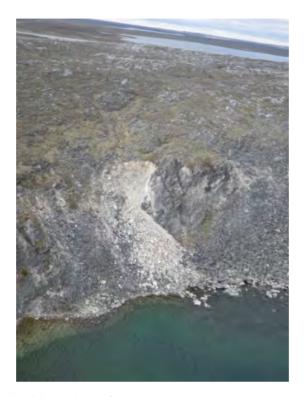
Photo 13: Frost-shattered colluvium lying at base of slope

Colluvial materials are formed by the downslope movement of material due to gravity. They are characterised by angular fragments of frost shattered or frost wedged bedrock lying at the base of steep bedrock exposures (Photo 13, Appendix A). Only 0.2% (13.5 ha) of the satellite deposit study area and 0.1% (1.8 ha) of the Haul Road study area is covered by colluvial deposits (Table 3-1). The Haul Road crosses less than 0.1% (Table 3-2) material identified as colluvial.

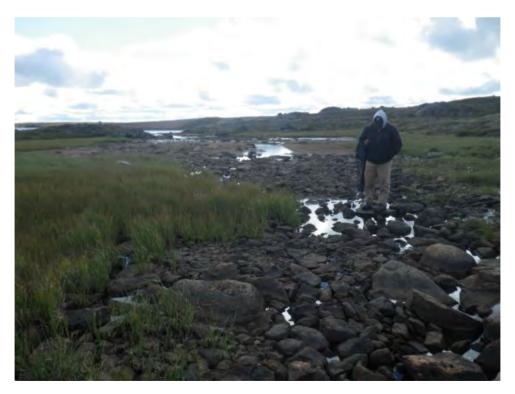
Photo 14: Boulder stream - fine grained material has been washed away by flowing water

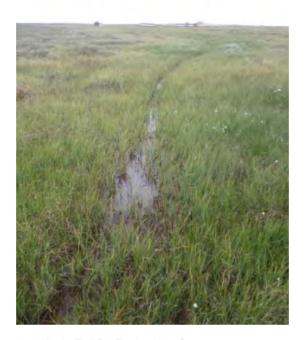
Photo 15: Fluvial sediments near the Whale Tail Pit Exploration Camp

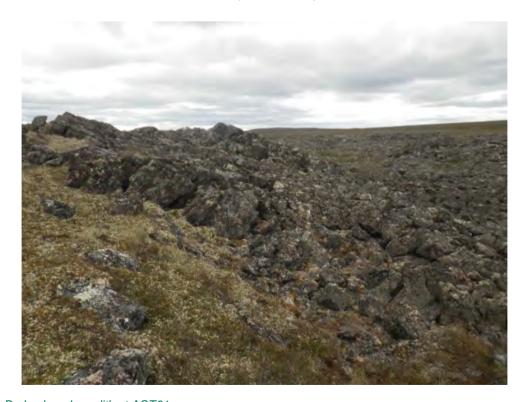
Photo 16: Bedrock and regolith at AQT61

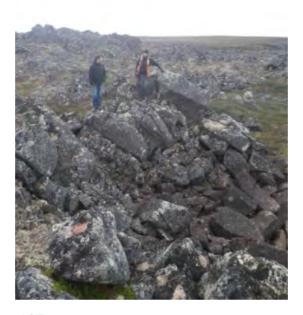
Photo 17: Bedrock and regolith at AQT63

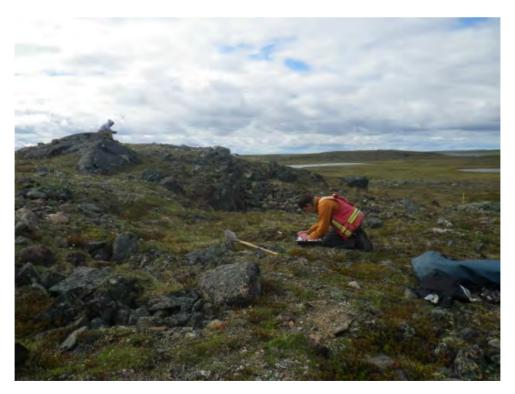
Photo 18: Bedrock with plucked lee side at AQT28

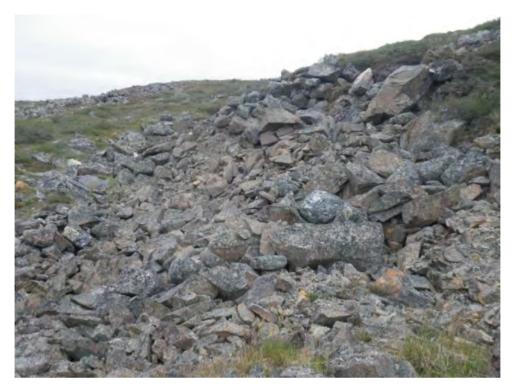
Photo 19: Frost-shattered bedrock

Frost shattering and wedging occur on exposed bedrock and in coarse grained boulder fields. The frost shattered bedrock accumulates at the base of steeper slopes as colluvium (Photo 19, Appendix A). Photo 20 (Appendix A) shows an example of a frost shattered stone.

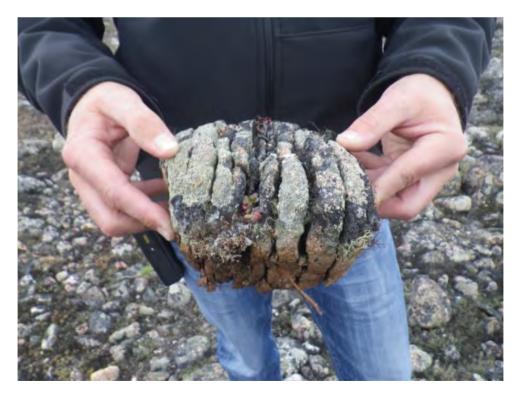
Photo 20: Frost-shattered stone

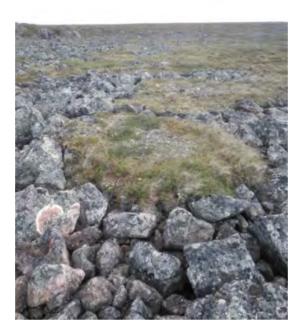
Photo 21: An example of sorted polygons

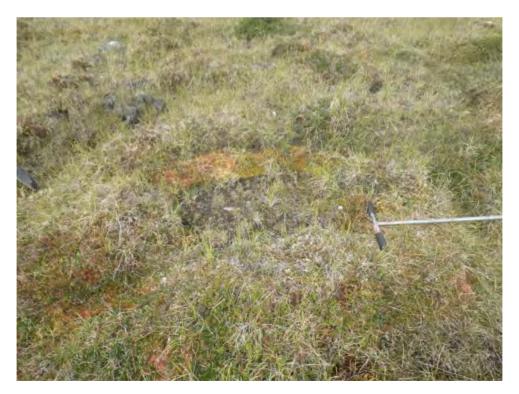
Photo 22: An example of non-sorted polygons

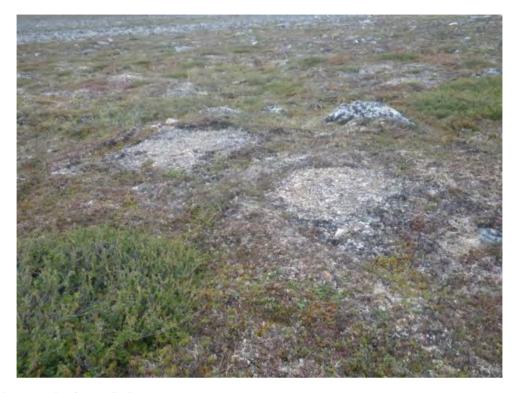
Photo 23: An example of a mudboil

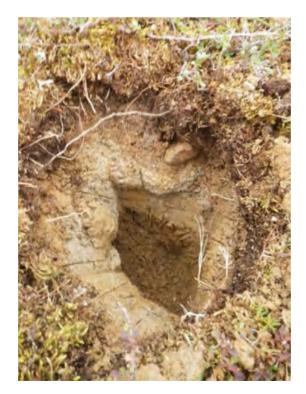
Photo 24: Super-saturated layer starting to slowly flow back into the hand dug pit

cm thick underlain by a thawed substrate approximately 15 to 20 cm thick. The thawed substrate is super-saturated due to the underlying permafrost table restricting the free drainage of water (Shilts 1978). As a result, this super-saturated layer can liquefy and in many of the hand dug pits, slowly flowed back into the excavated hole (Photo 24, Appendix A).

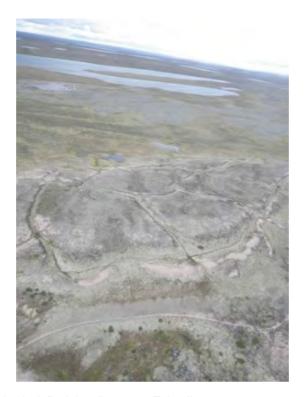
Photo 25: Ice wedge polygons in glaciofluvial sediments at Esker #5

Ice wedge polygons are also evident within the study area and are associated with thick glaciofluvial deposits (Photo 25, Appendix A). Ice wedges form by the infilling of thermal contraction cracks in frozen ground with meltwater and sediment. Repeated contraction cracking of the ice in the wedge, followed by freezing of the water in the crack gradually increases the width and depth of the wedge (Everdingen 1998). The surface expression of ice wedges is generally a network of polygonal troughs at the ground surface (Photo 25, Appendix A).

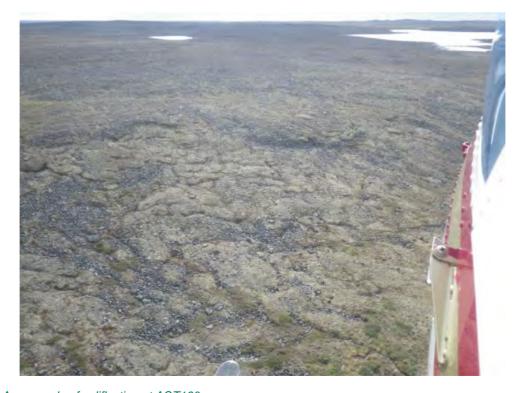
Photo 26: An example of solifluction at AQT160

Solifluction is the slow downslope movement of saturated unfrozen sediment over impermeable frozen ground. The rate of movement varies in response to changing soil properties, vegetation, drainage, snow cover, and topography. The slow movement results in the formation of distinct step-like landforms called solifluction lobes (Photo 26, Appendix A). Solifluction was noted in several areas throughout the study area on gentle slopes.
