2022-06-16 WTP 800L Engine Oil

GN reference #: 2022-282

Please find the following information as a follow up to the Spill report submitted June 16, 2022, by Agnico Eagle Meadowbank division. This detailed report is submitted to the Inspector in compliance with the conditions under the Nunavut Water Board License 2AM-WTP1830, Part H, Item 8c.

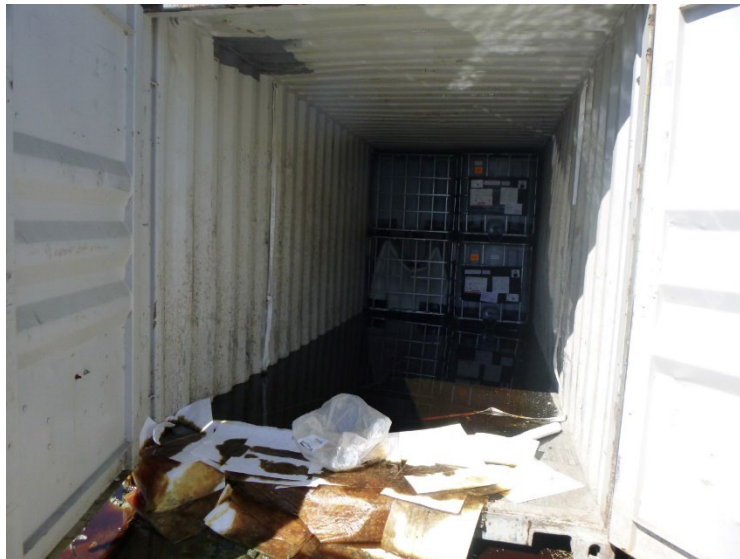
During operations at the Whale Tail Project, a tote containing 1000L of engine oil was punctured by an equipment during the process of removing the reservoir from the sea can, causing a total of 800L of oil to leak on the ground of the warehouse sea cans storage pad.

Spill Location: Northing: N65°24'05.85" W96°40'30.85" on IOL

There were no off-site impacts or discharges. Distance to the closest water body is 550m to Lake A55

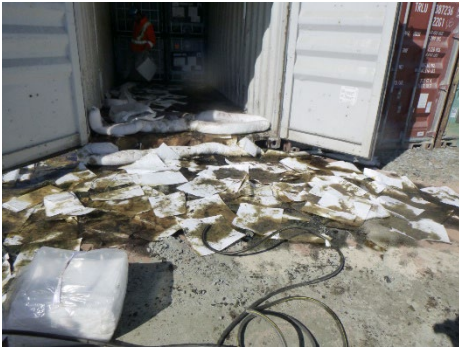
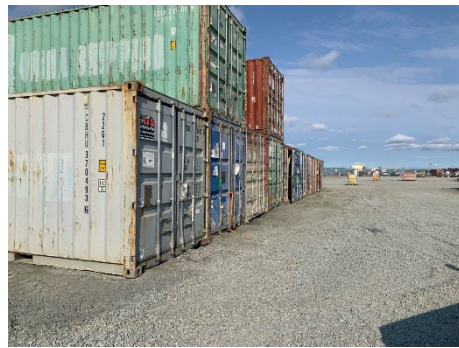
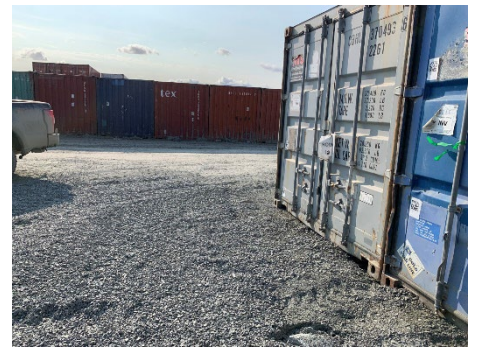
The equipment was immediately removed from the area by the operator and absorbent pads/booms were placed around the seacan to contain the leak. Additionally, granular absorbent and a small pump were used to collect as much oil as possible. The seacan was then removed by the container handler to allow the decontamination of the area, approximately 12m³ of contaminated soil was collected and brought to the Meadowbank landfarm.

A job task observation (JTO) of the tele handler operation was performed to identify the environmental and health & safety risks associated to the task. Following the JTO, wireless camera systems that will be mounted to the equipment forks boom were ordered and will be installed upon reception.
