Meadowbank Interim Closure and Reclamation Plan (ICRP) - Update 2018

MEADOWBANK GOLD PROJECT

Meadowbank, Agnico Eagle Mines Limited

Report > Final Report > Rev. 00
Internal ref. 654769-5000-4EER-0001_00

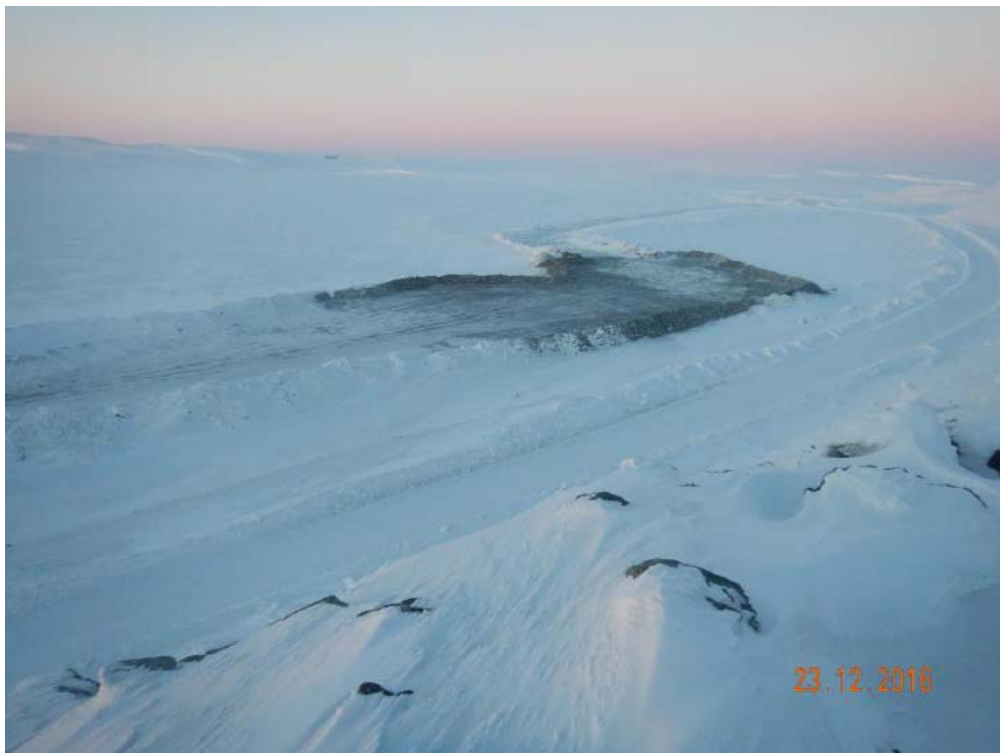
Photo 8: TSF North Cell, NPAG Cover construction, winter 2016

Preliminary design work was completed for the TSF cover in 2015 and 2016. The tailings cover will consist of non-acid generating granular material (NPAG) and ensures that the active layer remains within the NPAG layer. The objective for the cover system is to keep the tailings under 0°C in most conditions and to maintain saturation above 85%. Progressive reclamation of the North Cell has started in 2015 and continued to 2017 with the NPAG cover placement. The progressive cover is expected to continue in 2018 and 2019. The TSF North Cell is instrumented for thermal monitoring with thermistors installed in the tailings or the NPAG cover.

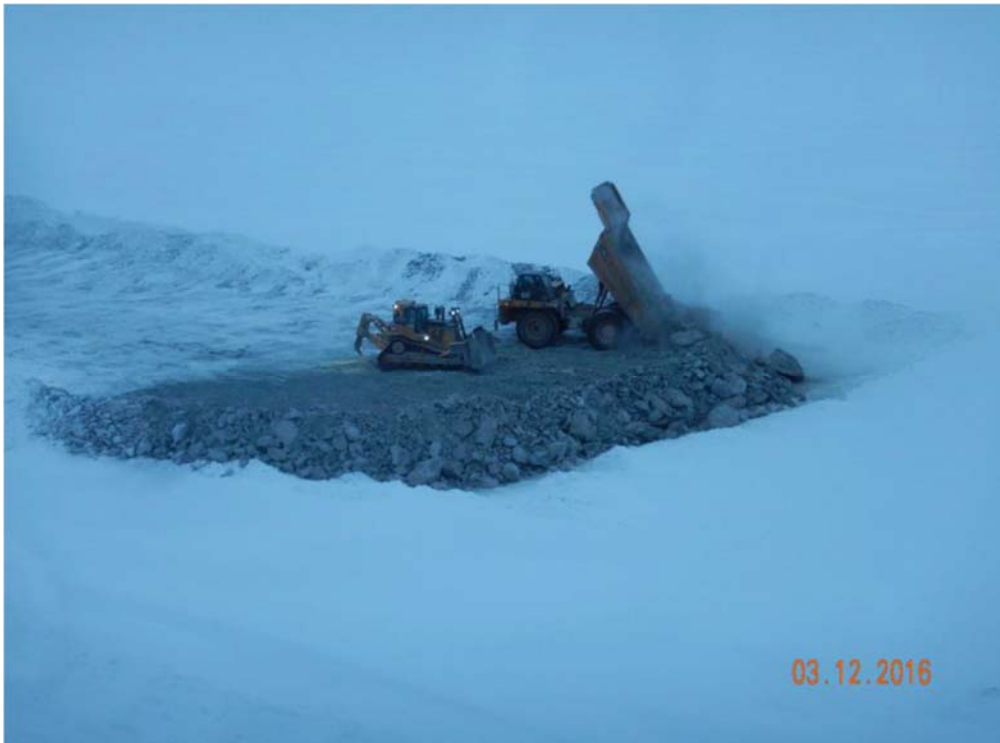
Photo 9: TSF North Cell, NPAG Cover construction, winter 2016
