August 28, 2001 Water Licence Inspection - Report

INDUSTRIAL WATER USE INSPECTION REPORT

Date: 2001/08/28 Company Rep. (Name/Title): Al Burton / Camp Manager
Licensee: WMC International Ltd., Meliadine Project Licence No.: NWB2MEL0103

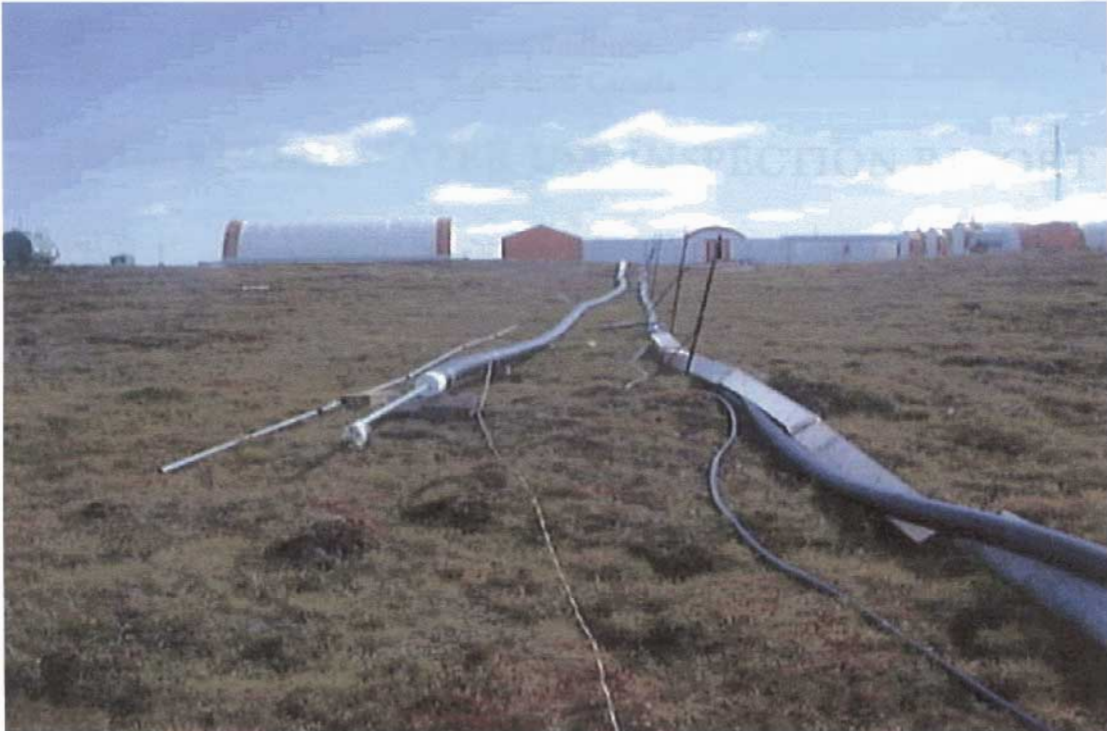
- **Water supply:** At the time of the inspection, the Licensee was seeing to the installation of a replacement water supply conveyance line (figure 1), which unlike the previous one will withstand wintertime and will include a flow gauging device. This being said, the attached analytical results relating to a sample taken in vicinity of the intake station indicate that the raw water meets the *Guidelines for Canadian Drinking Water Quality* for all tested parameters.

Comments: Deficient conveyance line failed during wintertime; currently seeing to the installation of the replacement line. Flow meter will be included in new intake setup. Chlorination and filtration in use.

figure 1. Replacement of the water supply conveyance line; 2001/08/28.

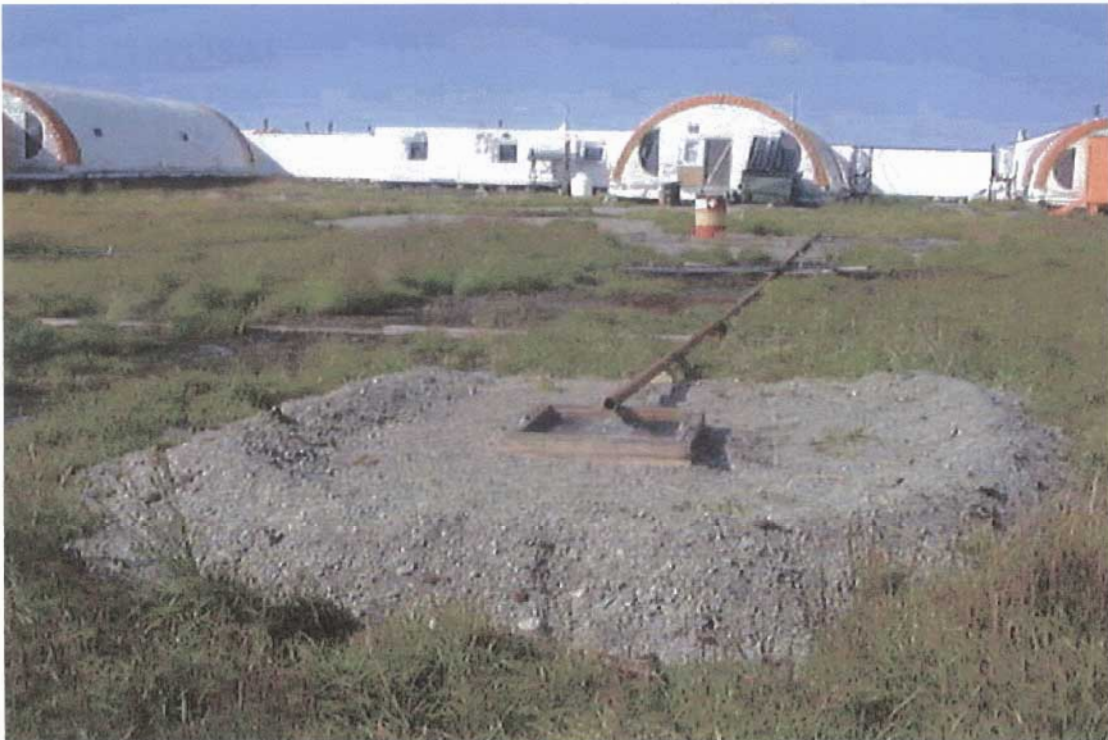
- **Waste disposal:** Since the last inspection, the Licensee has undertaken to upgrade the campsite's greywater disposal system (figure 2). Although it was mentioned that the sediment trap might have to be expanded in order to increase the retention capacity of the sump when the camp reverts to its former level of activity, the facility in the meantime appears quite adequate. As such, no evidence of solid wastes was noticeable beyond the facility, nor was flow noted along the shoreline downslope of the area. Thus, the attached analytical results relating to a sample collected from Meliadine Lake below the likely path of greywater discharge reveal that all tested parameters meet the *Canadian Water Quality Guidelines for the Protection of Freshwater Aquatic Life*. Further, the Microtox sample, which constitutes a reliable toxicity indicator (IC_{50}), did not denote toxicity.

Comments: Sewage and combustible wastes incinerated on-site; ashes, and non-combustible/hazardous wastes dispatched to the Rankin Inlet solid waste disposal facility. Waste oil delivered to a third party equipped with a furnace, in Rankin Inlet. Waste well segregated at the on-site waste management area. Greywater disposal system upgraded since the previous inspection; no evidence of solids beyond the new sump and sediment trap. No flow noted along the shoreline downslope of the discharge point, although soil somewhat saturated.

figure 2. Upgraded greywater disposal system; 2001/08/28.

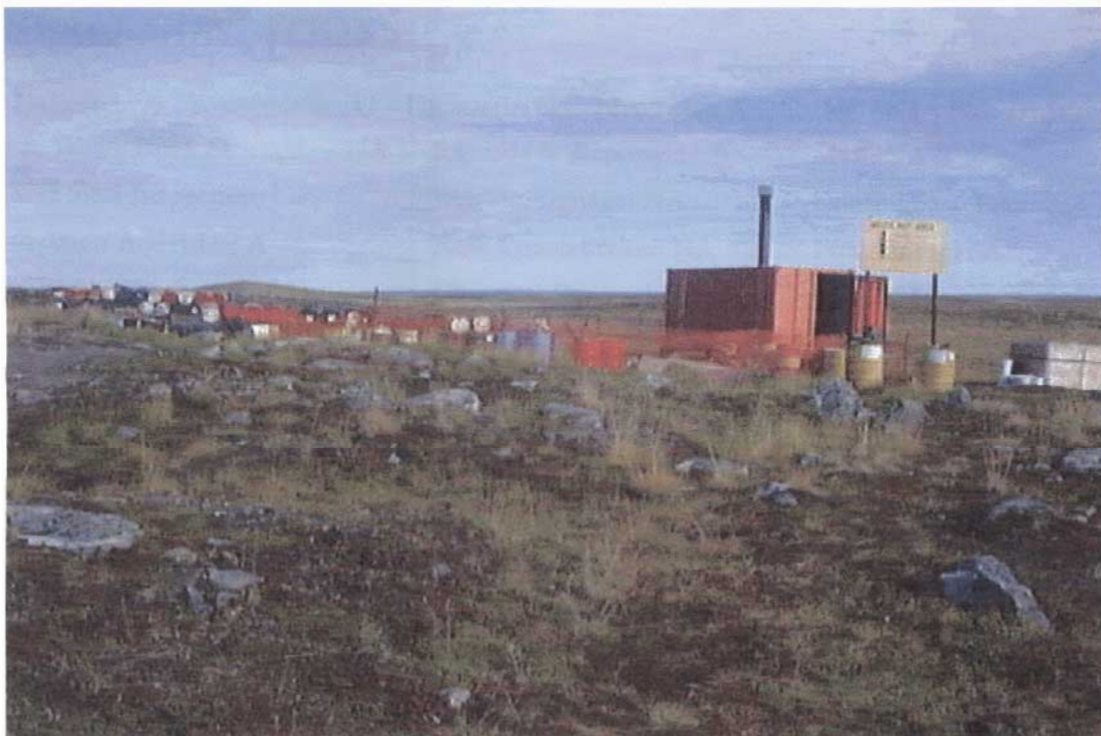
In parallel, the Inspector commends the Licensee for the considerable on-site segregation of waste initiated at the campsite's waste management area (figure 3). Accordingly, through on-site incineration and off-site disposal, the Licensee minimizes the likelihood of camp operations bringing about the deposit of waste into waters.

figure 3. Waste management facility; 2001/08/28.
