# Follow Up Report: #2022112

### 150 L Drilling Recirculation Water on Waterbody A8

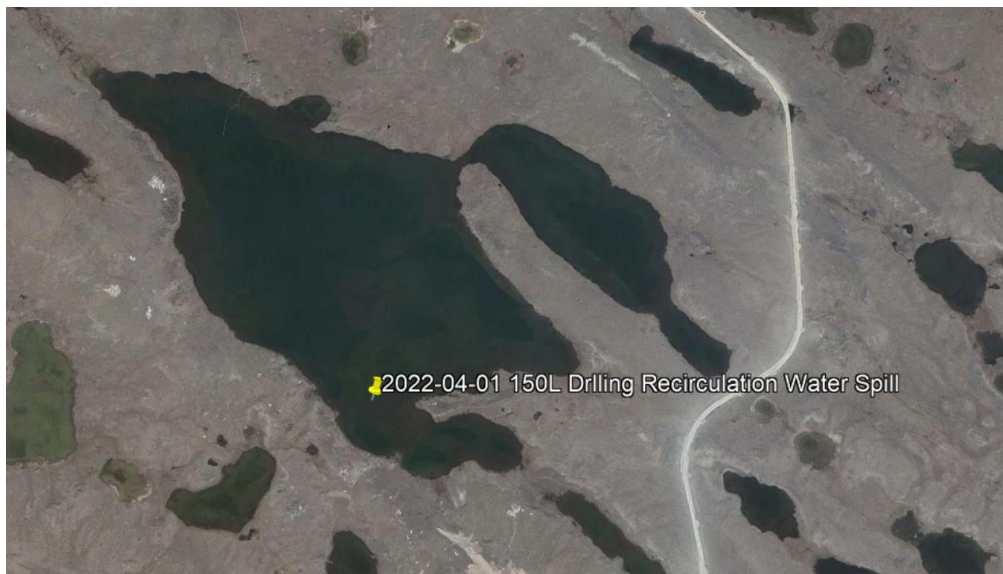
**Figure 1:** Drilling recirculation water spill location

The coordinates of the spill are: 63° 0' 34.15" N, 92°12' 11.74"W, which is on waterbody A8.

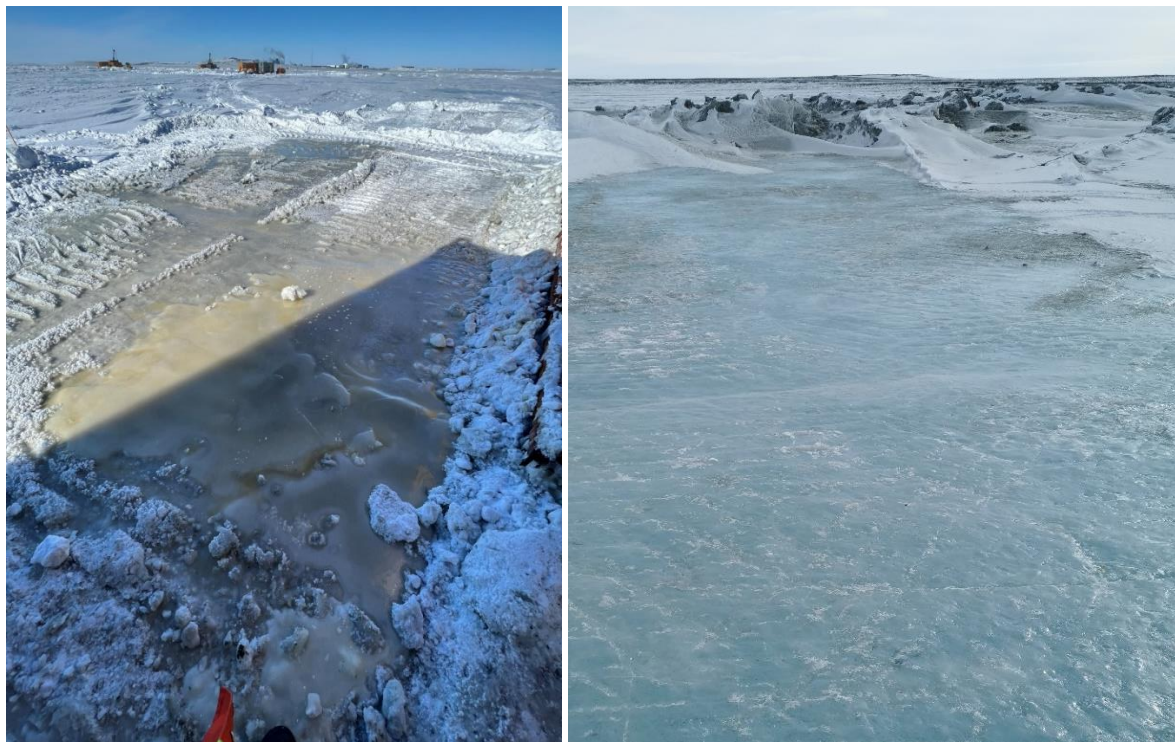
**Figure 2&3:** Spill Location- Pre-clean (left) and post clean up (right)

On April 1<sup>st</sup>, 2022, during an environmental inspection of the Orbit Garant drill rigs located on waterbody A8, a worker identified that 150 L of drilling recirculation water had overflowed from the decantation tank to the surface of the ice.

The release was a result of a human error as the worker didn't stop the pump that was filling the tank. The decantation tank overflowed spilling recirculation water onto the surface ice. Orbit Garant stopped the flow of fresh water into the decantation tank immediately after the overflow was observed.

At the time of inspection, the decantation tank was no longer overflowing, and drilling recirculation water was no longer spilling onto the ice. The cleanup of the spill was completed as part of the final site cleanup as all drilling operations were complete at the site. During the drill site cleanup all impacted snow and ice was removed and sent to the drill cuttings disposal area with the remaining drill cuttings.

As an effort to mitigate the frequency of spills on lake ice, Orbit has committed to implementing a series of actions aimed at reducing the risk of spills from drills. One of these actions is to install water level sensors on the decantation tanks which will be connected to a signal light system installed in the drill shake. The intention to implement this action was communicated via a Letter of Intent provided by Orbit to Agnico Eagle on April 28<sup>th</sup>, 2022 and is available upon request of regulatory bodies.
