Follow Up Report: #2022206

May 24th, 2022

B38 Post Drilling

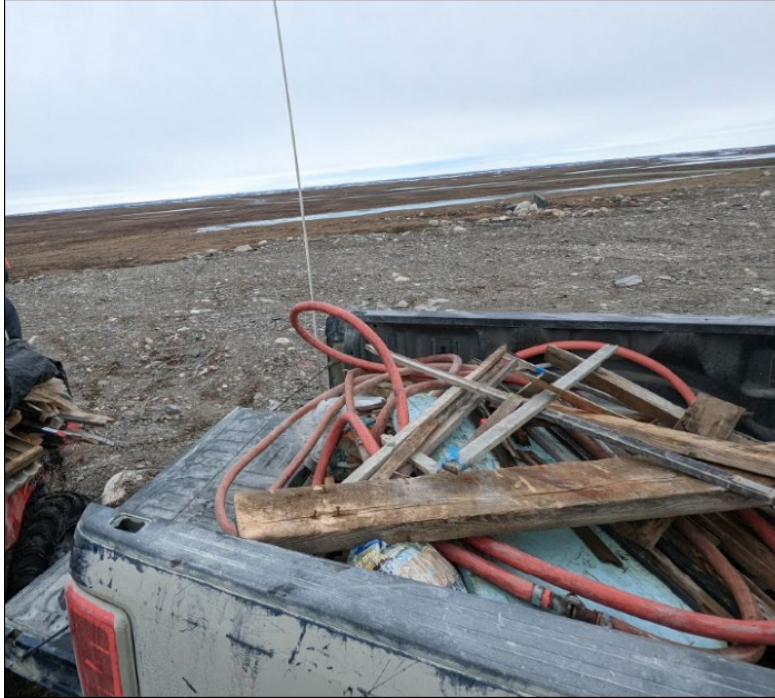
Figure 2: Drilling debris clean-up from clean-up efforts on May 29th, 2022

After the inspection, Orbit Garant and AEM's Exploration Geology and Environment Departments began a collaborative effort to clean up lake B38 and the shore of lake B38 on a regular basis, pending conditions were safe to proceed. The clean-up efforts began on May 24th, 2022 and were completed on May 29th, 2022. Each clean-up activity is documented in Table 1.

Some materials were frozen in place and couldn't be removed safely such as freshwater lines. These items were identified with buoys and GPS locations and will be removed by helicopter when safe to do so during the ice-free season.
