APPENDIX "C"

> FIGURES

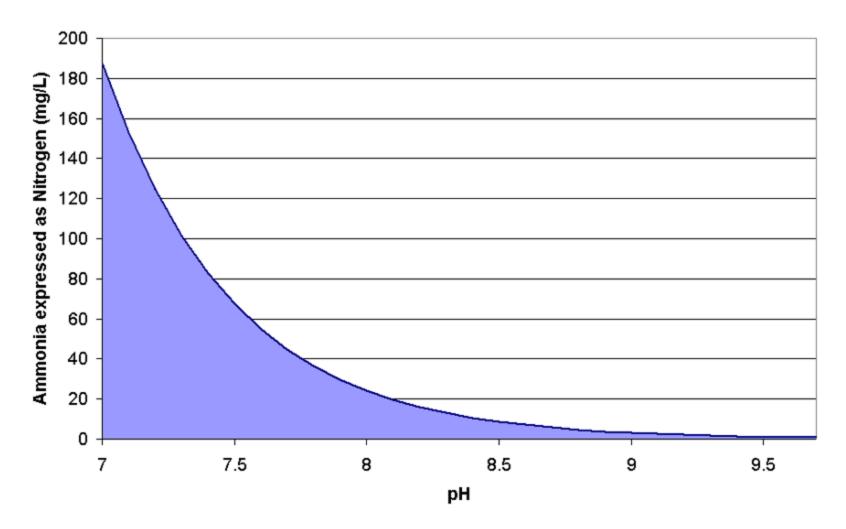
Figure 4. Acute Toxicity of Ammonia with pH.

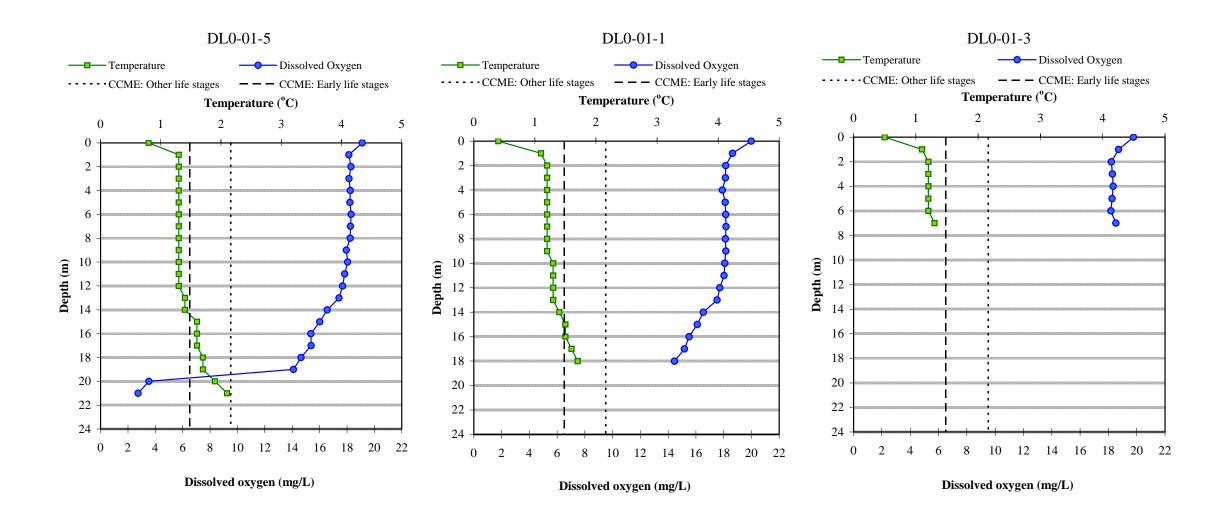
Figure 5. Temperature and dissolved oxygen depth profiles for the northwest basin of Sheardown Lake, May 2007.
