September 30, 2018 WTP Road

GN reference # : 2018-407

Spill Description

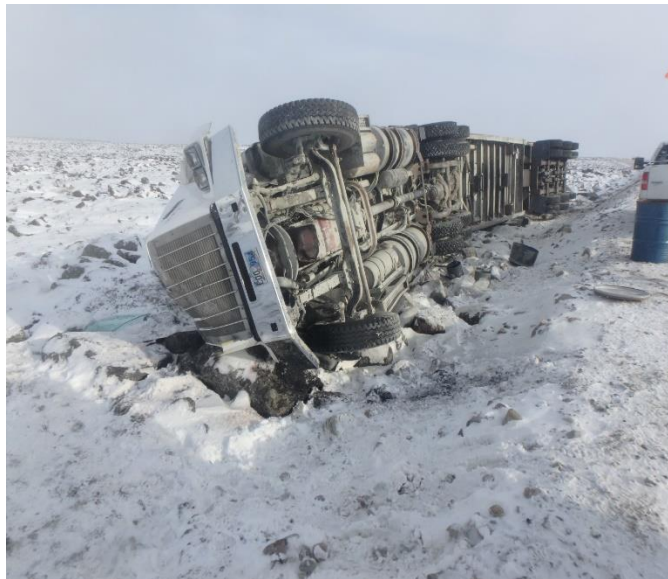
A tractor-trailer traveling north bound from Baker Lake to Whale Tail site went off the WTP road at km 51. The tractor was tipped on its side and diesel fuel was slowly leaking from the cap on the fuel tank.

There were no off site impact or discharge to any receiving watercourses. The distance to the closest lake is estimated at 230 meters.

The tractor-trailer was tipped on its side and diesel fuel was slowly leaking from the cap on the fuel tank.

Absorbent pads were laid out to contain the spill on the ground as well as a containment drum. Once the truck was placed back on the road and moved out of the area, the ground was scrapped clean and contaminated material was brought to the Meadowbank Landfarm area.
