Committee Bay Project

Annual Report

2016

North Country Gold Corp.
November 2016

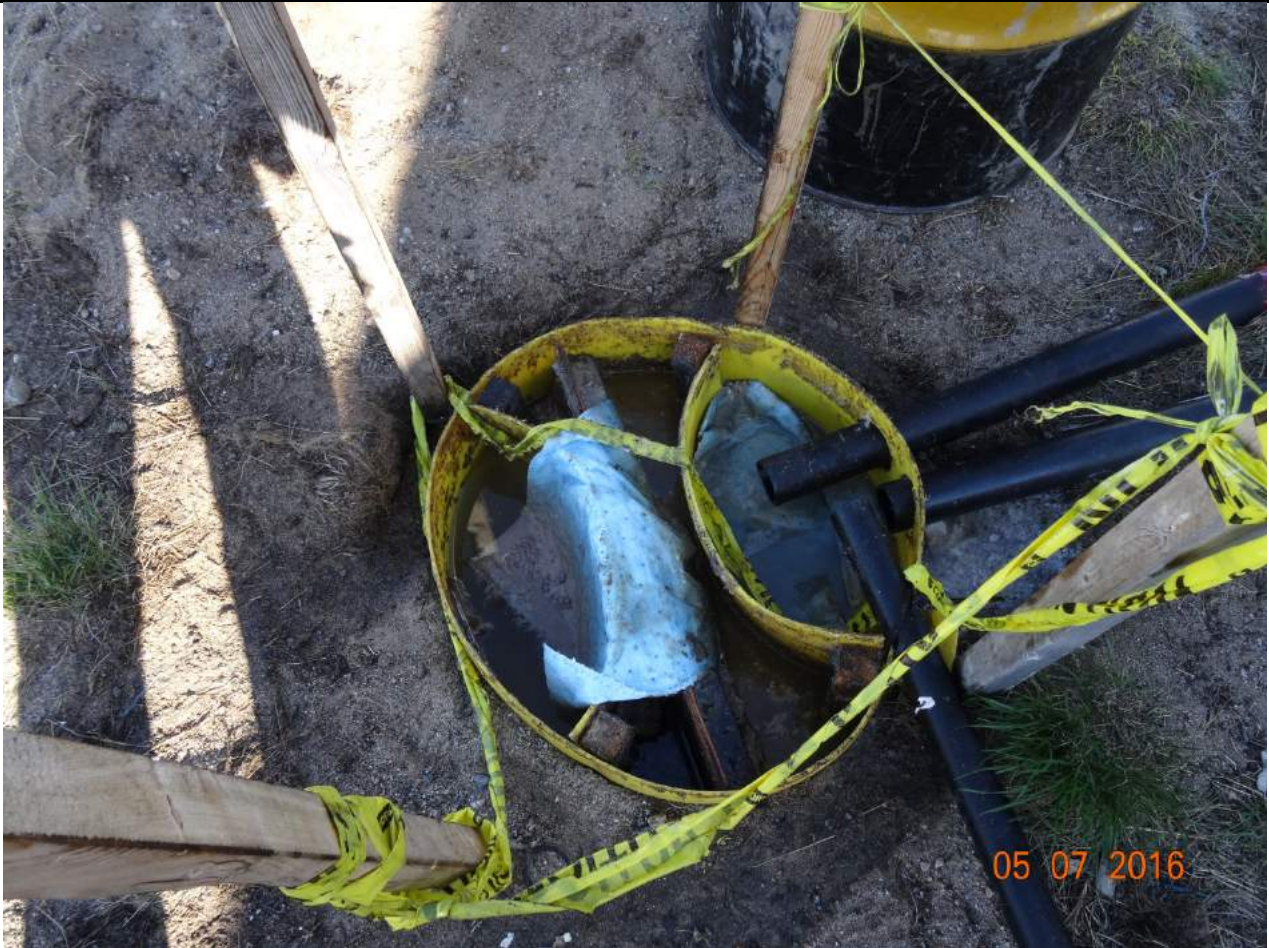
Date	Camera	Inspector	Authorization
05-07-2016	SONY DSC-HX50V	Eva Paul	2BE-CRA1520
Photo Log # 1		Location (NAD 83 DD MM SS.SS)	
Photo DSC05405		N66 23 49.1 W93 07 39.6

Description: Grease trap at Bullion Camp shows signs of overflowing.

- The grease trap at Bullion Camp was seen to have potentially overflowed and requires monitoring and deficiencies addressed if required.
- RAB drilling dust must be prevented from being blown into nearby water bodies.
- An increased effort must be made to protect vegetated areas around Hayes Camp especially in the gully between camp and the helicopter area.
- Measures need to be put in place to prevent sediment from flowing from Hayes Camp into the lake. This could include rerouting water flow to still vegetated areas.
- 2015 and 2016 drill activity coordinates must be submitted.

1. Monitor grease trap at Bullion and address deficiencies as required.
2. Ensure dust from RAB drills is not blown into nearby water bodies.
3. Protect the vegetated areas around Hayes Camp to preserve existing vegetation, particularly through the gully between camp and the helicopter area.
4. Implement measures to mitigate the sediment deposition south of camp (eg: by diversion or and dissipation of the flow to areas that are still vegetated or that don't flow directly into the lake). Evaluate the efficacy of the measures and adapt as necessary.
5. Provide to the inspector coordinates of all drill activities for 2015. Provide the 2016 coordinates with the annual report as required.

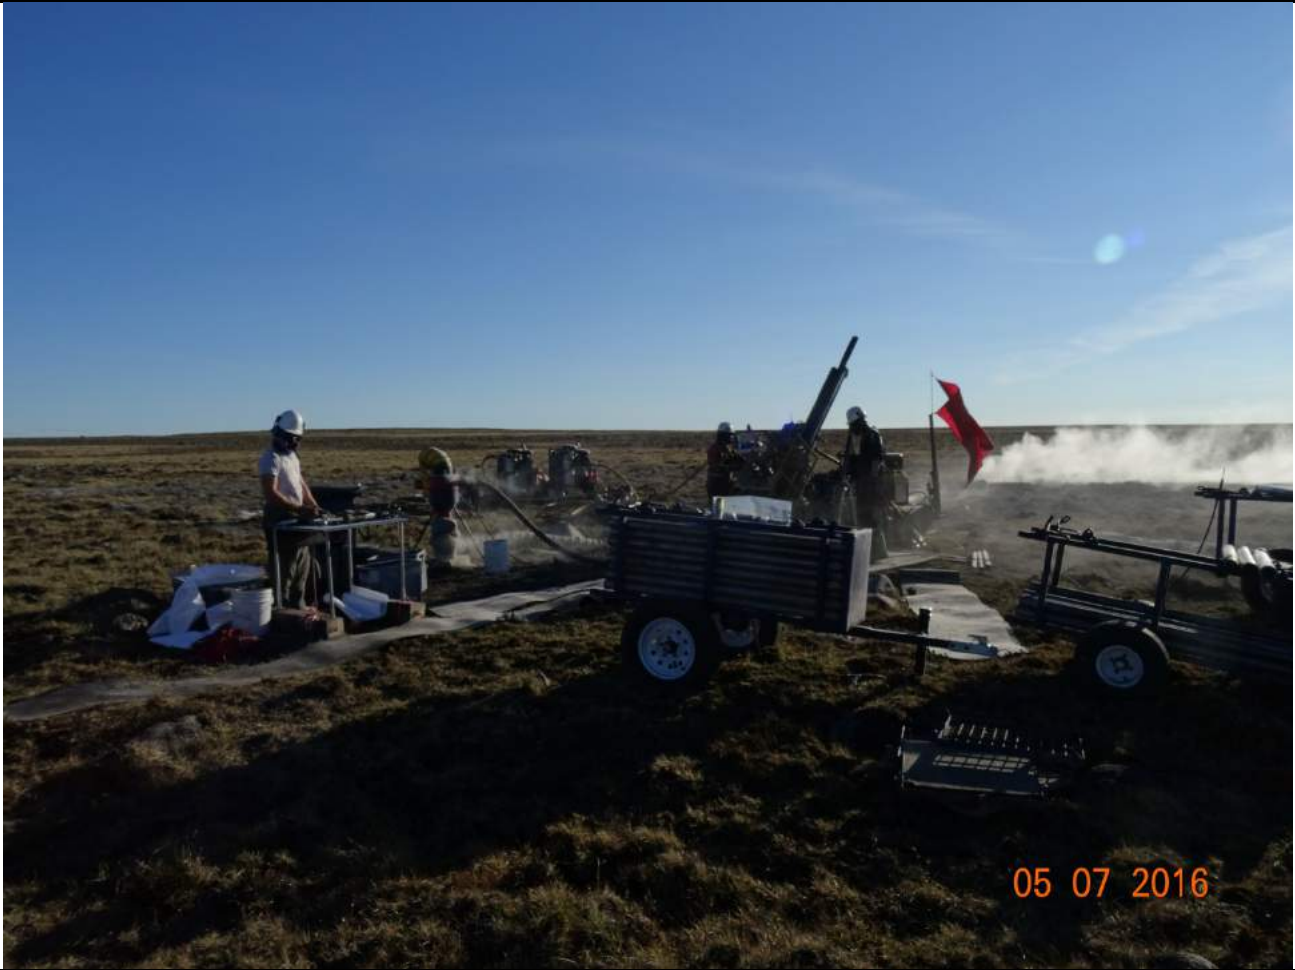
Photo Log # 2	Location (NAD 83 DD MM SS.SS)
Photo DSC05433	N67 07 07.2 W93 27 43.9

Description: Active RAB setup at hole 35. Chemicals/oils all in containment.

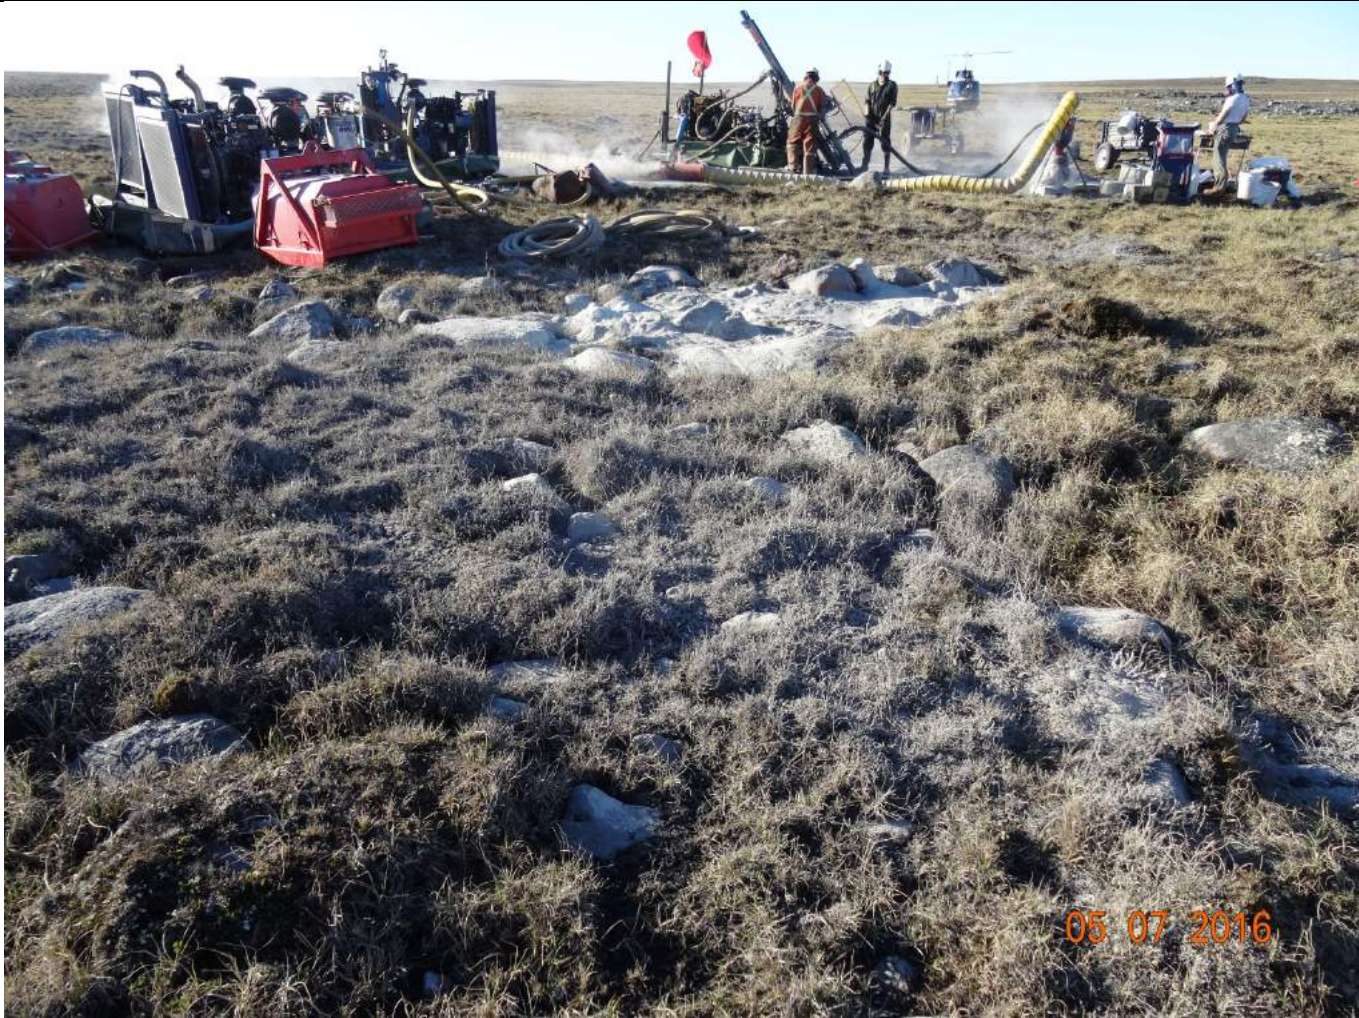
Description: Dry cuttings left on tundra, similar to process with wet diamond-drill cuttings.

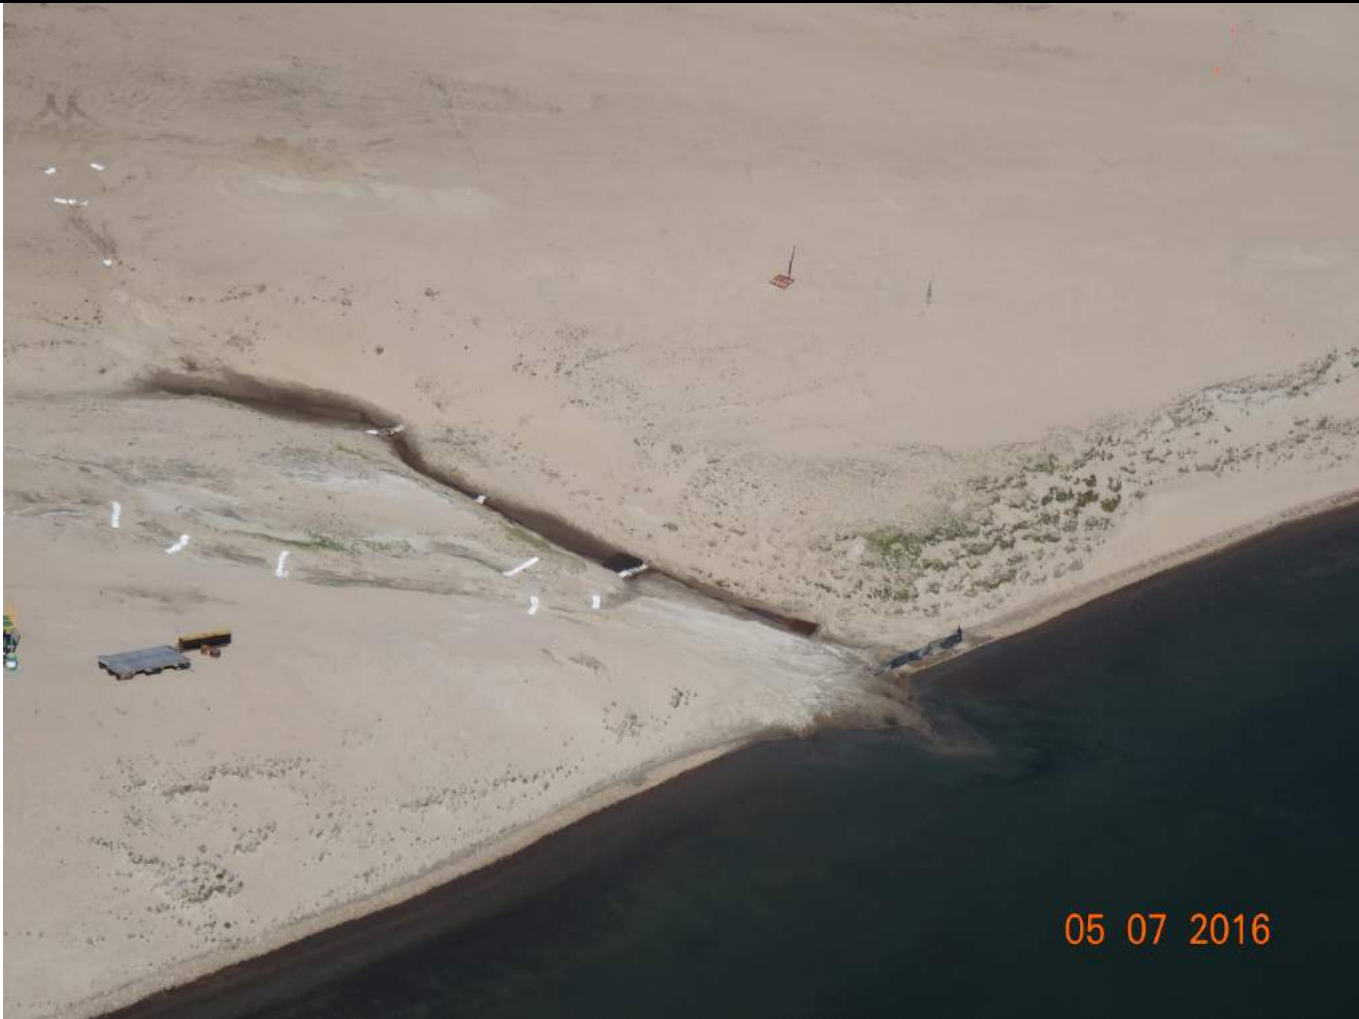
Photo Log # 4

Description: Erosion stream seen from the air.

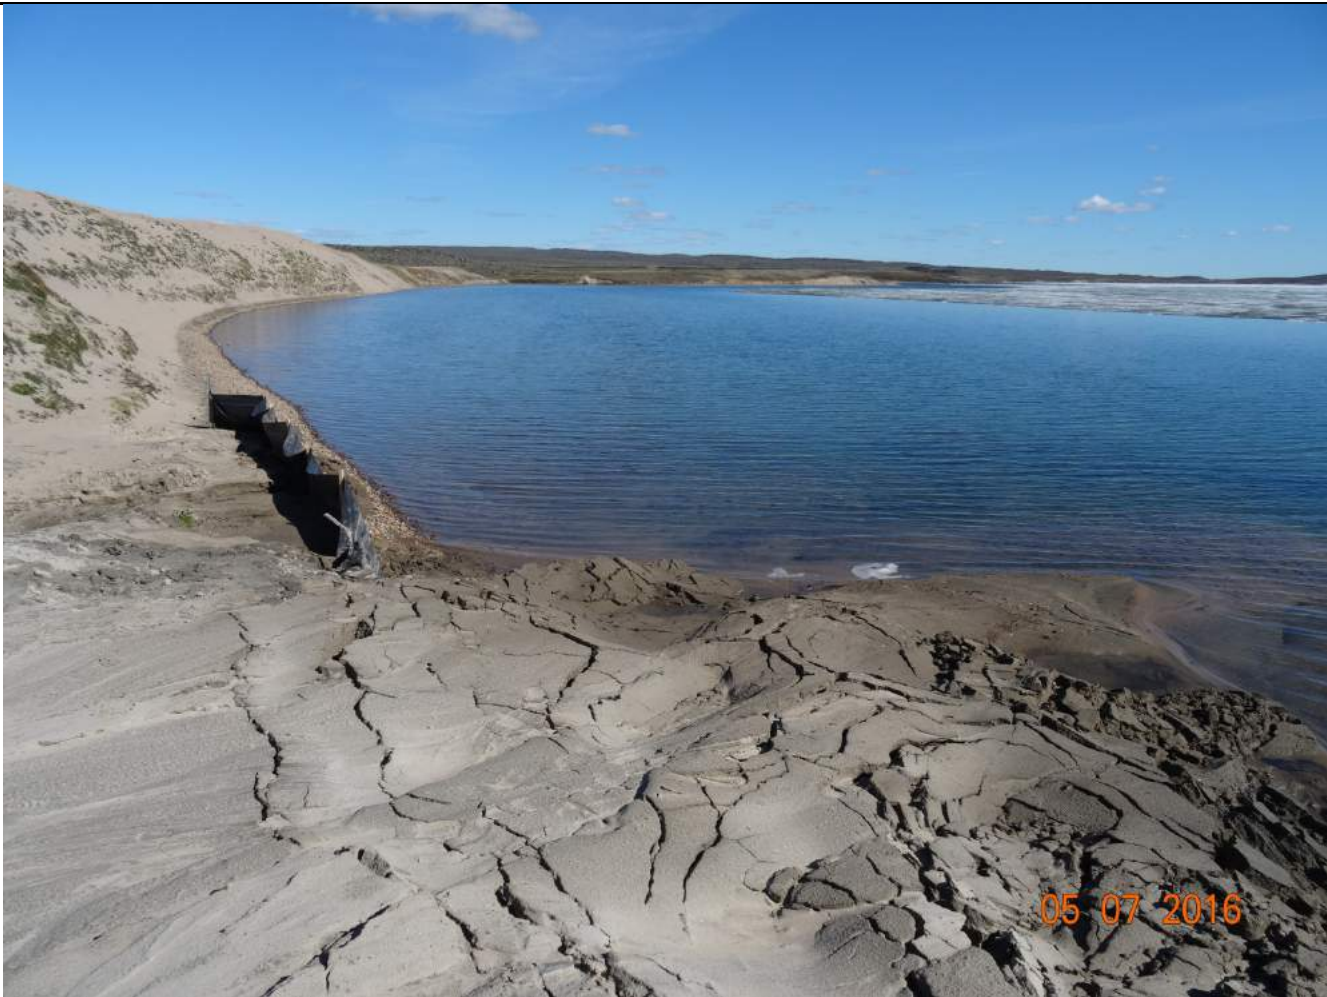
Description: Esker sand deposited in lake, as seen from the ground.

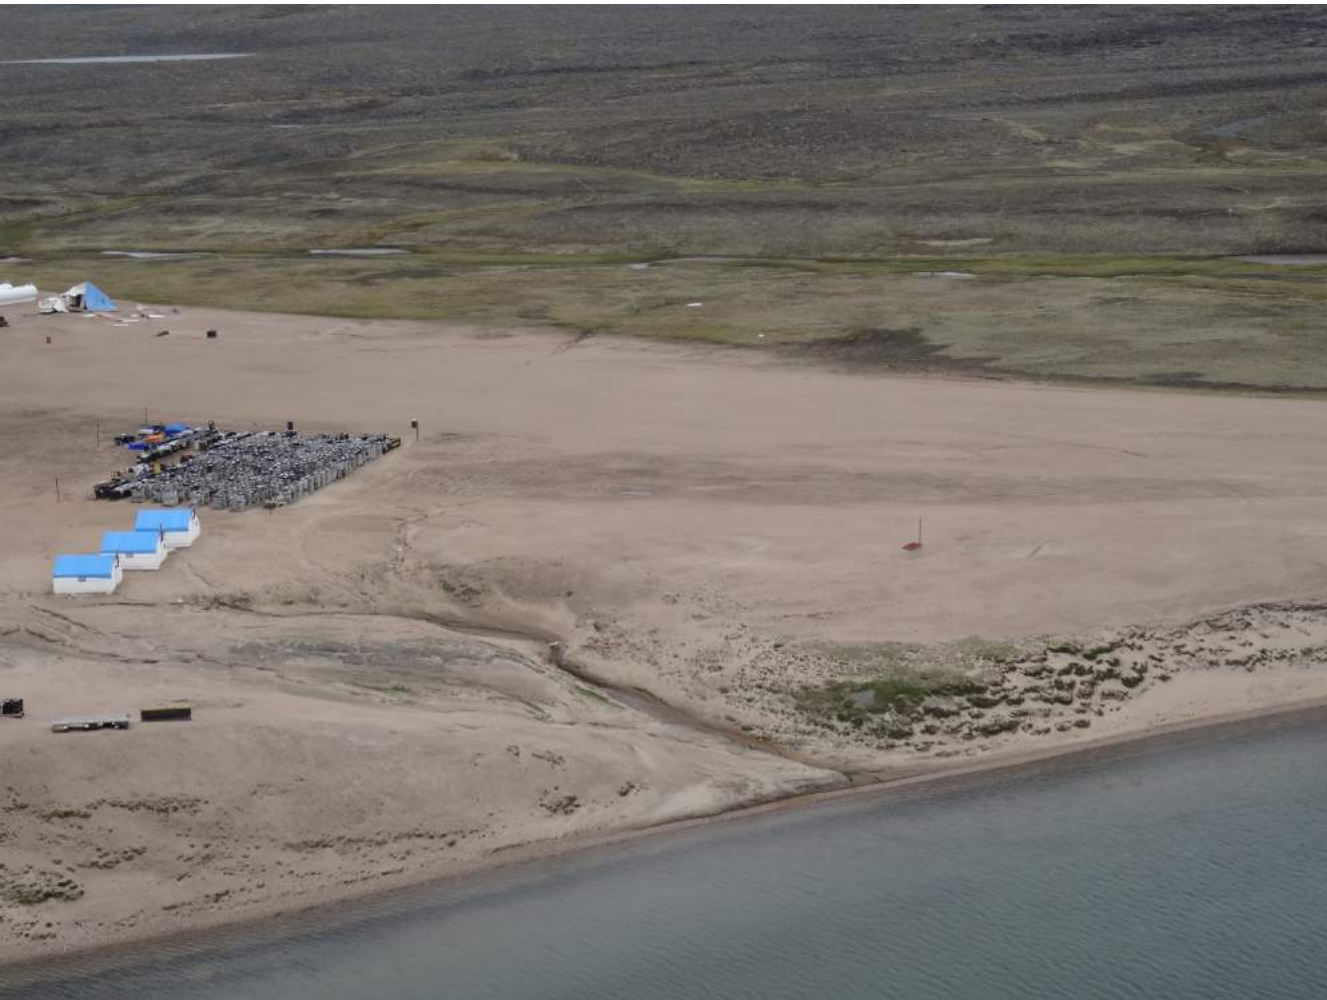
Photo Log # 6

Description: Erosion channel as seen in 2014.
