# Memorandum

**SUBJECT:** 2013 Fuel Containment Area Water Sampling

Starfield Resources Inc. constructed and operated a lined embankment secondary containment fuel storage area as part of their Ferguson Lake Project. Canadian North Resources and Development Corp. has acquired the property recently and at their request, ERM Rescan visited the Project area August 7 to 9, 2013 to assess the quality of the impounded water and to provide recommendations on its management.

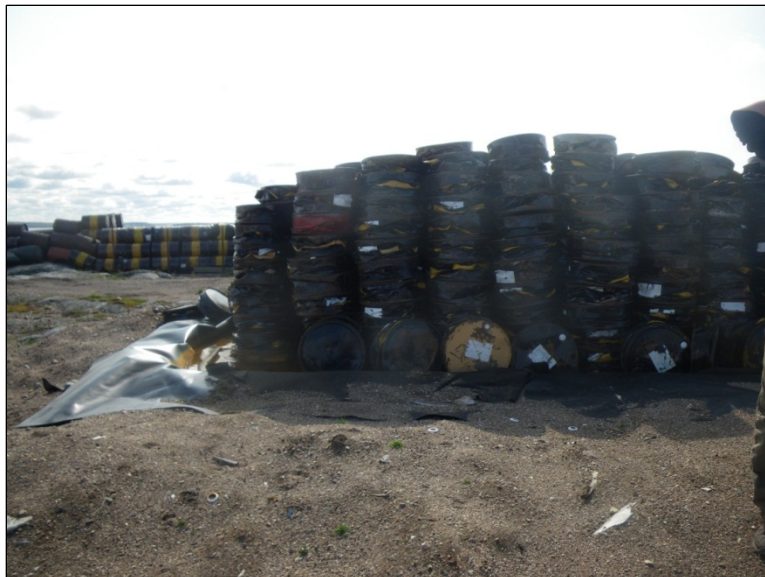
Sampling occurred on August 9, 2013. Untreated water samples were collected from the eastern, western, northern and centre portions of the FCA at depth, at the middle of the water column by way of a portable water pump installed at each of the sampling locations (Plate 4). For QA/QC purposes, duplicates were collected along the eastern and western portions of the FCA in addition to a field blank. An additional sample set was collected from the FCA for analysis of general water quality parameters, including pH, turbidity and nutrients. As requested by the onsite geologist, a grab sample was also collected from a separate area with a liner where crushed fuel barrels were stored on the eastern side of Ferguson Lake Camp (Plates 5 and 6).

*Plate 5. Crushed fuel barrel storage area.*

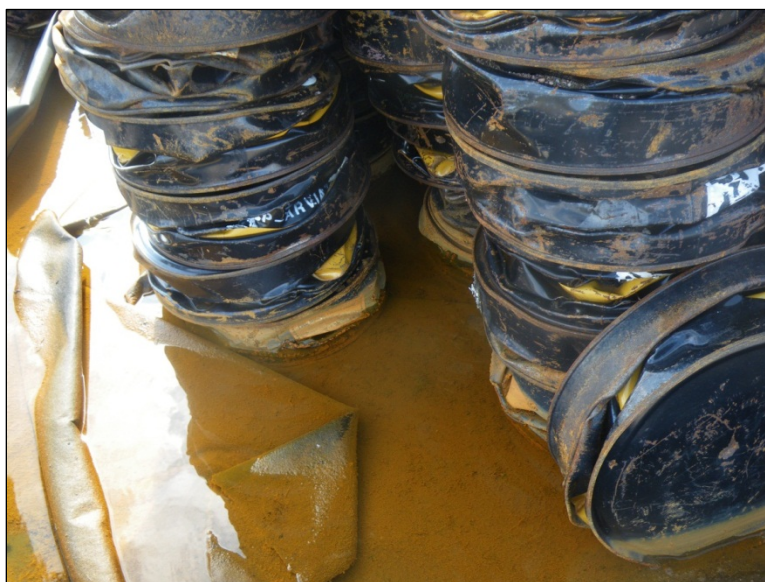
*Plate 6. Standing water in crushed fuel barrels berm with amber colour and visible oil sheen.*

There are 11 CCME water quality guidelines for PAHs and no CCME guidelines for other hydrocarbons (e.g. EPH10-19). All analytical detection limits were lower than corresponding CCME guidelines. No PAHs were detected in untreated waters within the north, east or west sampling locations of the FCA (Appendix 1). Naphthalene and pyrene were detected in the sample collected from the centre location, but at levels less than the CCME guideline value. Pyrene and fluoranthene were detected in the water located under the crushed barrels and exceeded the CCME guideline value by 42% and 38%, respectively (average of the two results; Appendix 1). The volume of water under the crushed barrels was minimal. Field observations confirmed the analytical results, as field technicians did not observe sheen or odour coming from the water in the FCA during the sampling events, but did observe a sheen and odor under the crushed barrels.

Hydrocarbons including extractable petroleum hydrocarbons (EPH), light extractable petroleum hydrocarbons (LEPH), heavy extractable petroleum hydrocarbons (HEPH) and three hydrocarbon fractions (F2, F3 and F4) were generally less than the analytical detection limit in all samples collected from the FCA, except in the centre area sample. Detectable levels of EPH, LEPH, HEPH, F2, and F3 were identified in the centre location (Appendix 1). Detectable hydrocarbons in the centre area sample may be attributed to collection technique. It is likely that fine sediment lining the bottom of the FCA was stirred up by repositioning the pump equipment, thus contaminating the sample. Detectable levels of EPH, LEPH, HEPH, and F3 were observed in the sample collected from under the crushed barrels (Appendix 1). The presence of detectable hydrocarbons in the crushed barrel sample confirms field observations.

Untreated water collected from the FCA was mostly free of detectable PAHs and fell below defined CCME guidelines for the protection of aquatic life (CCME 2011). Untreated water collected from under the crushed barrels, situated on a separate liner, slightly exceeded the CCME guidelines for pyrene and fluoranthene.

The low portion of samples containing hydrocarbons in the contact water suggests that fuel handling practices within the fuel containment area have been good. Given the lack of observable or detectable hydrocarbons in the untreated water located in the FCA, the water meets discharge criteria and can be discharged without treatment provided measures are taken to mitigate other potential impacts from the discharge (e.g., erosion). However, the untreated water located in the separate bermed liner, where the crushed barrels are stored, should not be discharged onto the tundra as a result of collected samples exceeding CCME guidelines. Measures should be taken to ensure the impacted water from the crushed barrels does not breach the liner and water is treated prior to discharge.
