# Memorandum

**SUBJECT:** 2013 Fuel Containment Area Water Sampling

Starfield Resources Inc. constructed and operated a lined embankment secondary containment fuel storage area as part of their Ferguson Lake Project. Canadian North Resources and Development Corp. has acquired the property recently and at their request, ERM Rescan visited the Project area August 7 to 9, 2013 to assess the quality of the impounded water and to provide recommendations on its management.

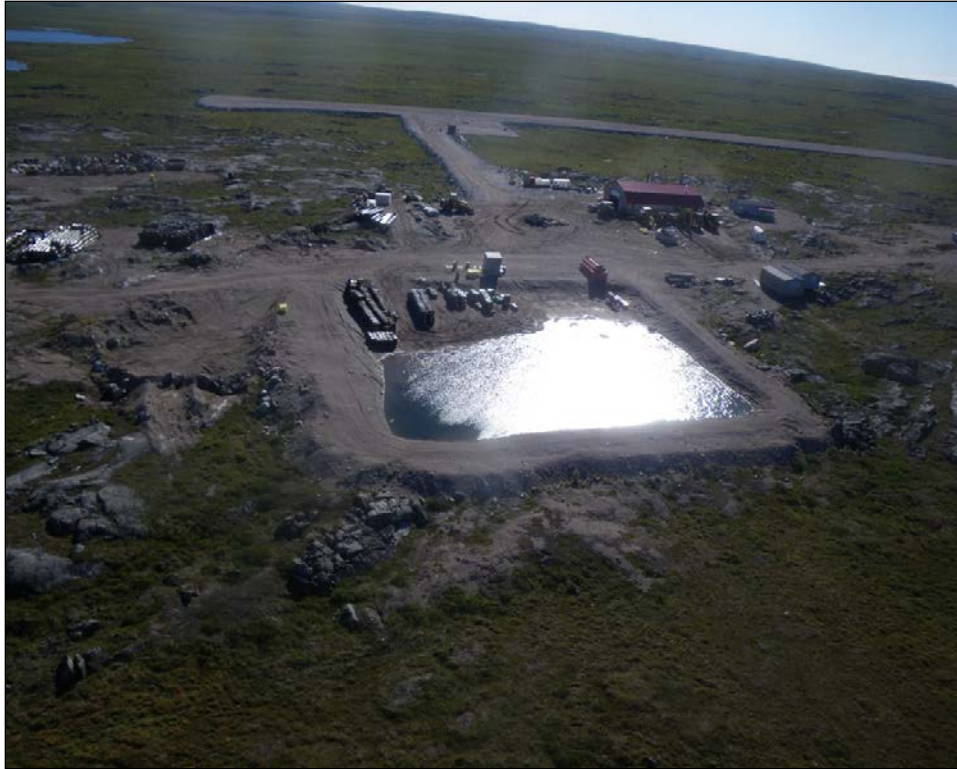
The fuel containment area (FCA) is approximately 40 m × 40 m (Plates 1 and 2). The containment area was constructed using local materials for the embankments and a HDPE liner was welded as the impermeable membrane. The liner was keyed into the top of the embankment and was covered with a non-woven geotextile fabric. A layer of sand and gravel was placed on top of the fabric to form a ramp and a working area within the embankment.

*Plate 1. Aerial view of flooded fuel containment area looking south.*

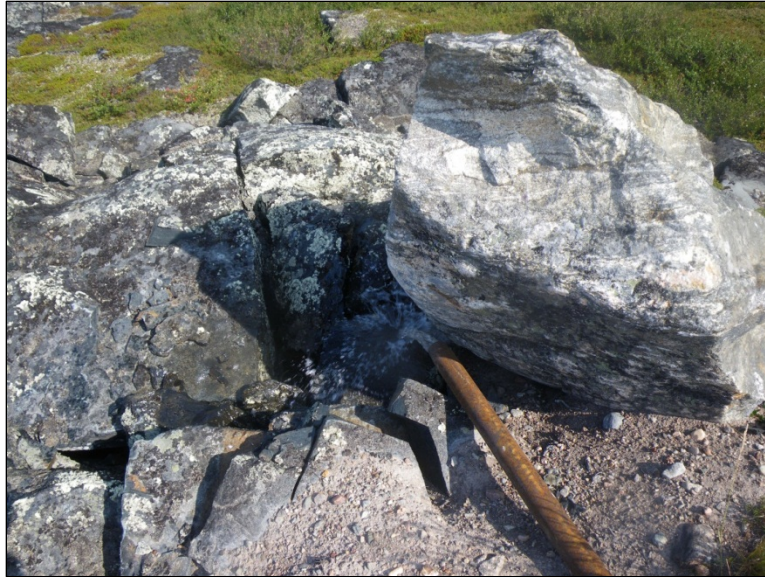
Contact water from snowmelt and rainfall collects seasonally in the containment area. Regular management of this contact water involves assessing water quality prior to discharge of untreated water onto the tundra from a point west of the FCA (Plate 3).

*Plate 3. Western water discharge point.*

The low portion of samples containing hydrocarbons in the contact water suggests that fuel handling practices within the fuel containment area have been good. Given the lack of observable or detectable hydrocarbons in the untreated water located in the FCA, the water meets discharge criteria and can be discharged without treatment provided measures are taken to mitigate other potential impacts from the discharge (e.g., erosion). However, the untreated water located in the separate bermed liner, where the crushed barrels are stored, should not be discharged onto the tundra as a result of collected samples exceeding CCME guidelines. Measures should be taken to ensure the impacted water from the crushed barrels does not breach the liner and water is treated prior to discharge.

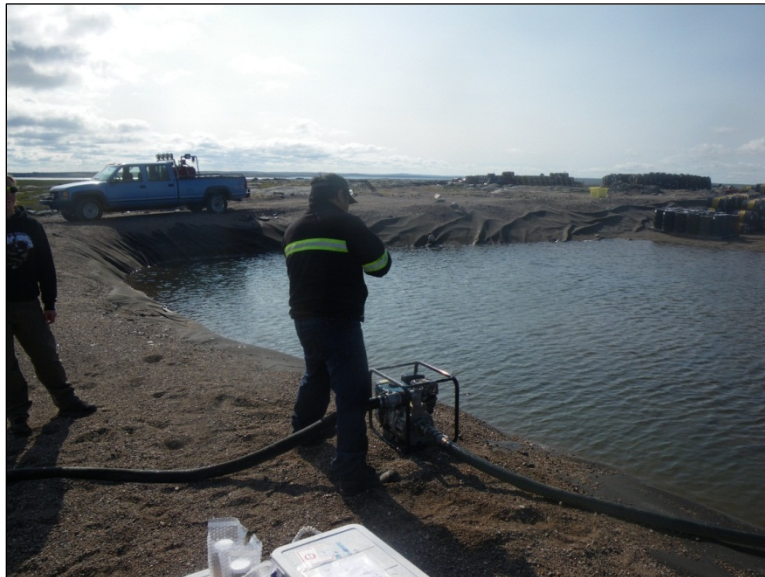
Sampling occurred on August 9, 2013. Untreated water samples were collected from the eastern, western, northern and centre portions of the FCA at depth, at the middle of the water column by way of a portable water pump installed at each of the sampling locations (Plate 4). For QA/QC purposes, duplicates were collected along the eastern and western portions of the FCA in addition to a field blank. An additional sample set was collected from the FCA for analysis of general water quality parameters, including pH, turbidity and nutrients. As requested by the onsite geologist, a grab sample was also collected from a separate area with a liner where crushed fuel barrels were stored on the eastern side of Ferguson Lake Camp (Plates 5 and 6).

*Plate 4. Maintenance worker setting up pump at the centre of the northern edge of the fuel berm area.*

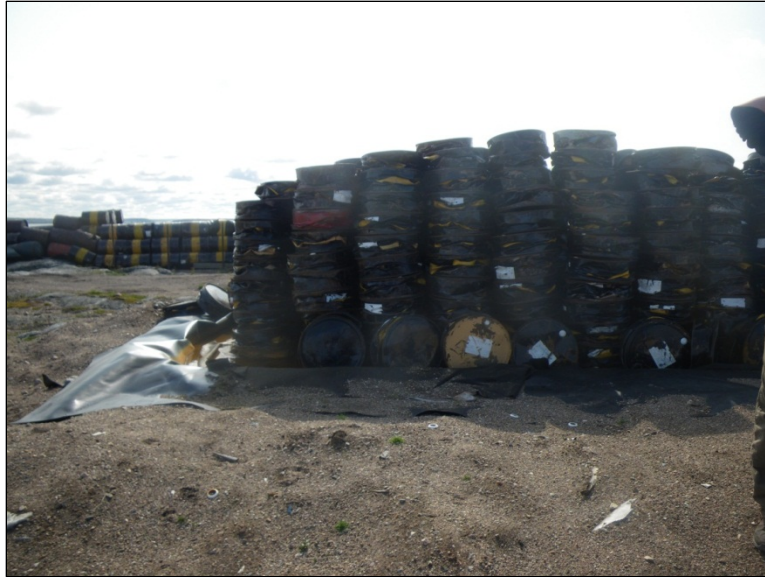
*Plate 5. Crushed fuel barrel storage area.*

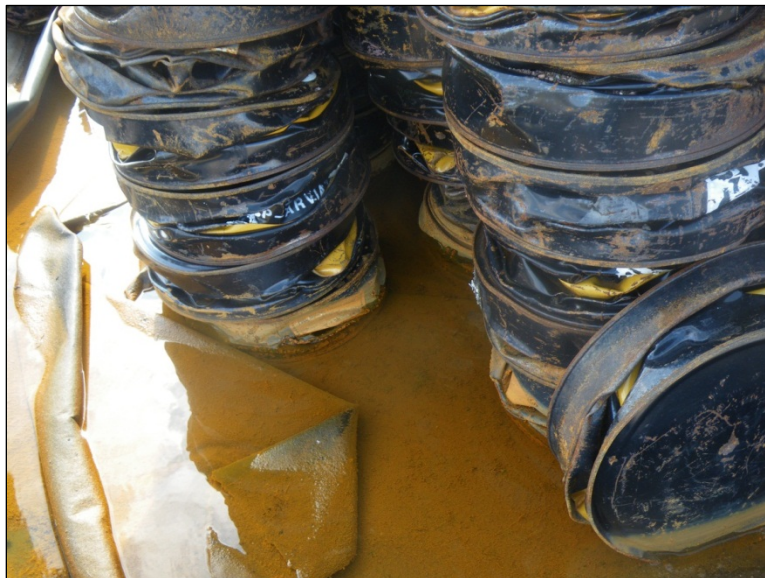
*Plate 6. Standing water in crushed fuel barrels berm with amber colour and visible oil sheen.*

Hydrocarbons including extractable petroleum hydrocarbons (EPH), light extractable petroleum hydrocarbons (LEPH), heavy extractable petroleum hydrocarbons (HEPH) and three hydrocarbon fractions (F2, F3 and F4) were generally less than the analytical detection limit in all samples collected from the FCA, except in the centre area sample. Detectable levels of EPH, LEPH, HEPH, F2, and F3 were identified in the centre location (Appendix 1). Detectable hydrocarbons in the centre area sample may be attributed to collection technique. It is likely that fine sediment lining the bottom of the FCA was stirred up by repositioning the pump equipment, thus contaminating the sample. Detectable levels of EPH, LEPH, HEPH, and F3 were observed in the sample collected from under the crushed barrels (Appendix 1). The presence of detectable hydrocarbons in the crushed barrel sample confirms field observations.

Untreated water collected from the FCA was mostly free of detectable PAHs and fell below defined CCME guidelines for the protection of aquatic life (CCME 2011). Untreated water collected from under the crushed barrels, situated on a separate liner, slightly exceeded the CCME guidelines for pyrene and fluoranthene.
