RE: Water Licence 2BE-FER0712 Inspection Report

RE: Inspection of Water License 2BE-FER0712

PHOTO LOG: 2BE-FER0712

July 13, 2012 INSPECTION

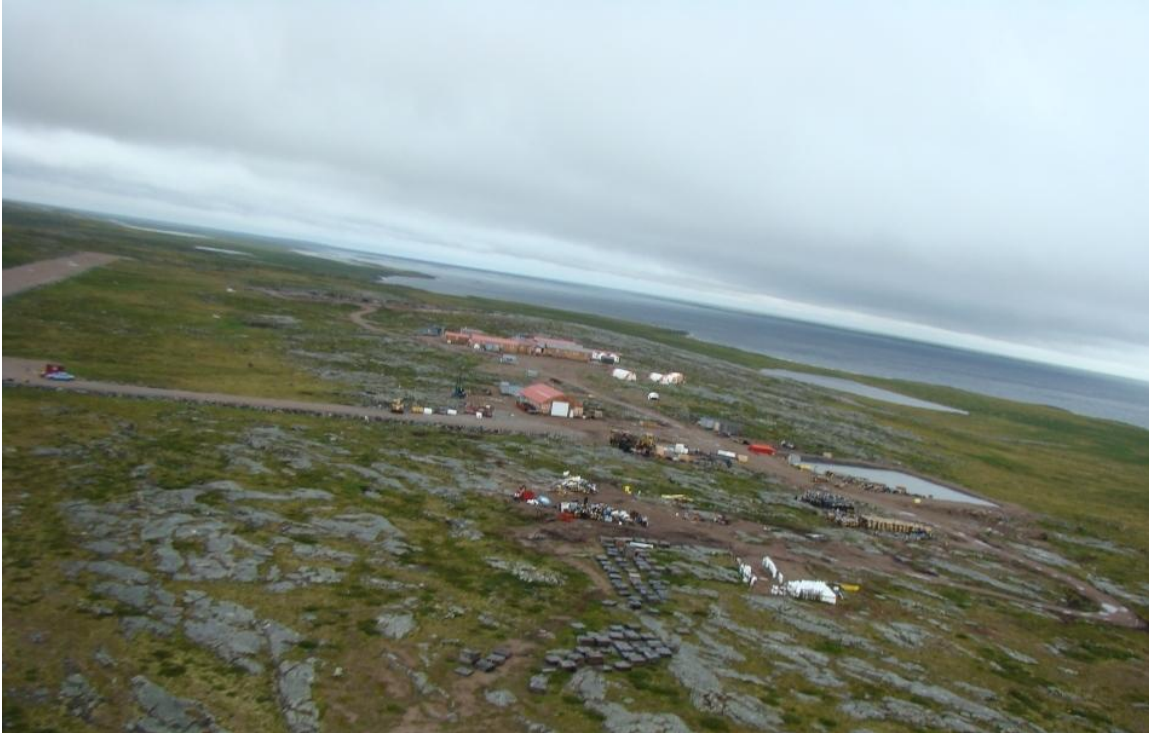
Ferguson Lake Camp, July 13th, 2012 Cwilson

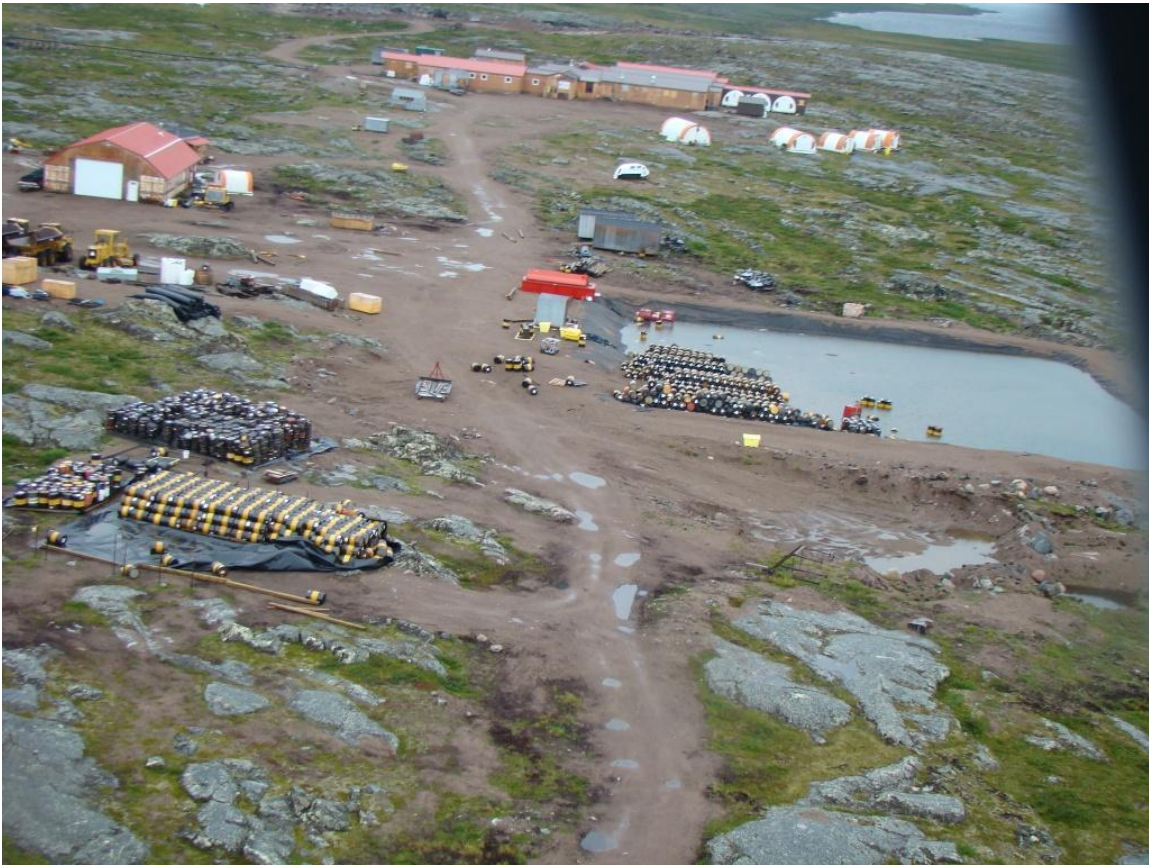
Empty Fuel Drums and Secondary Containment, Ferguson Lake Camp, July 13th, 2012 Cwilson

The Plan titled “A.1-Abandonment and Restoration Plan 2007” details procedures for temporary shutdown. Specifically the Plan details the backhaul of fuel drums to approved facility. During the July 13th inspection 200+ fuel drums are being stored at the site therefore the Licensee has failed to carry out Plans to their full extent.

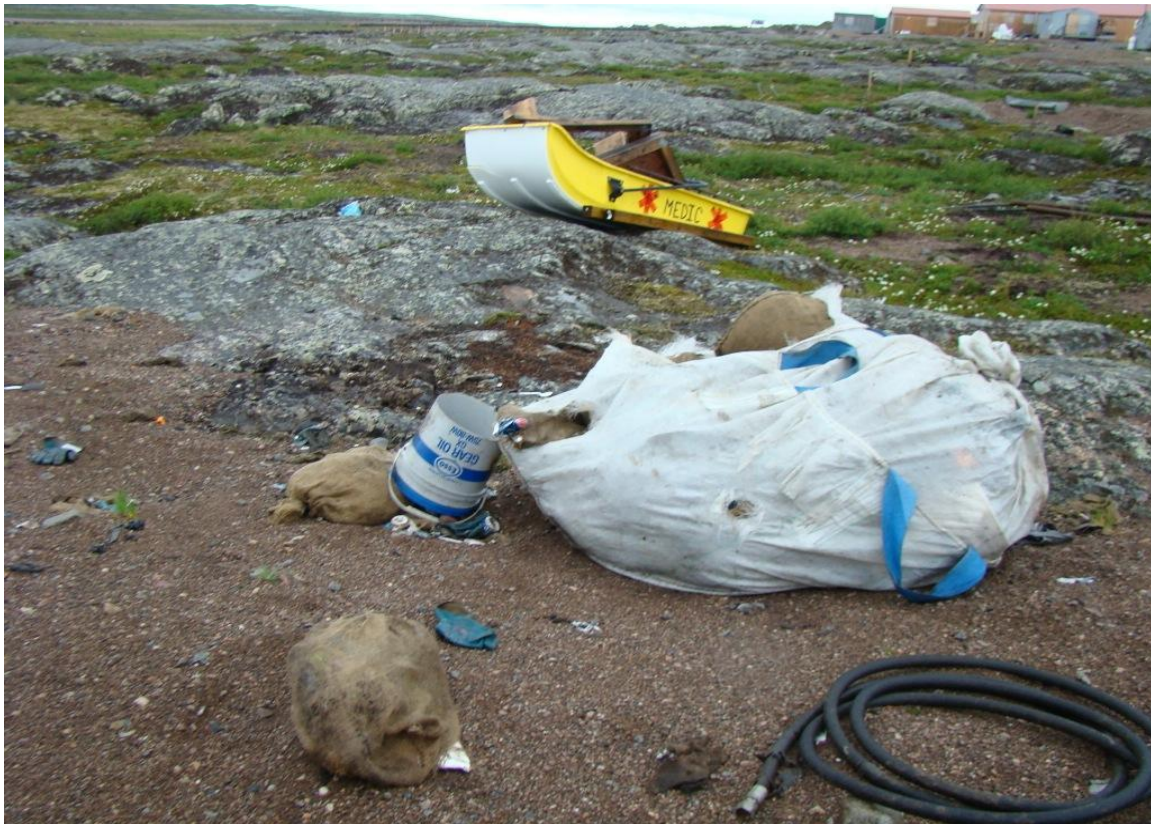
During the inspection on July 13th, 2012 an excessive amount of hazardous materials, empty drums, inert metals and other waste is being stored onsite. Hazardous waste generated through the life of the project is to be backhauled annually. The Project description submitted with the application in 2007 indicated one propane cylinder to be estimated in the fuel used annually. The Inspector counted 100+ propane cylinders; this would indicate that hazardous waste generated from this project has remained onsite.

Unsecured waste, Ferguson Lake Camp, July 13th, 2012 C.wilson

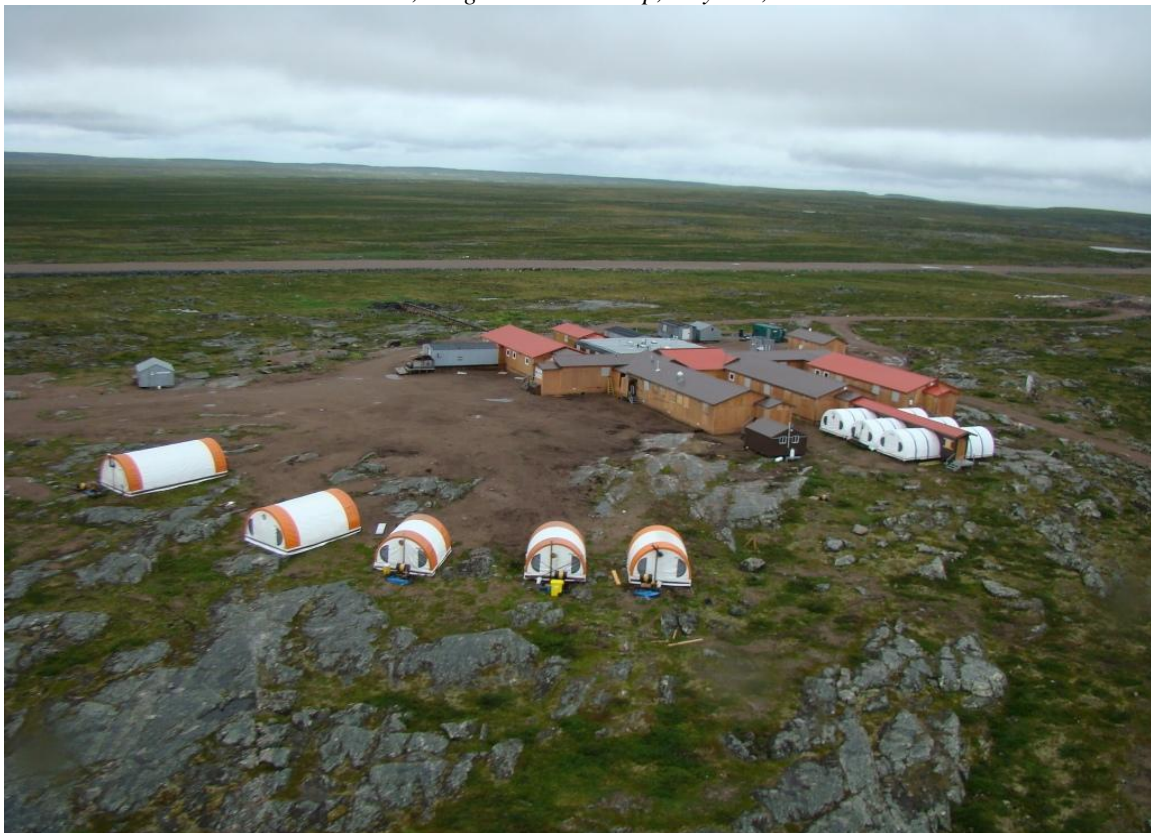
Main Camp, Ferguson Lake Camp , July 13th, 2012 C.wilson

Item 3 of this section requires the Licensee to complete all restoration activities before the expiry of the license. Seeing that the License expired on July 1st, 2012 and the site still remains, the Licensee has failed this requirement.

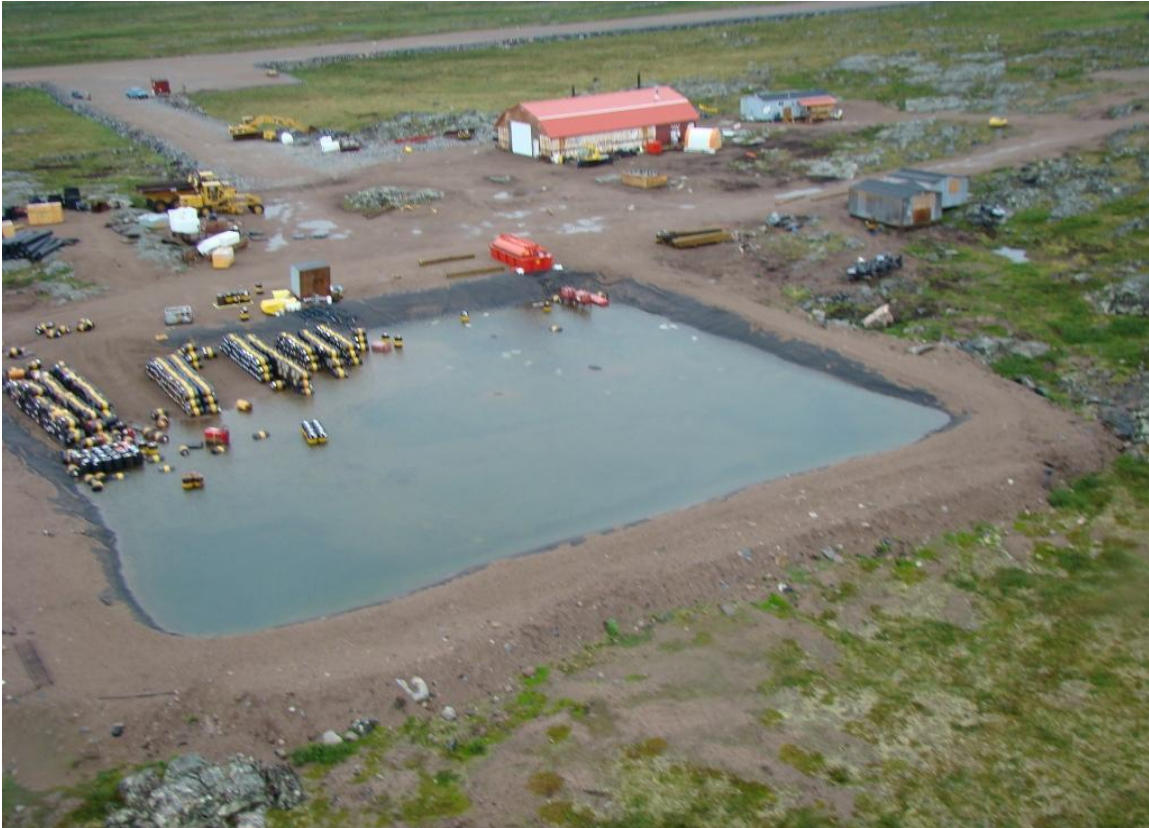
- The License expired on July 1st, 2012.
- Care and maintenance is required immediately; the earthen berm holding drums of hydrocarbon has accumulated a large amount of water.
- The exterior of the earthen berm walls show signs of hydrocarbon staining and overtopping at the northern side of the structure.
- Water with in the berm appears to be contaminated; the water smells of hydrocarbons and has visible sheen
- Hydrocarbon staining indicates spills have occurred around site in numerous locations
- Drums of hydrocarbons are found outside of secondary containment
- Spills have not been reported to spill line
- Garbage and debris scattered around site
- Domestic waste noted outside of incinerator
- Hazardous waste is noted around the site (ect. Oil filters, absorbent materials, fuel kegs, jerry cans, pressurized cylinders)

Earthen berm and contact water, Ferguson Lake Camp, July 13th, 2012, C.wilson

Taking into account the economic situation with Starfield and the coming freshet, this Inspector is concern that the site will remain unmonitored through freshet which may result in a release of hydrocarbons contaminated water.

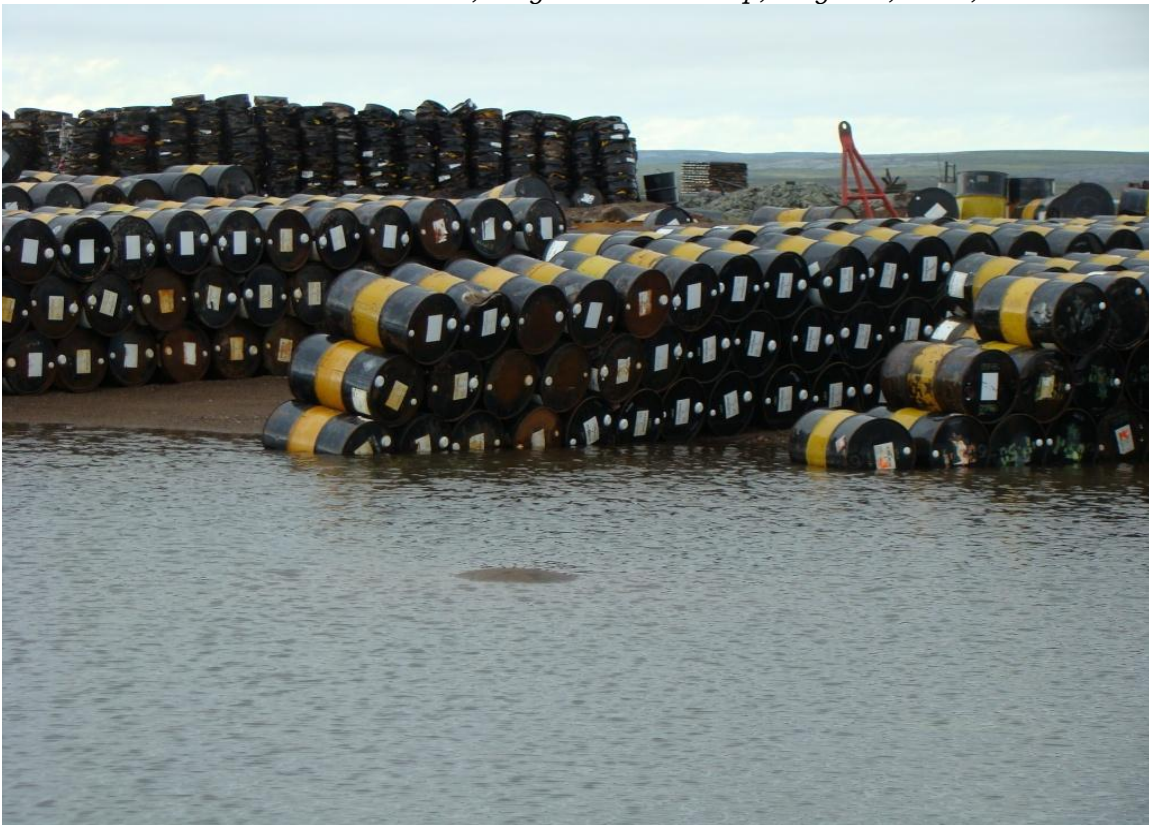
P50, Heating oil and Gasoline, Earthen berm, Ferguson Lake, July 13, 2012 C.wilson

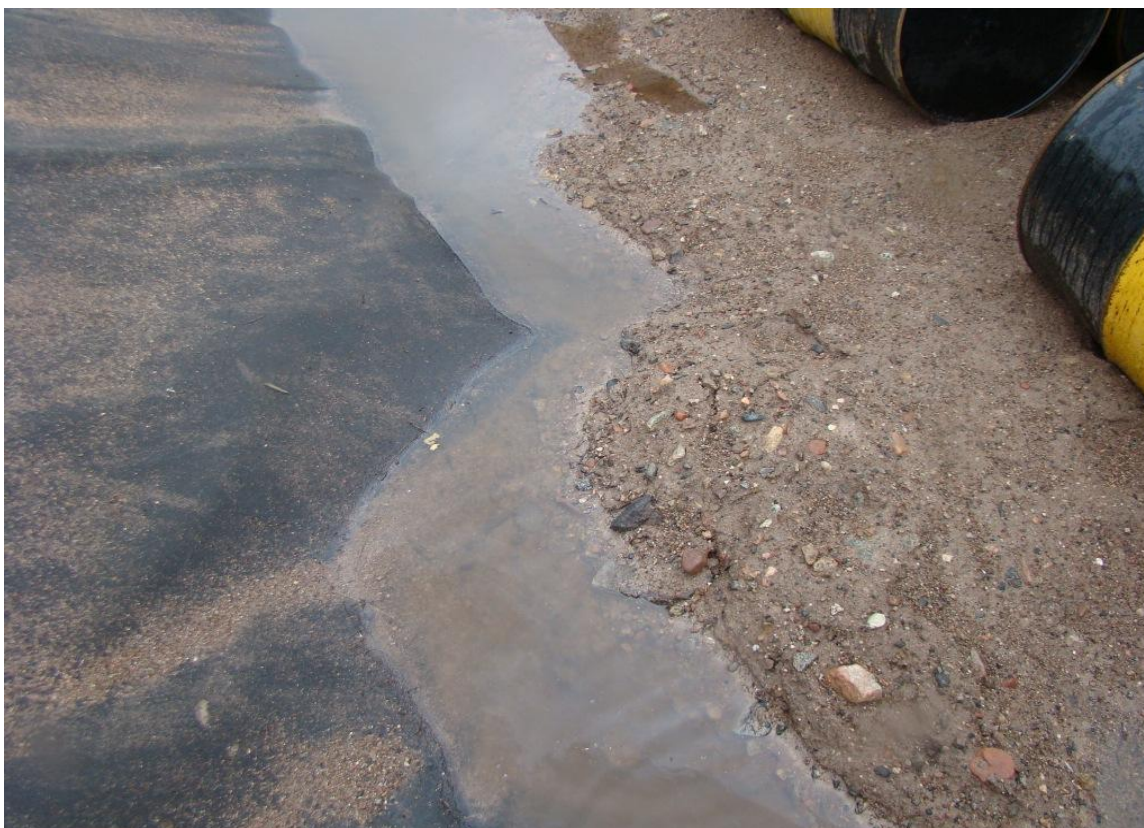
Visible sheen on water in earthen berm, Ferguson Lake, July 13th, 2012, C.wilson

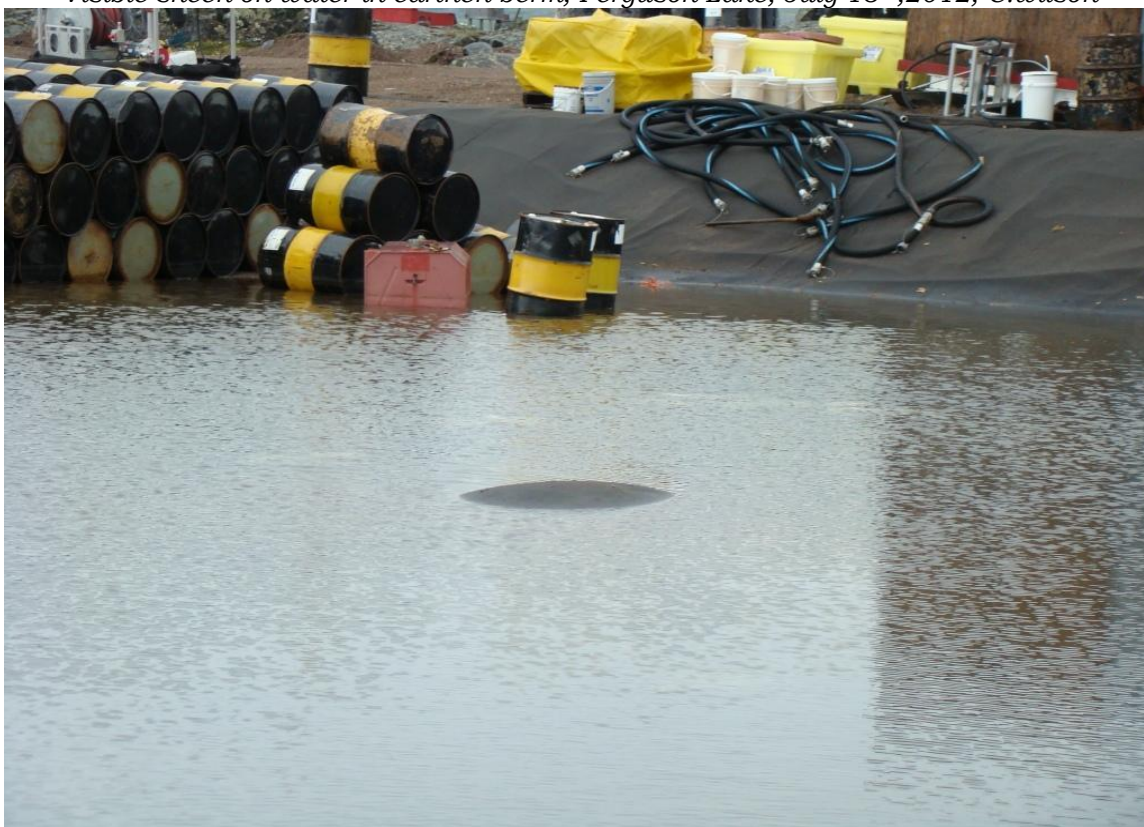
Bubbling in impermeable liner, earthen berm, Ferguson Lake Camp, July 13th, 2012 C.wilson.

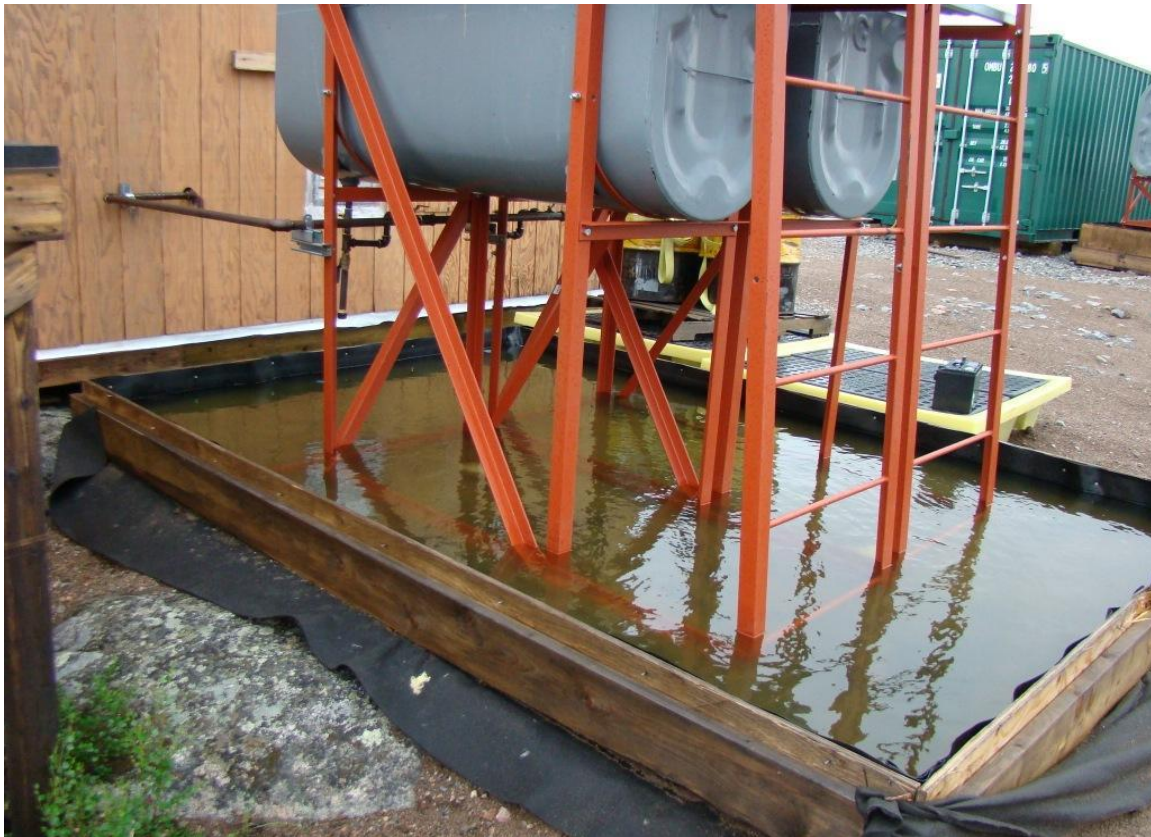
Required care and maintenance, Ferguson Lake Camp, July 13th, 2012, C.wilson

Following the July 13th a Care and Maintenance Plan was submitted by the Licensee to the Inspector. This Plan committed the Licensee to quarterly monitoring requirements at the Ferguson Lake Camp.

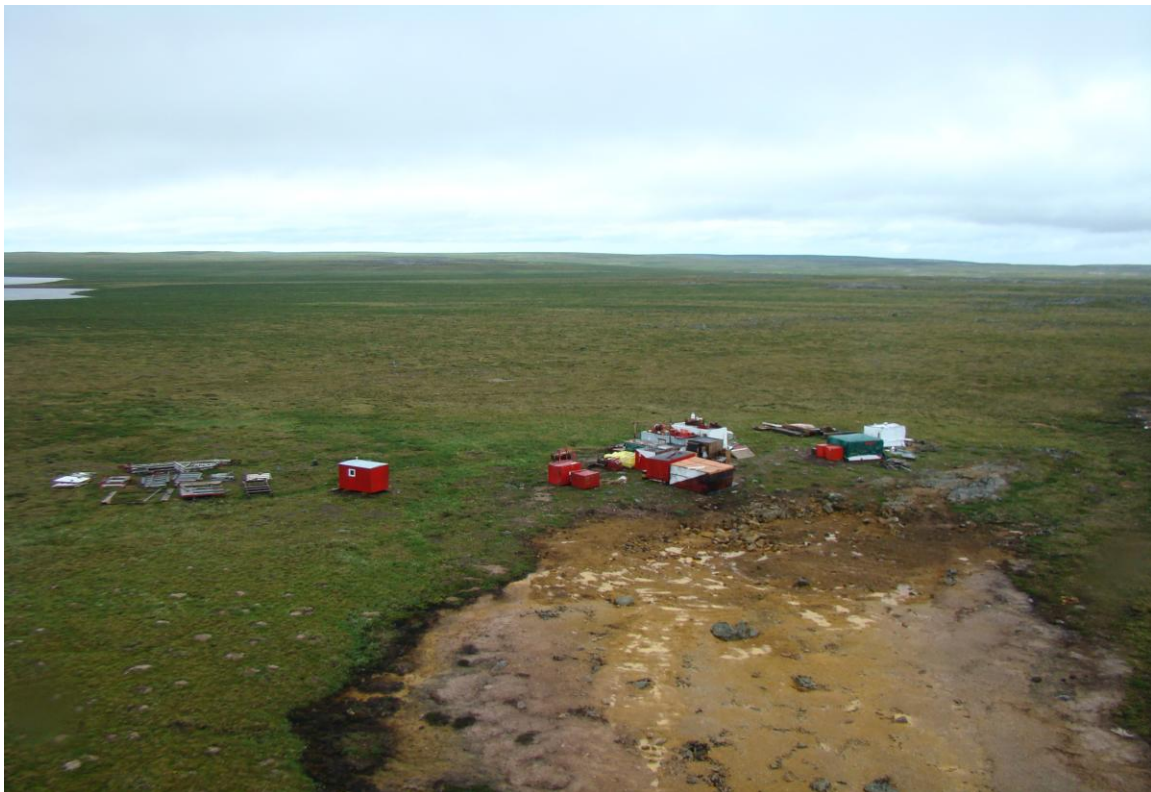
No drilling activities were in progress at the time of inspection. During the July 13th inspection a staging area was noted at a few kilometers from camp to the west.

West Staging Area, Ferguson Lake Camp , July 13th, 2012 C.wilson

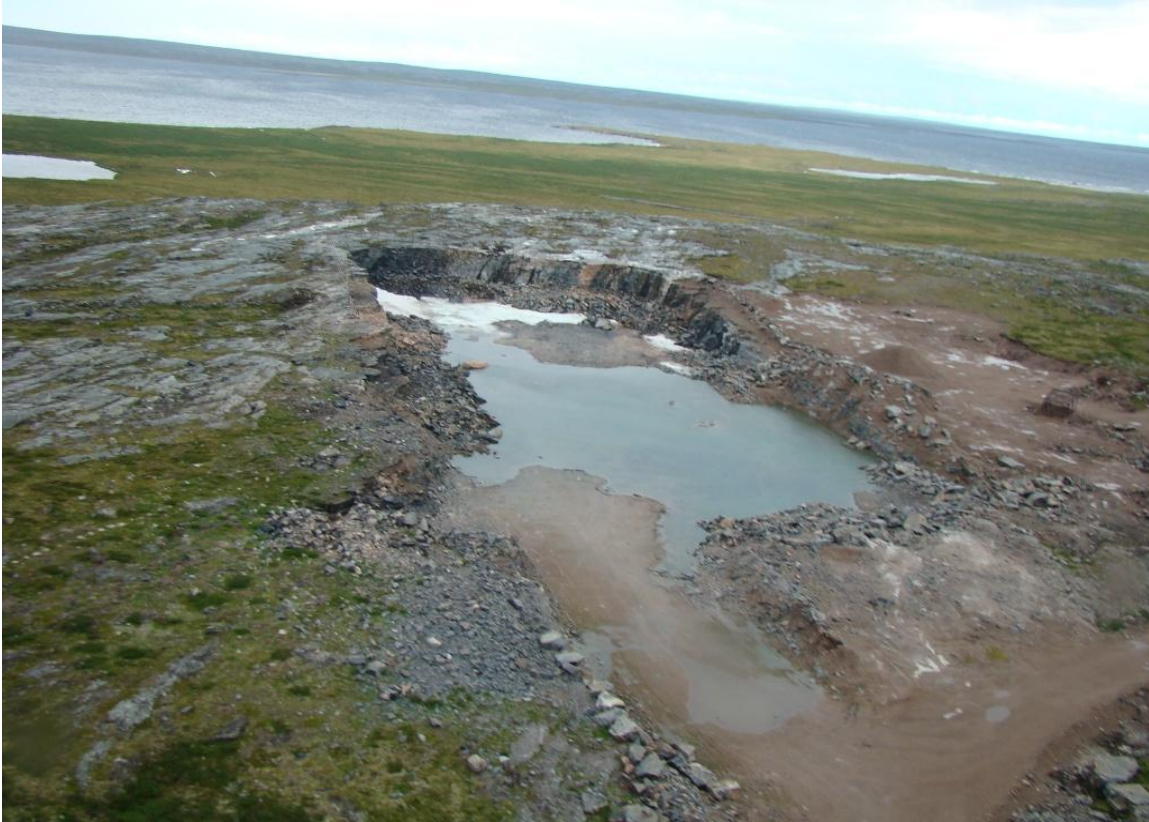
- A quarry is to the north of the main camp. The pit has accumulated a large amount of water
- The old camp across Ferguson Lake, which used to be occupied by Starfield, still remains. It is unclear to the Inspector who is liable for the site as correspondence in the early years of the Ferguson Lake Project indicate that Starfield accepted some responsibilities to clean up the hazardous waste contamination around the site.

Quarry, Ferguson Lake Camp, July 13th, 2012 C.wilson

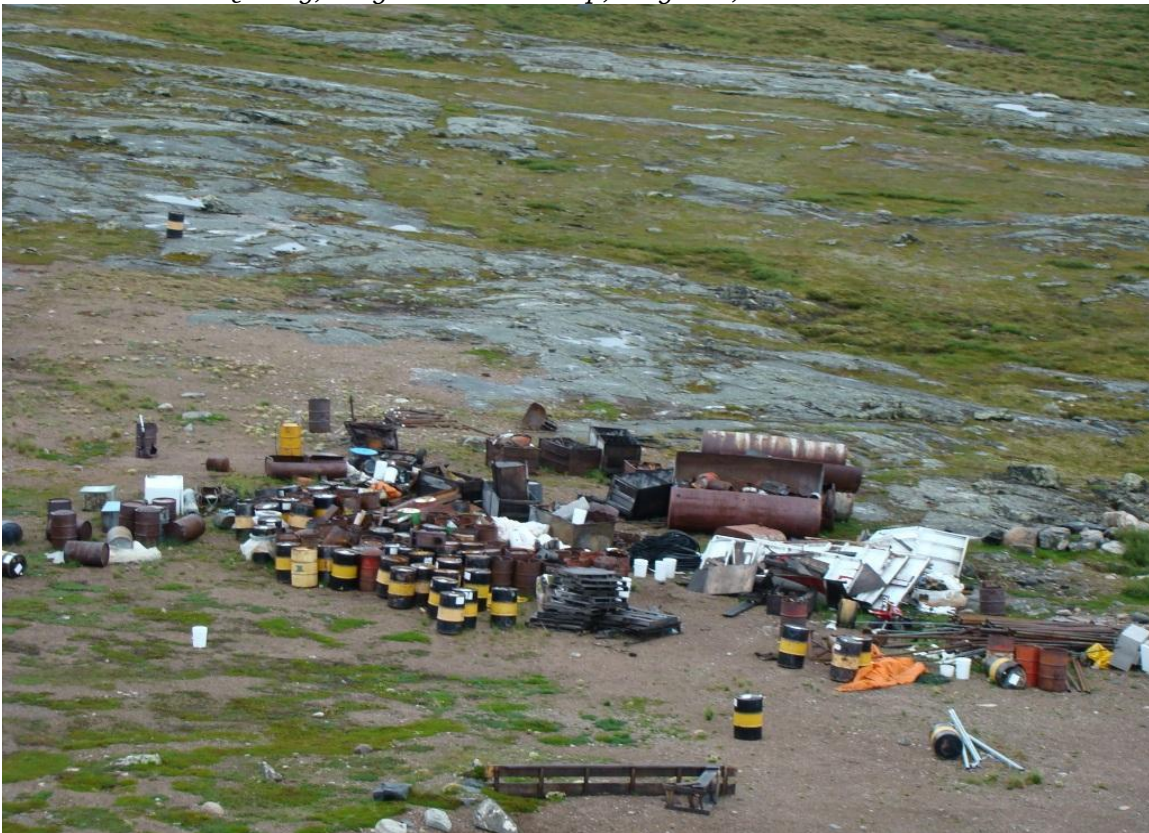
Hazardous Waste dump at old camp, Ferguson Lake Camp, July 13th, 2012, C.wilson

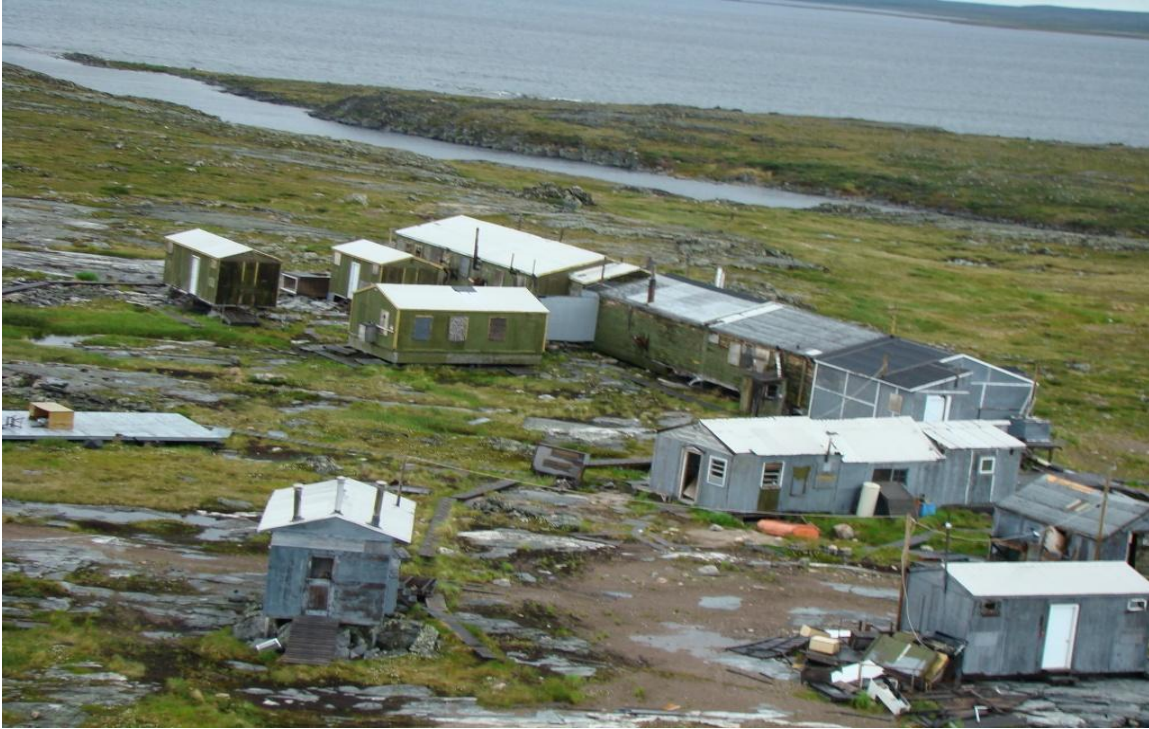
Old Camp, Ferguson Lake Camp, July 13th, 2012 C.wilson

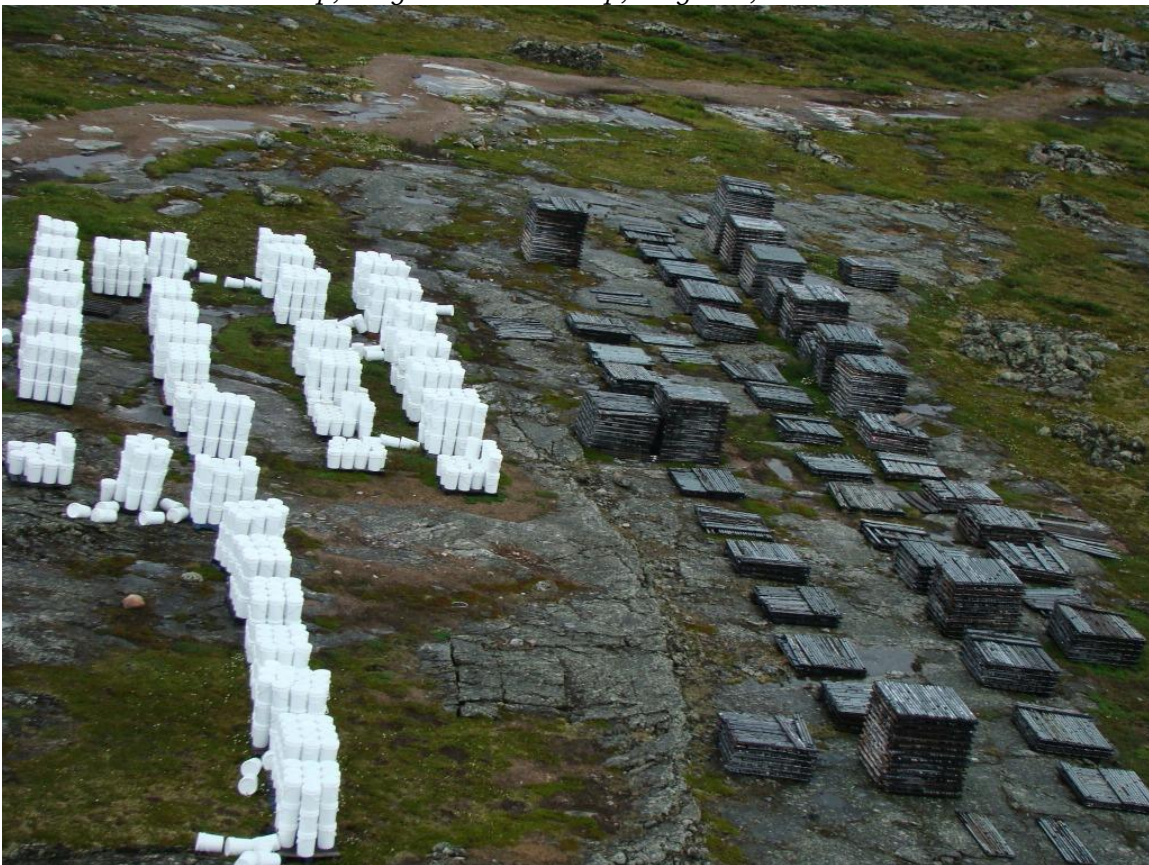
*Core and Rock samples storage at old camp, Ferguson Lake Camp, July 13th, 2012
C.wilson*
